Profile/Photo Observation Report

Date:	09/10/2021	Weather:		Coding:	PACP 7.0
Pipe Length (ft):	50.0	Owner:	City of Hobart	Pre Clean:	No Pre-Cleaning
P.O.#:	YES502259	Surveyor:	S. Bucklin	PSR:	M-504-104.R_M-504-104
Customer:	City of Hobart	Clean Date:		Shape:	C

Street:	North Colorado Street	Flow Control:	Not Controlled
City:	Hobart, IN	Year Renewed:	
Location:	Alley	Tape/Media #:	
Purpose:	Routine Assessment	Dia/Height:	8"
Use:	Sanitary Sewage Pipe	Material:	CP
Drain Area:		Lining:	None
Category:	NA		
Comment:

Location Details:		Direction of Survey:	Upstream
US MH:	M-504-104.R	DS MH:	M-504-104
		Total Length Surveyed (ft):	1.6

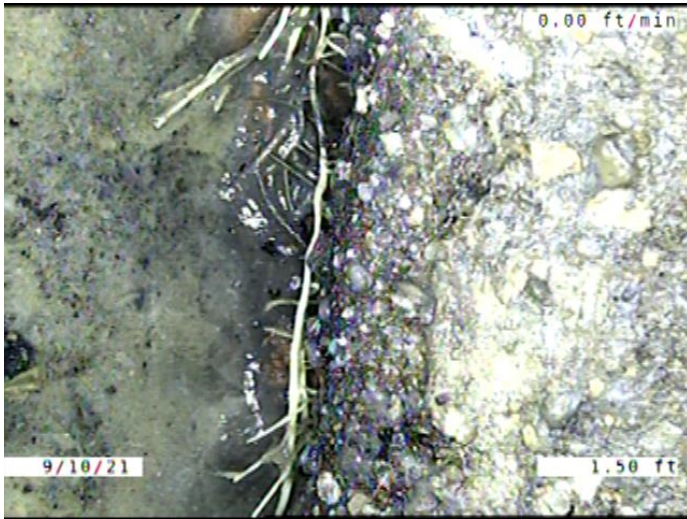
Code: **HSV**
Description: **Hole Soil Visible**

Distance (ft): **1.5**
Structural Grade: **5**
O&M Grade: **0**
Clock Start/From: **4**
Clock To: **5**
1st Value:
2nd Value:
Value Percent:
Continuous Index:
Within 8" of Joint: **YES**
Remarks:

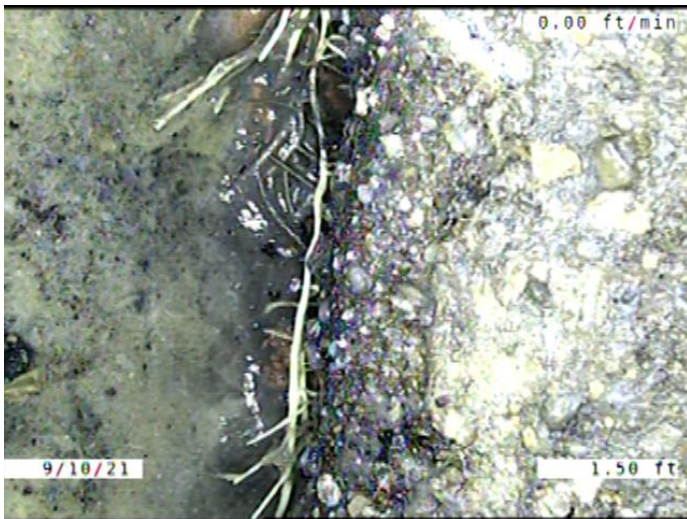
Code: **RFB**
Description: **Roots Fine Barrel**

Distance (ft): **1.5**
Structural Grade: **0**
O&M Grade: **2**
Clock Start/From: **4**
Clock To:
1st Value:
2nd Value:
Value Percent:
Continuous Index:
Within 8" of Joint: **NO**
Remarks:
