Profile/Photo Observation Report

Street:	Eastin Ave.	Flow Control:	Not Controlled
City:	Hobart, IN	Year Renewed:	
Location:	Other	Tape/Media #:	
Purpose:	Not Known	Dia/Height:	8"
Use:	Sanitary	Material:	PVC
Drain Area:	NA	Lining:	
Category:	NA		
Comment:

Location Details:		Direction of Survey:	Upstream
US MH:	M-1004-097	DS MH:	M-1004-003
		Total Length Surveyed (ft):	257.2

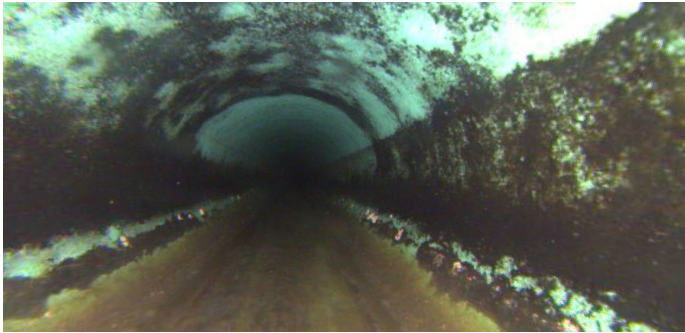
Code:	MWL
Description:	Water Level

Distance (ft):	.0
Structural Grade:	0
O&M Grade:	0
Clock Start/From:	
Clock To:	
1st Value:	
2nd Value:	
Value Percent:	10.000
Continuous Index:	
Within 8" of Joint:	NO
Remarks:

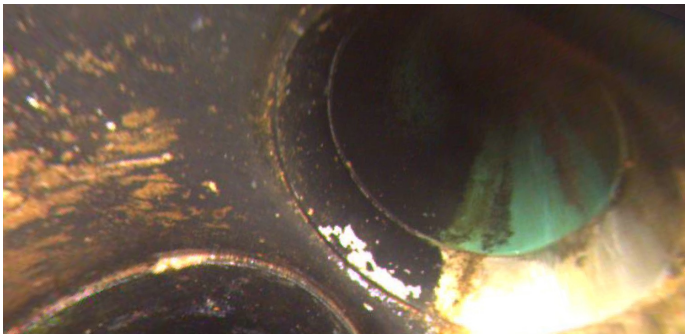
Code:	TFA
Description:	Tap Factory Active

Distance (ft):	95.9
Structural Grade:	0
O&M Grade:	0
Clock Start/From:	1
Clock To:	
1st Value:	4.000
2nd Value:	
Value Percent:	
Continuous Index:	
Within 8" of Joint:	
Remarks:

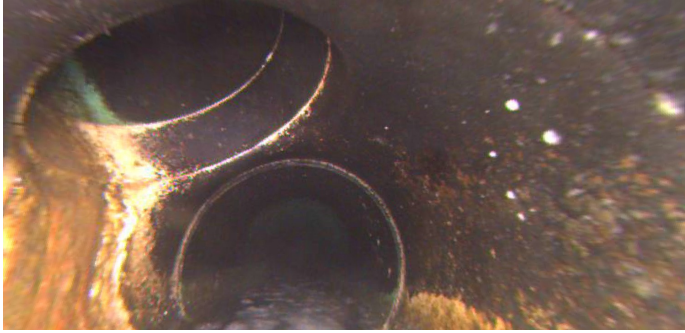
Code: **TFA**
Description: **Tap Factory Active**

Distance (ft): **106.4**
Structural Grade: **0**
O&M Grade: **0**
Clock Start/From: **11**
Clock To:
1st Value: **4.000**
2nd Value:
Value Percent:
Continuous Index:
Within 8" of Joint:
Remarks:

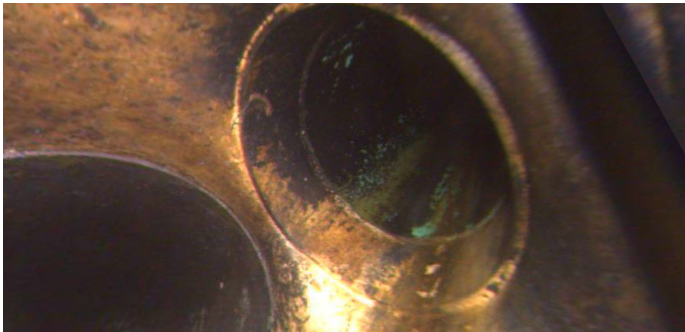
Code: **TF**
Description: **Tap Factory**

Distance (ft): **239.5**
Structural Grade: **0**
O&M Grade: **0**
Clock Start/From: **2**
Clock To:
1st Value: **4.000**
2nd Value:
Value Percent:
Continuous Index:
Within 8" of Joint:
Remarks:

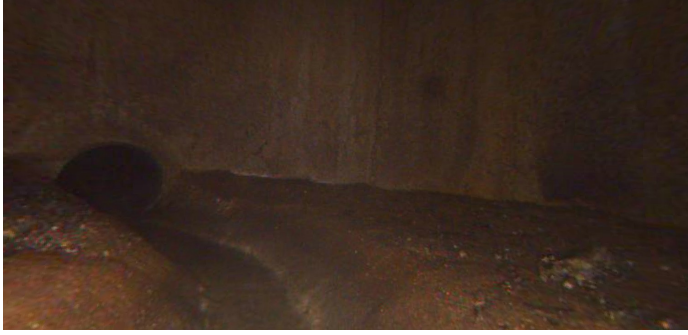
Code:	AMH
Description:	Manhole
Distance (ft):	257.2
Structural Grade:	0
O&M Grade:	0
Clock Start/From:	
Clock To:	
1st Value:	
2nd Value:	
Value Percent:	
Continuous Index:	
Within 8" of Joint:	NO
Remarks:	M-1004-097
