Profile/Photo Observation Report

Street:	S County Line Rd.	Flow Control:	Not Controlled
City:	Hobart, IN	Year Renewed:	
Location:	Other	Tape/Media #:	
Purpose:	Not Known	Dia/Height:	8"
Use:	Sanitary	Material:	PVC
Drain Area:	NA	Lining:	
Category:	NA		
Comment:

Location Details:		Direction of Survey:	Downstream
US MH:	M-1005-003	DS MH:	M-1005-004
		Total Length Surveyed (ft):	327.5

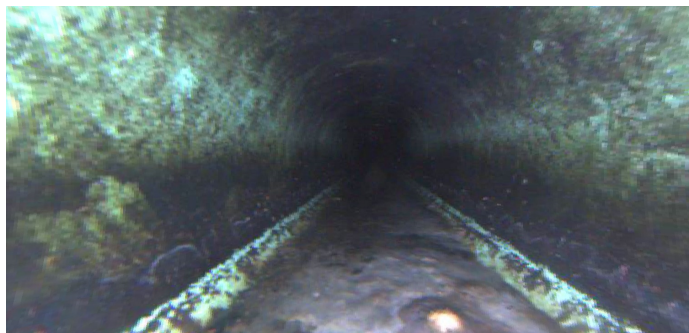
Code: **MWL**
Description: **Water Level**

Distance (ft): **.0**
Structural Grade: **0**
O&M Grade: **0**
Clock Start/From:
Clock To:
1st Value:
2nd Value:
Value Percent: **5.000**
Continuous Index:
Within 8" of Joint: **NO**
Remarks:

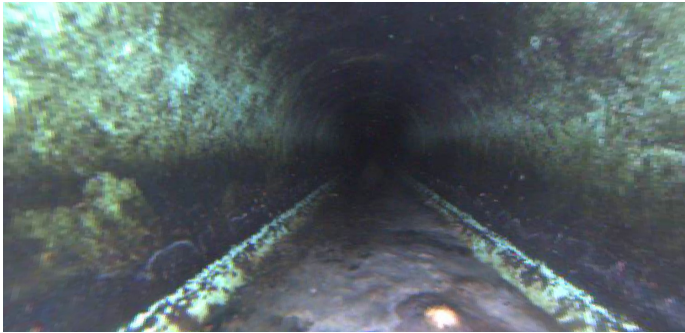
Code: **AMH**
Description: **Manhole**

Distance (ft): **.0**
Structural Grade: **0**
O&M Grade: **0**
Clock Start/From:
Clock To:
1st Value:
2nd Value:
Value Percent:
Continuous Index:
Within 8" of Joint: **NO**
Remarks: **M-1005-003**

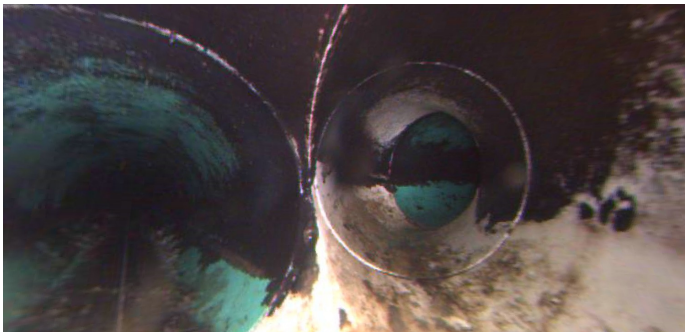
Code: **TF**
Description: **Tap Factory**

Distance (ft): **18.9**
Structural Grade: **0**
O&M Grade: **0**
Clock Start/From: **9**
Clock To:
1st Value: **4.000**
2nd Value:
Value Percent:
Continuous Index:
Within 8" of Joint:
Remarks:

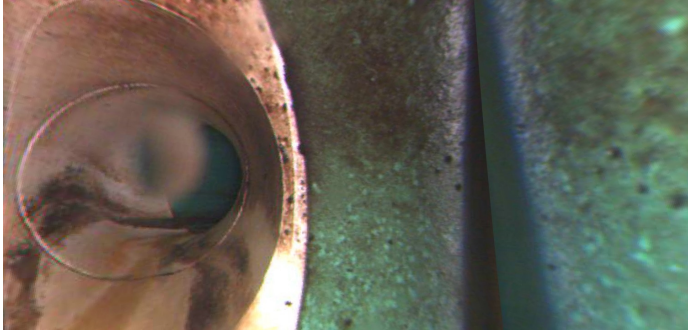
Code: **TF**
Description: **Tap Factory**

Distance (ft): **101.6**
Structural Grade: **0**
O&M Grade: **0**
Clock Start/From: **9**
Clock To:
1st Value: **4.000**
2nd Value:
Value Percent:
Continuous Index:
Within 8" of Joint:
Remarks:

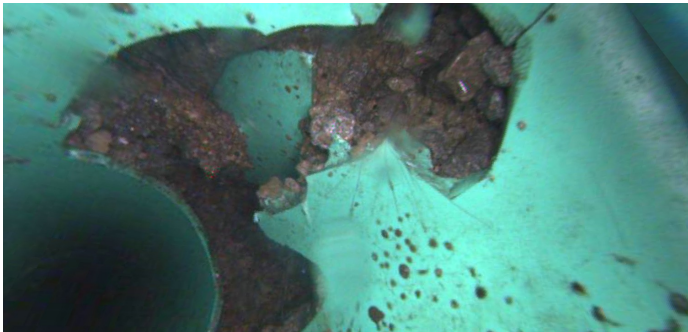
Code: **BSV**
Description: **Broken Soil Visible**

Distance (ft): **150.5**
Structural Grade: **5**
O&M Grade: **0**
Clock Start/From: **10**
Clock To: **12**
1st Value:
2nd Value:
Value Percent:
Continuous Index:
Within 8" of Joint: **YES**
Remarks:

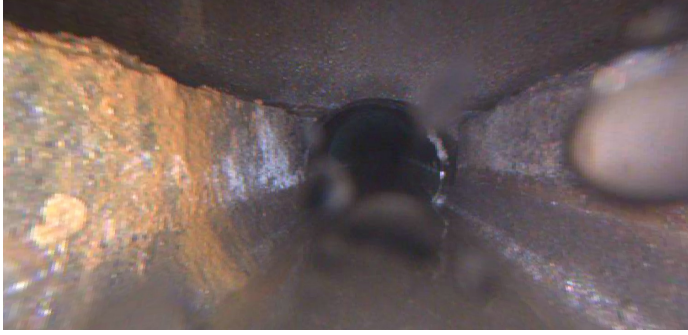
Code:	AMH
Description:	Manhole
Distance (ft):	327.5
Structural Grade:	0
O&M Grade:	0
Clock Start/From:	
Clock To:	
1st Value:	
2nd Value:	
Value Percent:	
Continuous Index:	
Within 8" of Joint:	NO
Remarks:	M-1005-004
