Profile/Photo Observation Report

Street:	E Cleveland Ave.	Flow Control:	Not Controlled
City:	Hobart, IN	Year Renewed:	
Location:	Other	Tape/Media #:	
Purpose:	Not Known	Dia/Height:	8"
Use:	Sanitary	Material:	PVC
Drain Area:	NA	Lining:	
Category:	NA		
Comment:

Location Details:		Direction of Survey:	Upstream
US MH:	M-1005-005	DS MH:	M-1004-001
		Total Length Surveyed (ft):	145.8

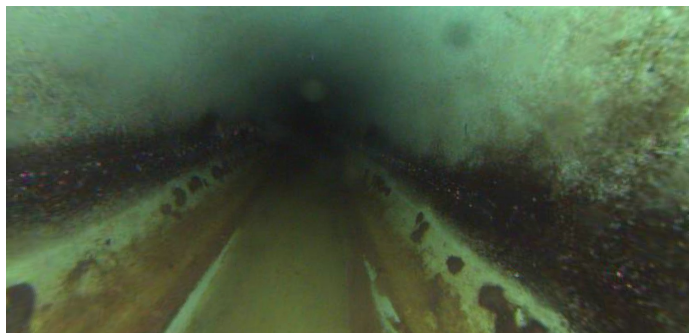
Code: **AMH**
Description: **Manhole**

Distance (ft): **.0**
Structural Grade: **0**
O&M Grade: **0**
Clock Start/From:
Clock To:
1st Value:
2nd Value:
Value Percent:
Continuous Index:
Within 8" of Joint: **NO**
Remarks: **M-1004-001**

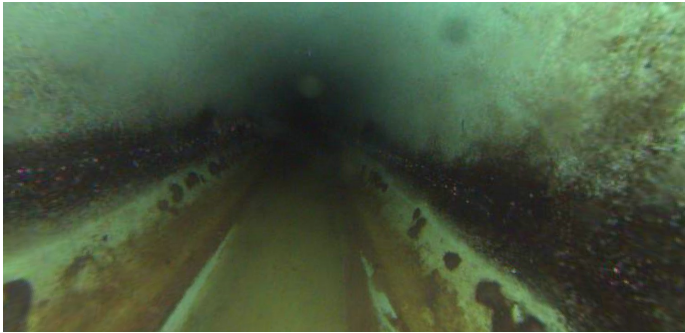
Code:	MWL
Description:	Water Level

Distance (ft):	.0
Structural Grade:	0
O&M Grade:	0
Clock Start/From:	
Clock To:	
1st Value:	
2nd Value:	
Value Percent:	5.000
Continuous Index:	
Within 8" of Joint:	NO
Remarks:

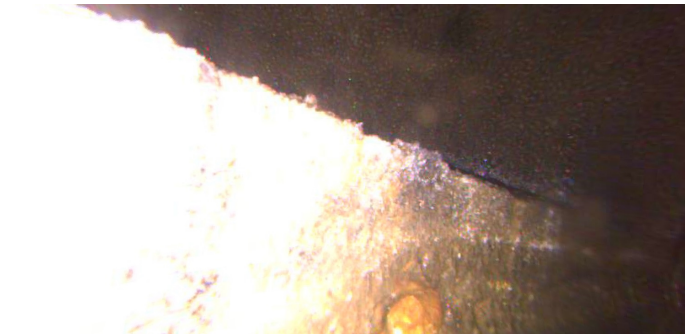
Code:	AMH
Description:	Manhole

Distance (ft):	145.8
Structural Grade:	0
O&M Grade:	0
Clock Start/From:	
Clock To:	
1st Value:	
2nd Value:	
Value Percent:	
Continuous Index:	
Within 8" of Joint:	NO
Remarks:	M-1005-005
