Profile/Photo Observation Report

Date:	01/14/2023	Weather:		Coding:	PACP 7.0
Pipe Length (ft):		Owner:	City of Hobart	Pre Clean:	Heavy Cleaning
P.O.#:	YES502259	Surveyor:	S. Bucklin	PSR:	M-905-009.1-M-905-009
Customer:	City of Hobart	Clean Date:	10/15/2022	Shape:	C

Street:	Sullivan Street	Flow Control:	Not Controlled
City:	Hobart, IN	Year Renewed:	
Location:	Local rural streets with light traffic, t	Tape/Media #:	
Purpose:	Routine Assessment	Dia/Height:	8"
Use:	Sanitary Sewage Pipe	Material:	PVC
Drain Area:		Lining:	None
Category:	NA		
Comment:			
Location Details:		Direction of Survey:	Upstream
US MH:	M-905-009.1	DS MH:	M-905-009
		Total Length Surveyed (ft):	66.3

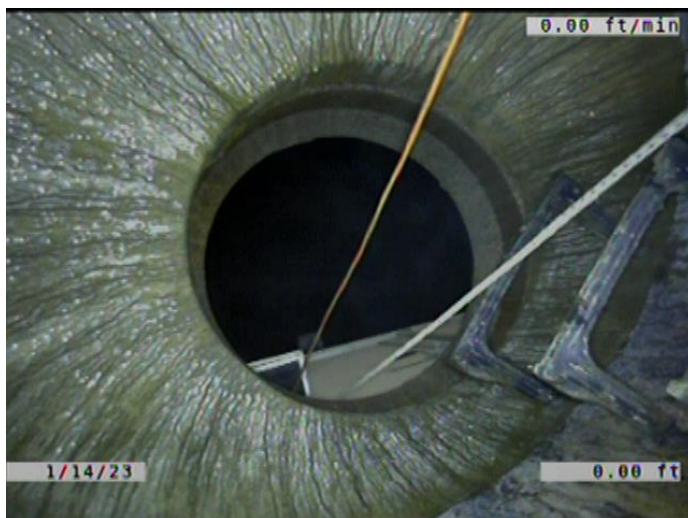
Code: **AMH**
 Description: **Manhole**

Distance (ft): **.0**
 Structural Grade: **0**
 O&M Grade: **0**
 Clock Start/From:
 Clock To:
 1st Value:
 2nd Value:
 Value Percent:
 Continuous Index:
 Within 8" of Joint: **NO**
 Remarks: **M-905-009**

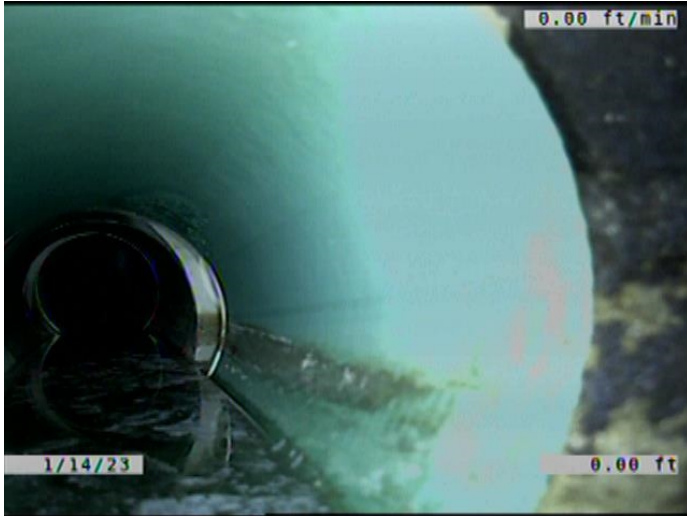
Code: **MWL**
Description: **Miscellaneous Water Level**

Distance (ft): **.0**
Structural Grade: **0**
O&M Grade: **0**
Clock Start/From:
Clock To:
1st Value:
2nd Value:
Value Percent: **15.000**
Continuous Index:
Within 8" of Joint: **NO**
Remarks:

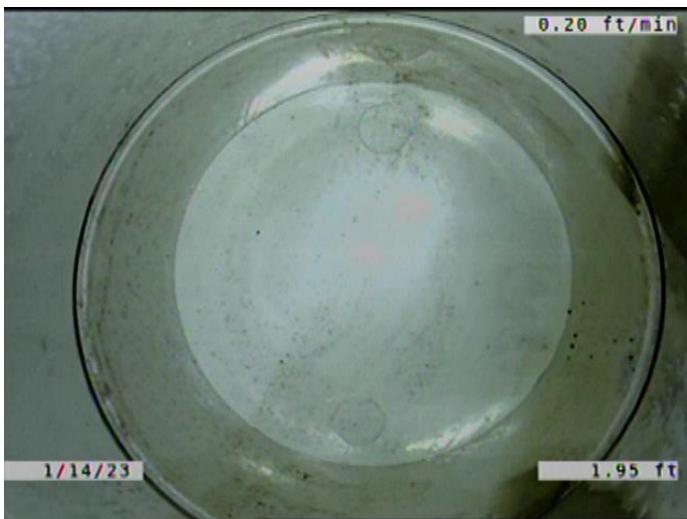
Code: **TFC**
Description: **Tap Factory Capped**

Distance (ft): **1.9**
Structural Grade: **0**
O&M Grade: **0**
Clock Start/From: **3**
Clock To:
1st Value: **6.000**
2nd Value:
Value Percent:
Continuous Index:
Within 8" of Joint: **YES**
Remarks:

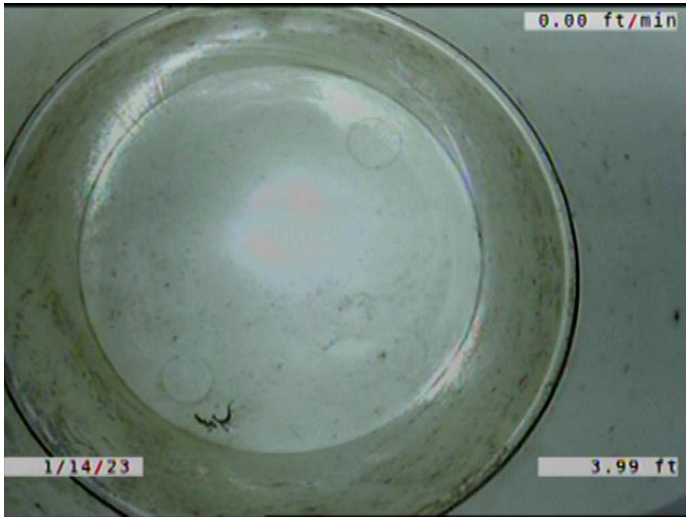
Code: **TFC**
 Description: **Tap Factory Capped**

Distance (ft): **4.0**
 Structural Grade: **0**
 O&M Grade: **0**
 Clock Start/From: **10**
 Clock To:
 1st Value: **6.000**
 2nd Value:
 Value Percent:
 Continuous Index:
 Within 8" of Joint: **YES**
 Remarks:

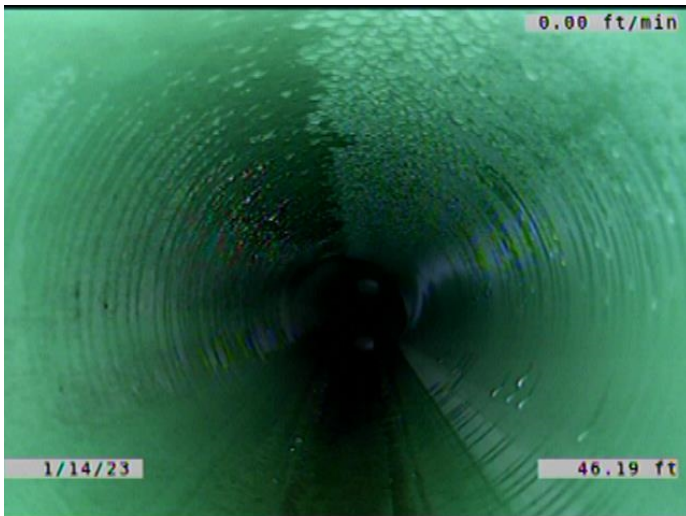
Code: **MWLS**
 Description: **Miscellaneous Water Level Sag**

Distance (ft): **46.2**
 Structural Grade: **2**
 O&M Grade: **0**
 Clock Start/From:
 Clock To:
 1st Value:
 2nd Value:
 Value Percent: **5.000**
 Continuous Index: **S01**
 Within 8" of Joint: **NO**
 Remarks:

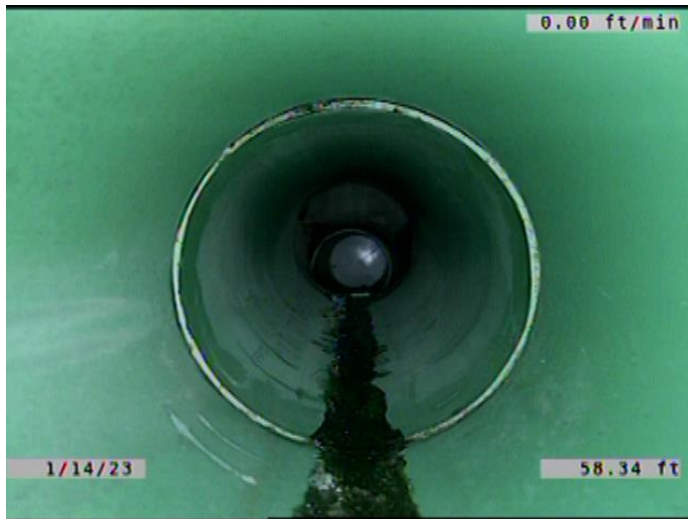
Code: **MWLS**
Description: **Miscellaneous Water Level Sag**

Distance (ft): **58.3**
Structural Grade: **2**
O&M Grade: **0**
Clock Start/From:
Clock To:
1st Value:
2nd Value:
Value Percent: **5.000**
Continuous Index: **F01**
Within 8" of Joint: **NO**
Remarks:

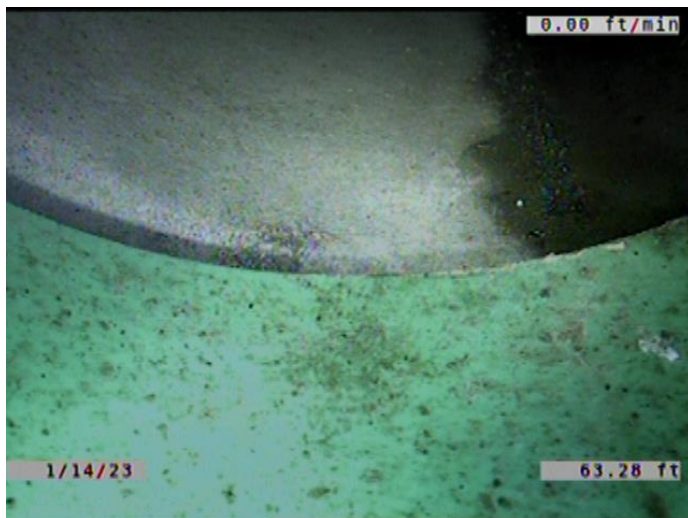
Code: **JAM**
Description: **Joint Angular Medium**

Distance (ft): **63.3**
Structural Grade: **3**
O&M Grade: **0**
Clock Start/From:
Clock To:
1st Value:
2nd Value:
Value Percent:
Continuous Index:
Within 8" of Joint: **NO**
Remarks:

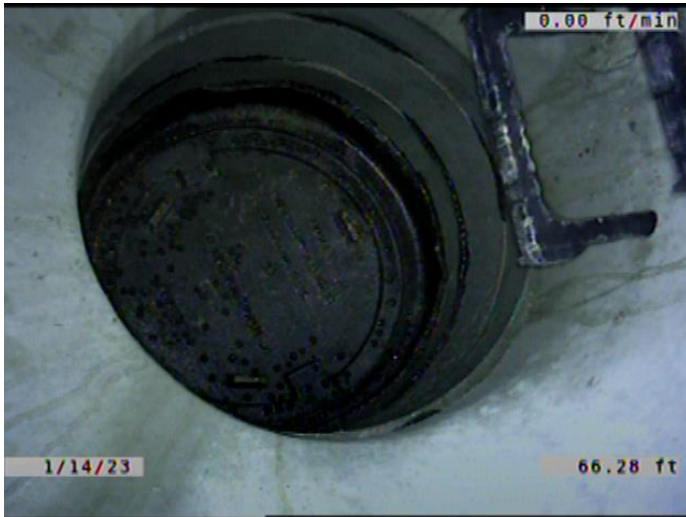
Code:	AMH
Description:	Manhole
Distance (ft):	66.3
Structural Grade:	0
O&M Grade:	0
Clock Start/From:	
Clock To:	
1st Value:	
2nd Value:	
Value Percent:	
Continuous Index:	
Within 8" of Joint:	NO
Remarks:	M-905-009.1
