Profile/Photo Observation Report

Street:	South Union Street	Flow Control:	Not Controlled
City:	Hobart, IN	Year Renewed:	
Location:	Easement/Right of Way	Tape/Media #:	
Purpose:	Routine Assessment	Dia/Height:	8"
Use:	Sanitary Sewage Pipe	Material:	PVC
Drain Area:		Lining:	None
Category:	NA		
Comment:

Location Details:	LINE RUNS JUST EAST OF THE DRIVE	Direction of Survey:	Downstream
US MH:	M-907-009.2	DS MH:	M-907-009.3
		Total Length Surveyed (ft):	151.2

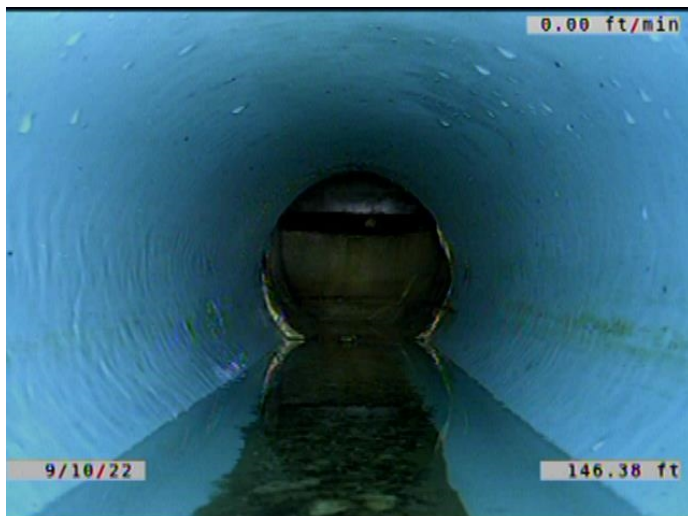
Code: **DSF**
 Description: **Deposits Settled Fine**

Distance (ft): **146.4**
 Structural Grade: **0**
 O&M Grade: **2**
 Clock Start/From: **5**
 Clock To: **7**
 1st Value:
 2nd Value:
 Value Percent: **5.000**
 Continuous Index:
 Within 8" of Joint: **YES**
 Remarks:

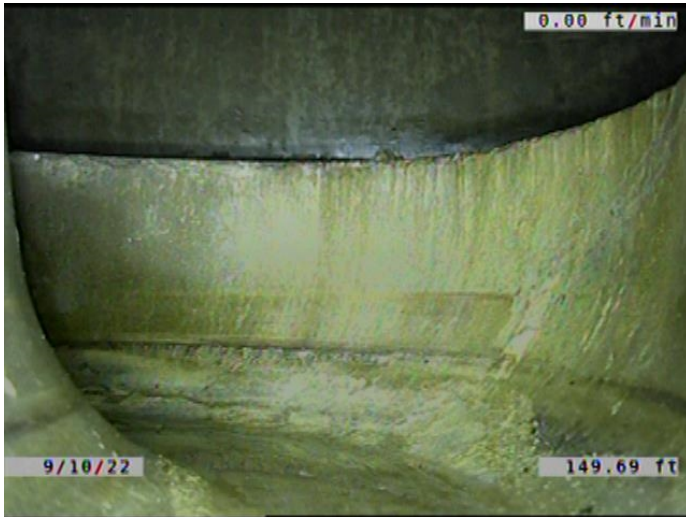
Code: **MWLS**
 Description: **Miscellaneous Water Level Sag**

Distance (ft): **149.7**
 Structural Grade: **2**
 O&M Grade: **0**
 Clock Start/From:
 Clock To:
 1st Value:
 2nd Value:
 Value Percent: **5.000**
 Continuous Index: **F01**
 Within 8" of Joint: **NO**
 Remarks:
