Profile/Photo Observation Report

Date:	09/10/2022	Weather:		Coding:	PACP 7.0
Pipe Length (ft):	112.0	Owner:	City of Hobart	Pre Clean:	Heavy Cleaning
P.O.#:	YES502259	Surveyor:	S. Bucklin	PSR:	M-907-009.3-M-907-020
Customer:	City of Hobart	Clean Date:	08/23/2022	Shape:	C

Street:	South Union Street	Flow Control:	Not Controlled
City:	Hobart, IN	Year Renewed:	
Location:	Easement/Right of Way	Tape/Media #:	
Purpose:	Routine Assessment	Dia/Height:	8"
Use:	Sanitary Sewage Pipe	Material:	PVC
Drain Area:		Lining:	None
Category:	NA		
Comment:			
Location Details:	LINE RUNS WEST	Direction of Survey:	Downstream
US MH:	M-907-009.3	DS MH:	M-907-020
		Total Length Surveyed (ft):	112.3

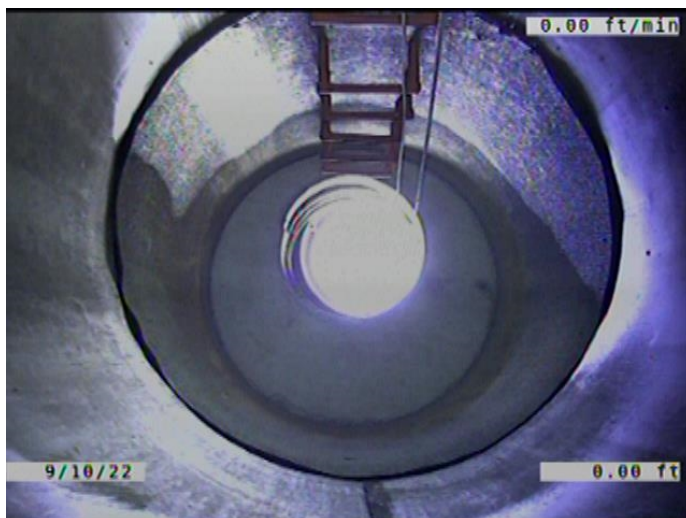
Code: **AMH**
Description: **Manhole**

Distance (ft): **.0**
Structural Grade: **0**
O&M Grade: **0**
Clock Start/From:
Clock To:
1st Value:
2nd Value:
Value Percent:
Continuous Index:
Within 8" of Joint: **NO**
Remarks: **M-907-009.3**

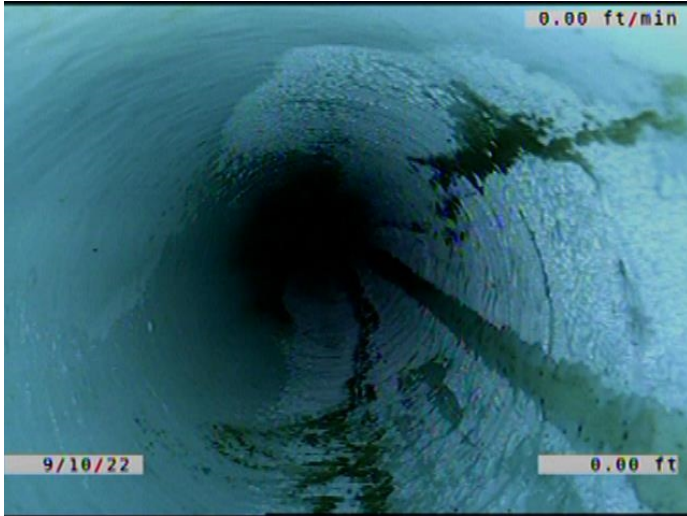
Code: **MWL**
Description: **Miscellaneous Water Level**

Distance (ft): **.0**
Structural Grade: **0**
O&M Grade: **0**
Clock Start/From:
Clock To:
1st Value:
2nd Value:
Value Percent: **5.000**
Continuous Index:
Within 8" of Joint: **NO**
Remarks:

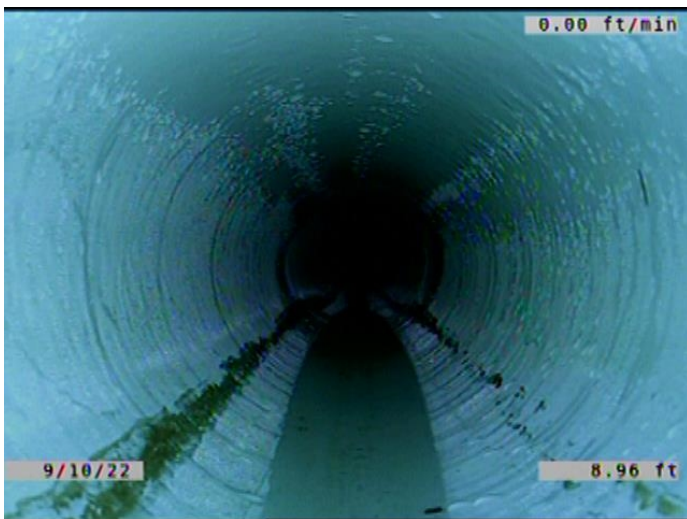
Code: **MWLS**
Description: **Miscellaneous Water Level Sag**

Distance (ft): **9.0**
Structural Grade: **2**
O&M Grade: **0**
Clock Start/From:
Clock To:
1st Value:
2nd Value:
Value Percent: **5.000**
Continuous Index:
Within 8" of Joint: **NO**
Remarks:

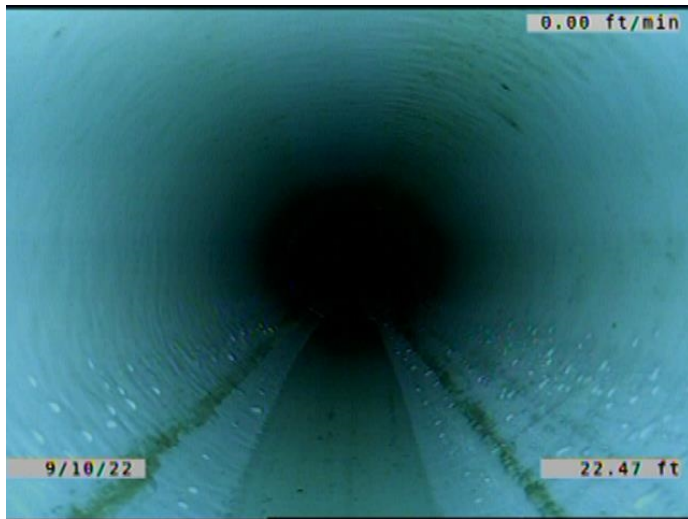
Code: **MWLS**
Description: **Miscellaneous Water Level Sag**

Distance (ft): **22.5**
Structural Grade: **2**
O&M Grade: **0**
Clock Start/From:
Clock To:
1st Value:
2nd Value:
Value Percent: **5.000**
Continuous Index:
Within 8" of Joint: **NO**
Remarks:

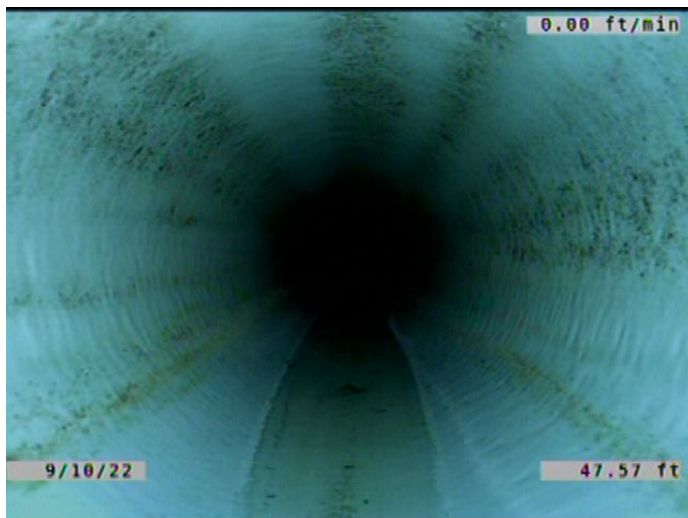
Code: **MWLS**
Description: **Miscellaneous Water Level Sag**

Distance (ft): **47.6**
Structural Grade: **2**
O&M Grade: **0**
Clock Start/From:
Clock To:
1st Value:
2nd Value:
Value Percent: **5.000**
Continuous Index: **S01**
Within 8" of Joint: **NO**
Remarks:

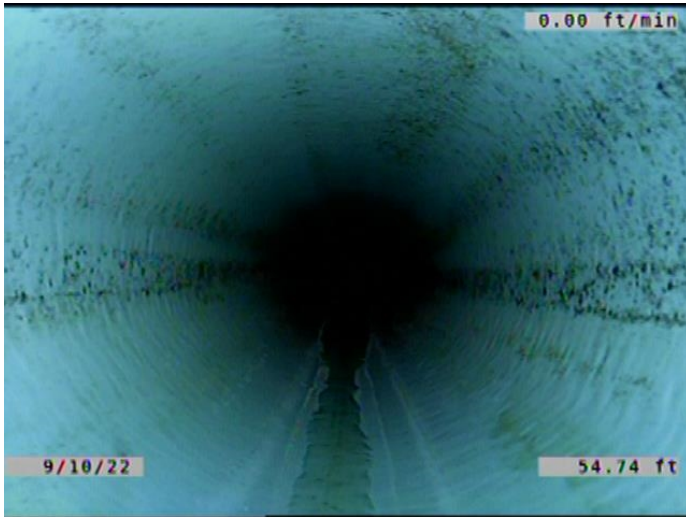
Code: **MWLS**
Description: **Miscellaneous Water Level Sag**

Distance (ft): **54.7**
Structural Grade: **2**
O&M Grade: **0**
Clock Start/From:
Clock To:
1st Value:
2nd Value:
Value Percent: **5.000**
Continuous Index: **F01**
Within 8" of Joint: **NO**
Remarks:

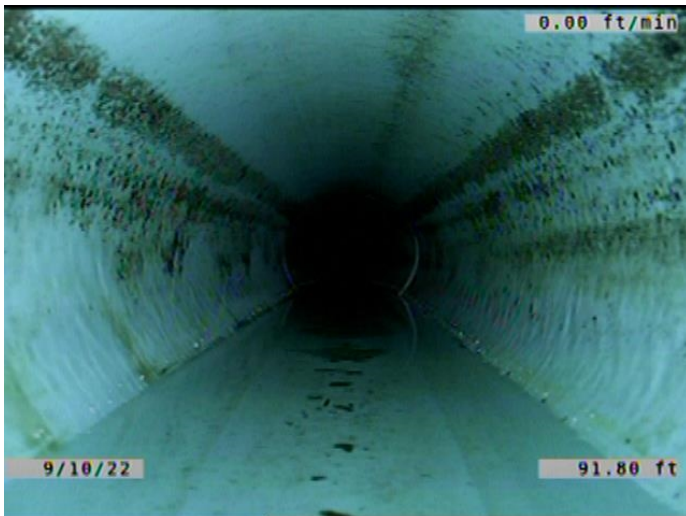
Code: **MWLS**
Description: **Miscellaneous Water Level Sag**

Distance (ft): **91.8**
Structural Grade: **2**
O&M Grade: **0**
Clock Start/From:
Clock To:
1st Value:
2nd Value:
Value Percent: **10.000**
Continuous Index: **S02**
Within 8" of Joint: **NO**
Remarks:

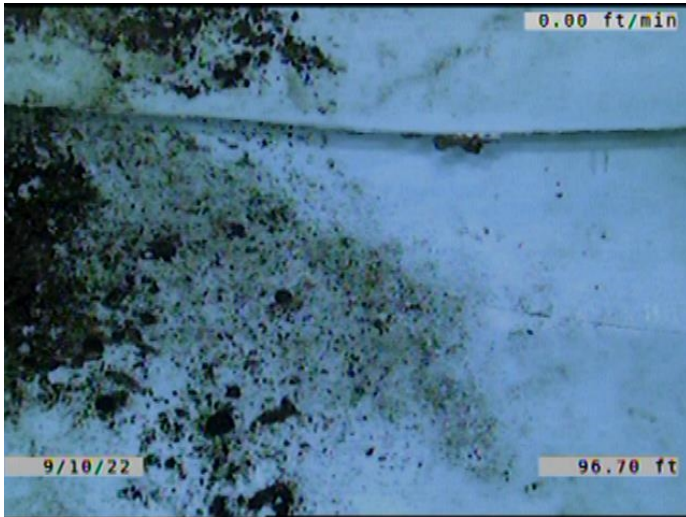
Code:	MGO
Description:	Miscellaneous General Observation
Distance (ft):	96.7
Structural Grade:	0
O&M Grade:	0
Clock Start/From:	
Clock To:	
1st Value:	
2nd Value:	
Value Percent:	
Continuous Index:	
Within 8" of Joint:	NO
Remarks:	JOINT/ PIPES NOT PUSHED ALL THE WAY TOGETHER WHEN INSTALLED

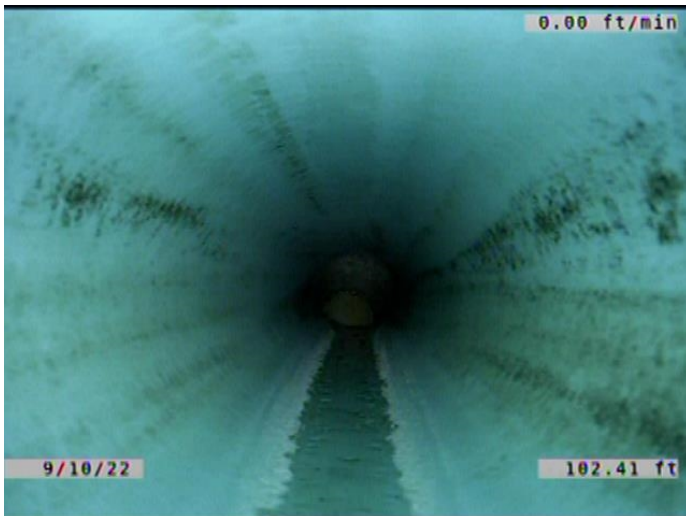
Code:	MWLS
Description:	Miscellaneous Water Level Sag
Distance (ft):	102.4
Structural Grade:	2
O&M Grade:	0
Clock Start/From:	
Clock To:	
1st Value:	
2nd Value:	
Value Percent:	10.000
Continuous Index:	F02
Within 8" of Joint:	NO
Remarks:

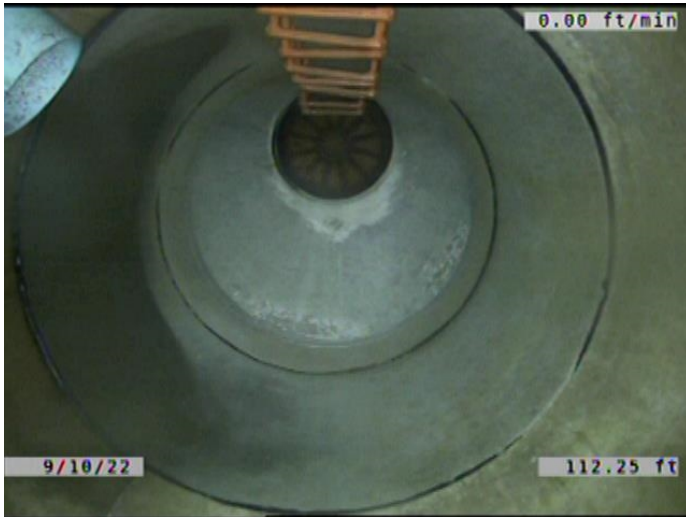
Code:	AMH
Description:	Manhole
Distance (ft):	112.3
Structural Grade:	0
O&M Grade:	0
Clock Start/From:	
Clock To:	
1st Value:	
2nd Value:	
Value Percent:	
Continuous Index:	
Within 8" of Joint:	NO
Remarks:	M-907-020
