Profile/Photo Observation Report

Date:	04/12/2018	Weather:		Coding:	PACP 6.0
Pipe Length (ft):	269.6	Owner:	NA	Pre Clean:	Not Known
P.O.#:		Surveyor:	Jen Costello	PSR:	P-1006-006-003
Customer:		Clean Date:	01/01/1900	Shape:	C

Street:	VERMILLION ST	Flow Control:	Not Controlled
City:	Hobart, IN	Year Renewed:	
Location:	Yard	Tape/Media #:	
Purpose:	Maintenance Related	Dia/Height:	8"
Use:	Sanitary	Material:	PVC
Drain Area:	NA	Lining:	Cured in Place
Category:	NA		
Comment:	2nd attempt. flow incorrect.		
Location Details:		Direction of Survey:	Upstream
US MH:	M-1006-003	DS MH:	M-1006-006
		Total Length Surveyed (ft):	263.2

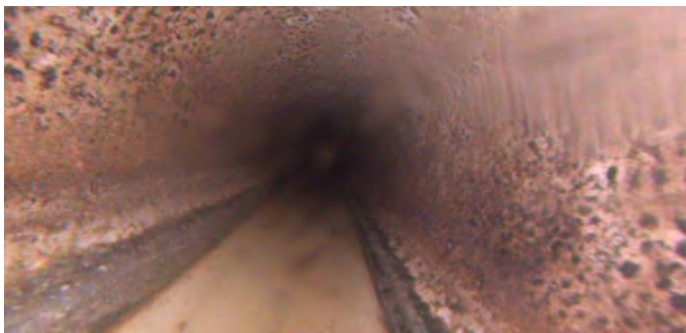
Code: **AMH**
Description: **Manhole**

Distance (ft): **.0**
Structural Grade: **0**
O&M Grade: **0**
Clock Start/From:
Clock To:
1st Value:
2nd Value:
Value Percent:
Continuous Index:
Within 8" of Joint: **NO**
Remarks: **M-1006-006**

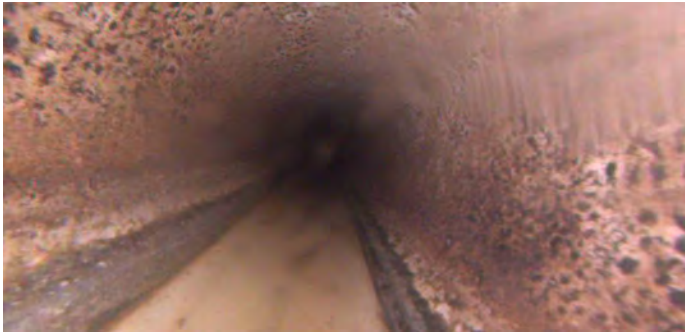
Code:	MWL
Description:	Water Level

Distance (ft):	.0
Structural Grade:	0
O&M Grade:	0
Clock Start/From:	
Clock To:	
1st Value:	
2nd Value:	
Value Percent:	5.000
Continuous Index:	
Within 8" of Joint:	NO
Remarks:

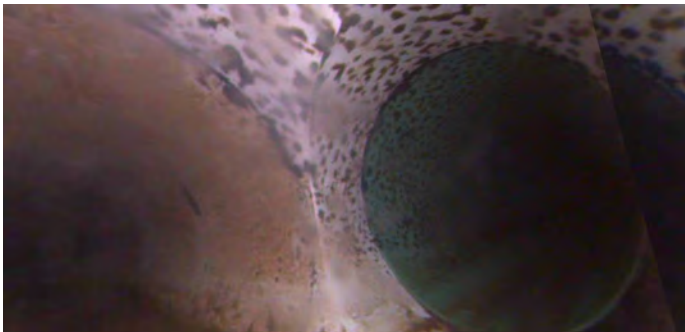
Code:	TF
Description:	Tap Factory

Distance (ft):	105.4
Structural Grade:	0
O&M Grade:	0
Clock Start/From:	9
Clock To:	
1st Value:	4.000
2nd Value:	
Value Percent:	
Continuous Index:	
Within 8" of Joint:	
Remarks:

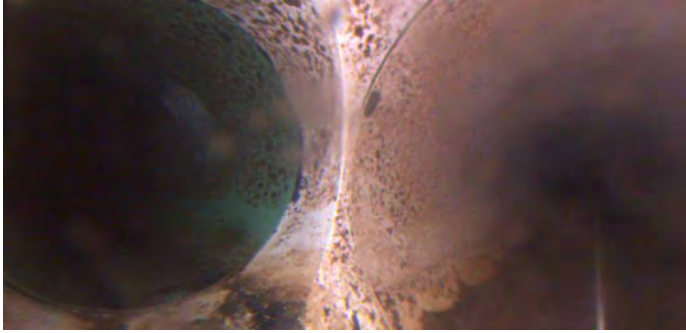
Code: **TF**
Description: **Tap Factory**

Distance (ft): **115.0**
Structural Grade: **0**
O&M Grade: **0**
Clock Start/From: **3**
Clock To:
1st Value: **4.000**
2nd Value:
Value Percent:
Continuous Index:
Within 8" of Joint:
Remarks:

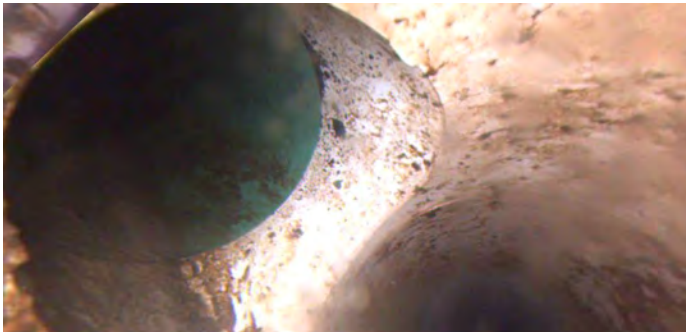
Code: **TF**
Description: **Tap Factory**

Distance (ft): **212.3**
Structural Grade: **0**
O&M Grade: **0**
Clock Start/From: **10**
Clock To:
1st Value: **4.000**
2nd Value:
Value Percent:
Continuous Index:
Within 8" of Joint:
Remarks:

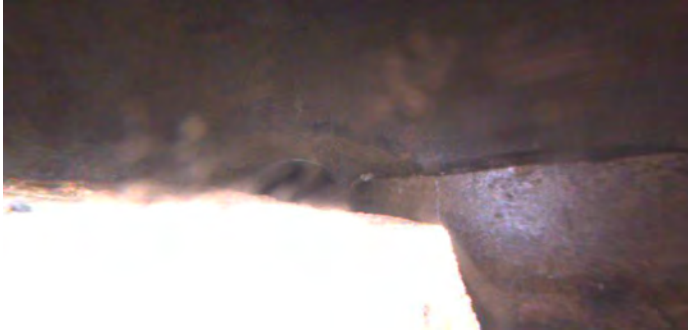
Code:	AMH
Description:	Manhole
Distance (ft):	263.2
Structural Grade:	0
O&M Grade:	0
Clock Start/From:	
Clock To:	
1st Value:	
2nd Value:	
Value Percent:	
Continuous Index:	
Within 8" of Joint:	NO
Remarks:	M-1006-003
