Profile/Photo Observation Report

Date:	04/12/2018	Weather:		Coding:	PACP 6.0
Pipe Length (ft):	269.6	Owner:	NA	Pre Clean:	Not Known
P.O.#:		Surveyor:	Jen Costello	PSR:	P-1006-006-003
Customer:		Clean Date:	01/01/1900	Shape:	C

Street:	Capitol	Flow Control:	Not Controlled
City:	Hobart, IN	Year Renewed:	
Location:	Yard	Tape/Media #:	
Purpose:	Maintenance Related	Dia/Height:	8"
Use:	Sanitary	Material:	PVC
Drain Area:	NA	Lining:	Cured in Place
Category:	NA		
Comment:	2nd attempt. flow incorrect.		
Location Details:		Direction of Survey:	Upstream
US MH:	M-1006-003	DS MH:	M-1006-006
		Total Length Surveyed (ft):	263.2

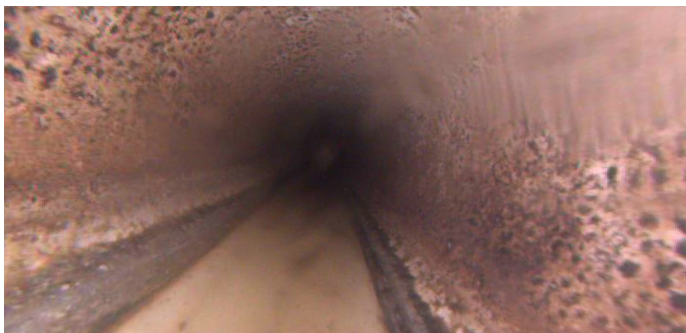
Code: **AMH**
Description: **Manhole**

Distance (ft): **.0**
Structural Grade: **0**
O&M Grade: **0**
Clock Start/From:
Clock To:
1st Value:
2nd Value:
Value Percent:
Continuous Index:
Within 8" of Joint: **NO**
Remarks: **M-1006-006**

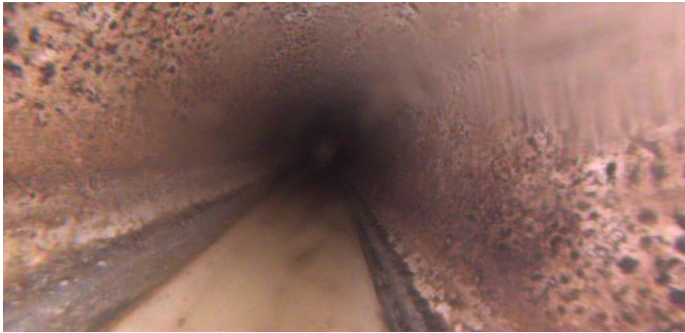
Code:	MWL
Description:	Water Level

Distance (ft):	.0
Structural Grade:	0
O&M Grade:	0
Clock Start/From:	
Clock To:	
1st Value:	
2nd Value:	
Value Percent:	5.000
Continuous Index:	
Within 8" of Joint:	NO
Remarks:

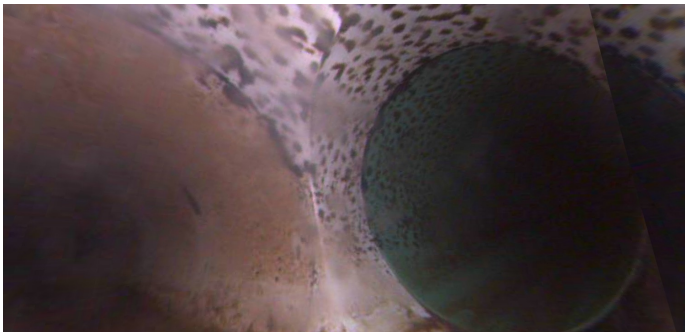
Code:	TF
Description:	Tap Factory

Distance (ft):	105.4
Structural Grade:	0
O&M Grade:	0
Clock Start/From:	9
Clock To:	
1st Value:	4.000
2nd Value:	
Value Percent:	
Continuous Index:	
Within 8" of Joint:	
Remarks:

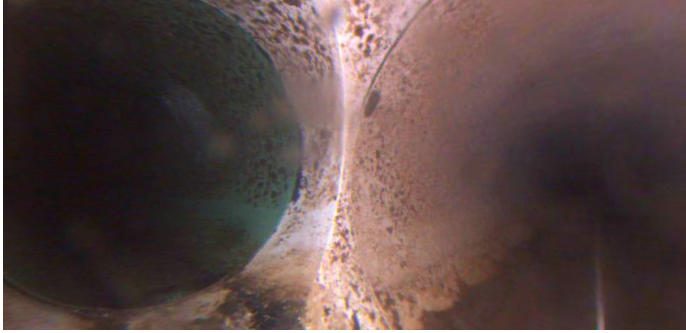
Code: **TF**
Description: **Tap Factory**

Distance (ft): **115.0**
Structural Grade: **0**
O&M Grade: **0**
Clock Start/From: **3**
Clock To:
1st Value: **4.000**
2nd Value:
Value Percent:
Continuous Index:
Within 8" of Joint:
Remarks:

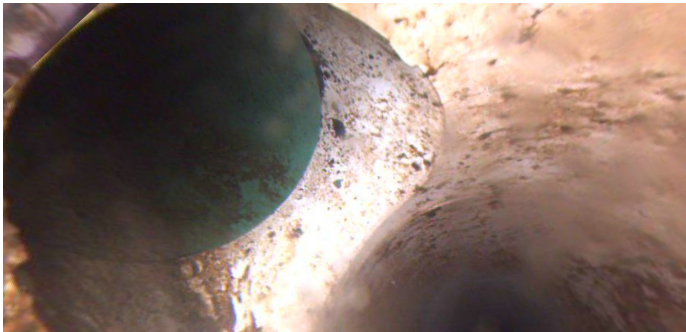
Code: **TF**
Description: **Tap Factory**

Distance (ft): **212.3**
Structural Grade: **0**
O&M Grade: **0**
Clock Start/From: **10**
Clock To:
1st Value: **4.000**
2nd Value:
Value Percent:
Continuous Index:
Within 8" of Joint:
Remarks:

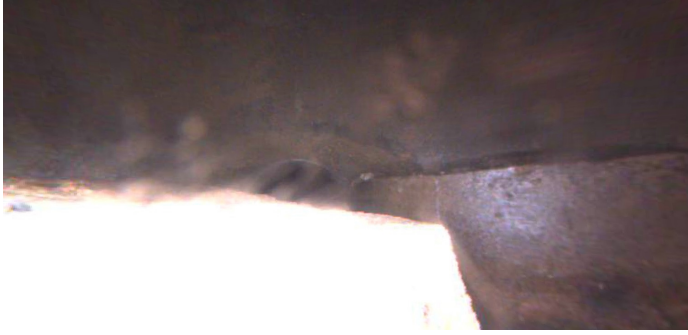
Code:	AMH
Description:	Manhole
Distance (ft):	263.2
Structural Grade:	0
O&M Grade:	0
Clock Start/From:	
Clock To:	
1st Value:	
2nd Value:	
Value Percent:	
Continuous Index:	
Within 8" of Joint:	NO
Remarks:	M-1006-003
