## Profile/Photo Observation Report

Street:	<b>Capitol</b>	Flow Control:	<b>Not Controlled</b>
City:	<b>Hobart, IN</b>	Year Renewed:	
Location:	<b>Yard</b>	Tape/Media #:	
Purpose:	<b>Maintenance Related</b>	Dia/Height:	<b>8"</b>
Use:	<b>Sanitary</b>	Material:	<b>PVC</b>
Drain Area:	<b>NA</b>	Lining:	<b>Cured in Place</b>
Category:	<b>NA</b>		
Comment:	<b>flow incorrect.</b>

Location Details:		Direction of Survey:	<b>Downstream</b>
US MH:	<b>M-1006-006</b>	DS MH:	<b>M-1006-005</b>
		Total Length Surveyed (ft):	<b>301.5</b>

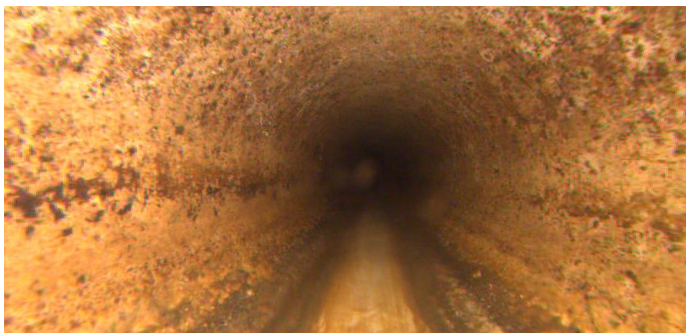
Code: **AMH**  
Description: **Manhole**

Distance (ft): **.0**  
Structural Grade: **0**  
O&M Grade: **0**  
Clock Start/From:  
Clock To:  
1st Value:  
2nd Value:  
Value Percent:  
Continuous Index:  
Within 8" of Joint: **NO**  
Remarks: **M-1006-006**

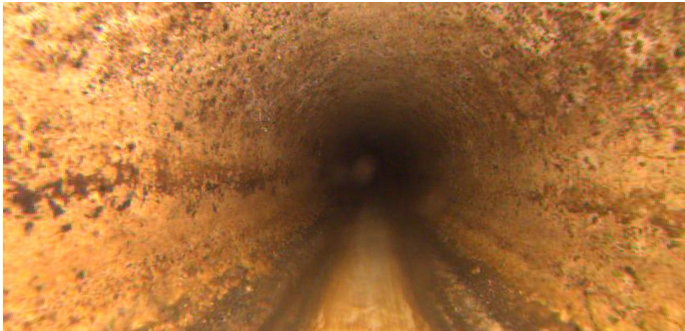
Code:	<b>MWL</b>
Description:	<b>Water Level</b>

Distance (ft):	<b>.0</b>
Structural Grade:	<b>0</b>
O&M Grade:	<b>0</b>
Clock Start/From:	
Clock To:	
1st Value:	
2nd Value:	
Value Percent:	<b>5.000</b>
Continuous Index:	
Within 8" of Joint:	<b>NO</b>
Remarks:

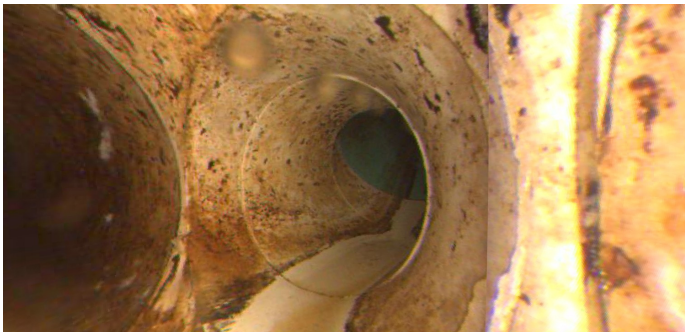
Code:	<b>TF</b>
Description:	<b>Tap Factory</b>

Distance (ft):	<b>49.1</b>
Structural Grade:	<b>0</b>
O&M Grade:	<b>0</b>
Clock Start/From:	<b>3</b>
Clock To:	
1st Value:	<b>4.000</b>
2nd Value:	
Value Percent:	
Continuous Index:	
Within 8" of Joint:	
Remarks:

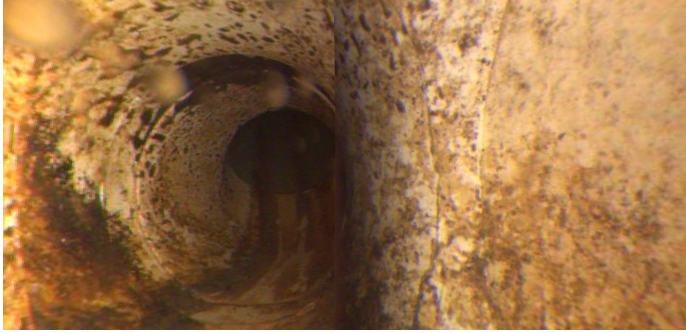
Code: **TF**  
Description: **Tap Factory**

Distance (ft): **148.0**  
Structural Grade: **0**  
O&M Grade: **0**  
Clock Start/From: **3**  
Clock To:  
1st Value: **4.000**  
2nd Value:  
Value Percent:  
Continuous Index:  
Within 8" of Joint:  
Remarks:

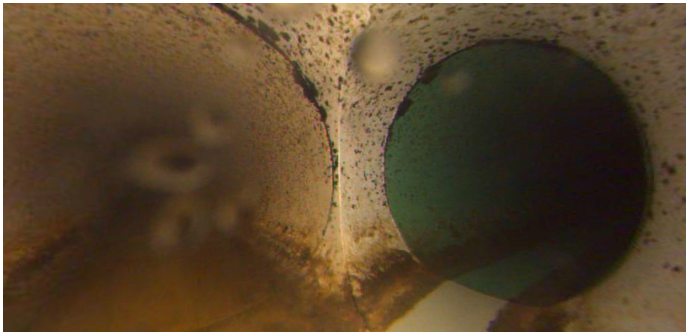
Code: **TF**  
Description: **Tap Factory**

Distance (ft): **249.2**  
Structural Grade: **0**  
O&M Grade: **0**  
Clock Start/From: **3**  
Clock To:  
1st Value: **4.000**  
2nd Value:  
Value Percent:  
Continuous Index:  
Within 8" of Joint:  
Remarks:

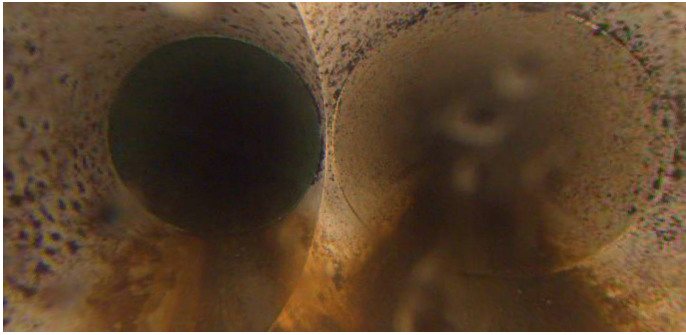
Code: **TFA**  
Description: **Tap Factory Active**

Distance (ft): **291.4**  
Structural Grade: **0**  
O&M Grade: **0**  
Clock Start/From: **9**  
Clock To:  
1st Value: **4.000**  
2nd Value:  
Value Percent:  
Continuous Index:  
Within 8" of Joint:  
Remarks:

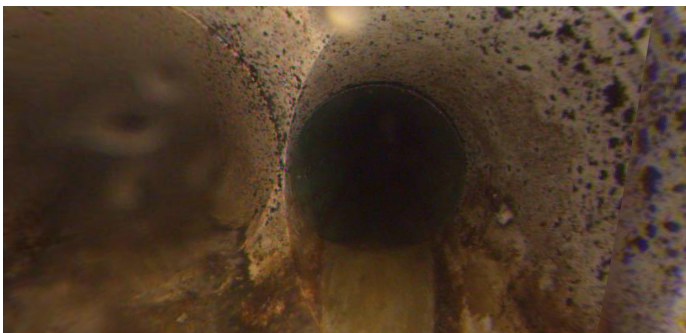
Code: **TFA**  
Description: **Tap Factory Active**

Distance (ft): **294.3**  
Structural Grade: **0**  
O&M Grade: **0**  
Clock Start/From: **3**  
Clock To:  
1st Value: **4.000**  
2nd Value:  
Value Percent:  
Continuous Index:  
Within 8" of Joint:  
Remarks:

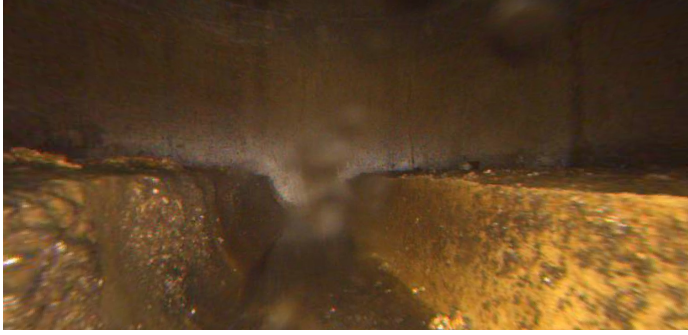
Code:	AMH
Description:	Manhole
Distance (ft):	301.5
Structural Grade:	0
O&M Grade:	0
Clock Start/From:	
Clock To:	
1st Value:	
2nd Value:	
Value Percent:	
Continuous Index:	
Within 8" of Joint:	NO
Remarks:	M-1006-005
