## Profile/Photo Observation Report

Street:	<b>E 9TH PL</b>	Flow Control:	<b>Not Controlled</b>
City:	<b>Hobart, IN</b>	Year Renewed:	
Location:	<b>Yard</b>	Tape/Media #:	
Purpose:	<b>Maintenance Related</b>	Dia/Height:	<b>8"</b>
Use:	<b>Sanitary</b>	Material:	<b>PVC</b>
Drain Area:	<b>NA</b>	Lining:	<b>Cured in Place</b>
Category:	<b>NA</b>		
Comment:	<b>flow incorrect.</b>

Location Details:		Direction of Survey:	<b>Downstream</b>
US MH:	<b>M-1006-006</b>	DS MH:	<b>M-1006-007</b>
		Total Length Surveyed (ft):	<b>313.5</b>

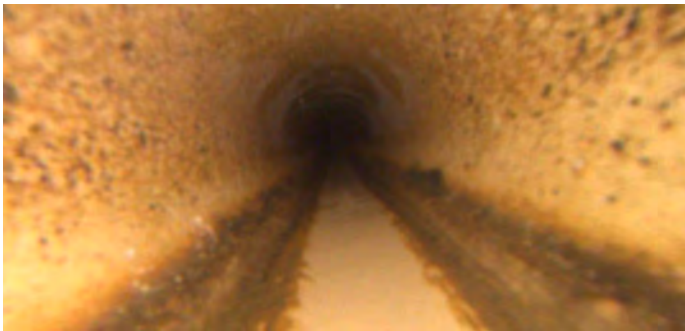
Code: **AMH**  
Description: **Manhole**

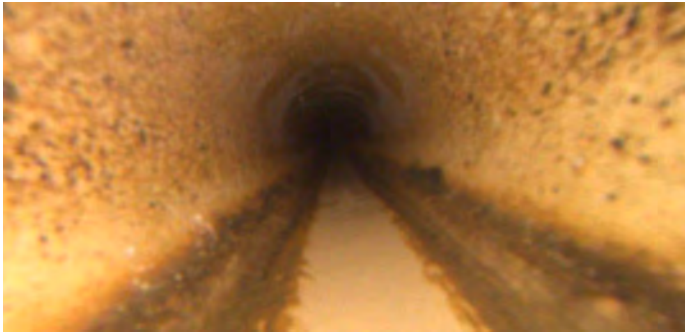
Code:	<b>MWL</b>
Description:	<b>Water Level</b>

Distance (ft):	<b>.0</b>
Structural Grade:	<b>0</b>
O&M Grade:	<b>0</b>
Clock Start/From:	
Clock To:	
1st Value:	
2nd Value:	
Value Percent:	<b>5.000</b>
Continuous Index:	
Within 8" of Joint:	<b>NO</b>
Remarks:

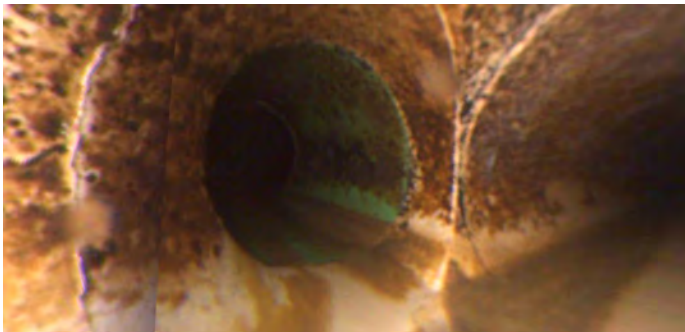
Code:	<b>TF</b>
Description:	<b>Tap Factory</b>

Distance (ft):	<b>48.1</b>
Structural Grade:	<b>0</b>
O&M Grade:	<b>0</b>
Clock Start/From:	<b>9</b>
Clock To:	
1st Value:	<b>4.000</b>
2nd Value:	
Value Percent:	
Continuous Index:	
Within 8" of Joint:	
Remarks:

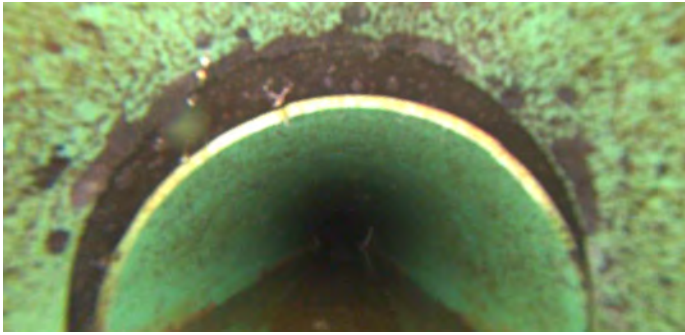
Code: **JOL**  
Description: **Joint Offset Large**

Distance (ft): **98.9**  
Structural Grade: **2**  
O&M Grade: **0**  
Clock Start/From:  
Clock To:  
1st Value:  
2nd Value:  
Value Percent:  
Continuous Index:  
Within 8" of Joint: **NO**  
Remarks:

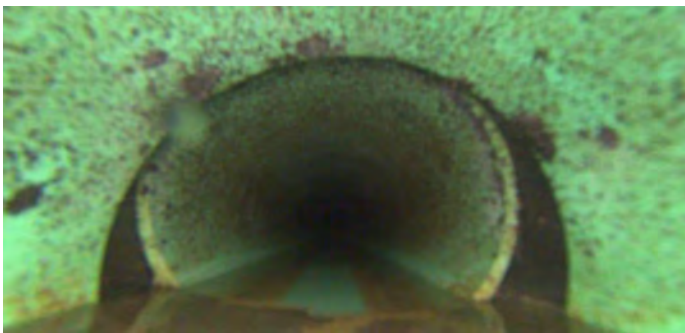
Code: **JOL**  
Description: **Joint Offset Large**

Distance (ft): **101.8**  
Structural Grade: **2**  
O&M Grade: **0**  
Clock Start/From:  
Clock To:  
1st Value:  
2nd Value:  
Value Percent:  
Continuous Index:  
Within 8" of Joint: **NO**  
Remarks:

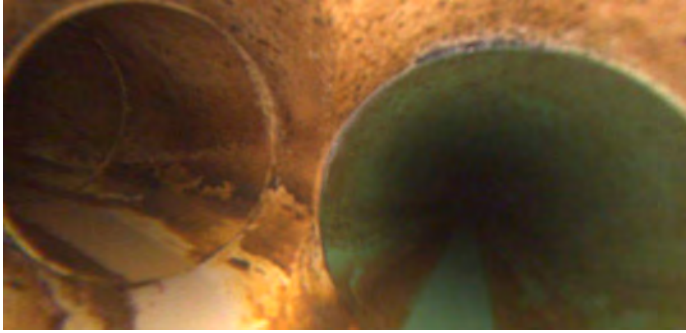
Code: **TFA**  
Description: **Tap Factory Active**

Distance (ft): **139.4**  
Structural Grade: **0**  
O&M Grade: **0**  
Clock Start/From: **9**  
Clock To:  
1st Value: **4.000**  
2nd Value:  
Value Percent:  
Continuous Index:  
Within 8" of Joint:  
Remarks:

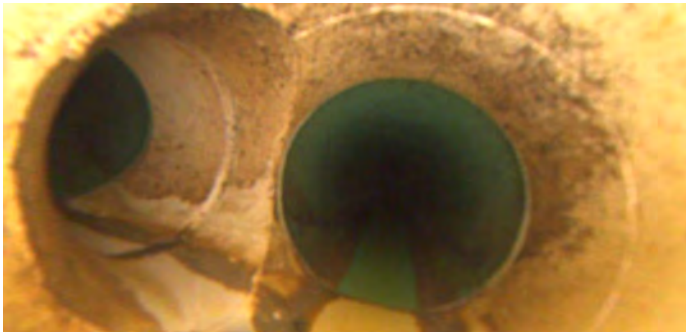
Code: **TFA**  
Description: **Tap Factory Active**

Distance (ft): **257.7**  
Structural Grade: **0**  
O&M Grade: **0**  
Clock Start/From: **9**  
Clock To:  
1st Value: **4.000**  
2nd Value:  
Value Percent:  
Continuous Index:  
Within 8" of Joint:  
Remarks:

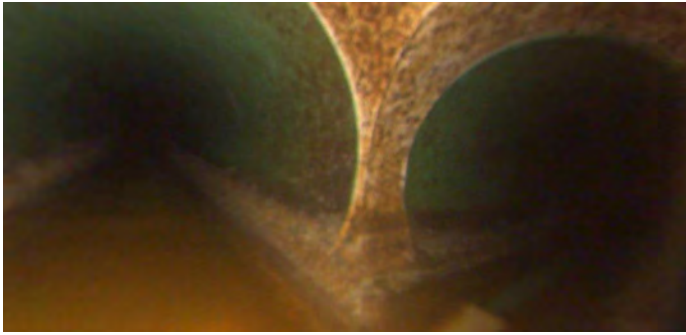
Code: **TFA**  
Description: **Tap Factory Active**

Distance (ft): **266.4**  
Structural Grade: **0**  
O&M Grade: **0**  
Clock Start/From: **3**  
Clock To:  
1st Value: **4.000**  
2nd Value:  
Value Percent:  
Continuous Index:  
Within 8" of Joint:  
Remarks:

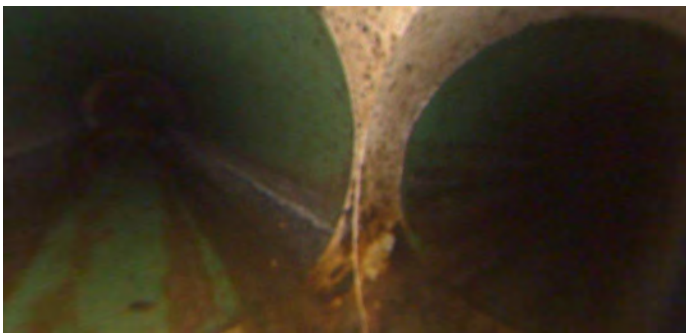
Code: **TFA**  
Description: **Tap Factory Active**

Distance (ft): **306.7**  
Structural Grade: **0**  
O&M Grade: **0**  
Clock Start/From: **3**  
Clock To:  
1st Value: **4.000**  
2nd Value:  
Value Percent:  
Continuous Index:  
Within 8" of Joint:  
Remarks:

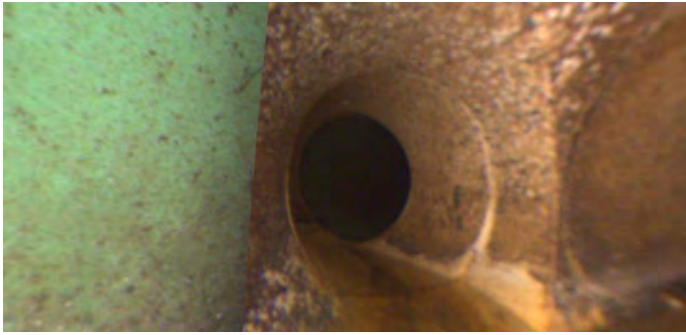
Code: **TFA**  
Description: **Tap Factory Active**

Distance (ft): **309.6**  
Structural Grade: **0**  
O&M Grade: **0**  
Clock Start/From: **9**  
Clock To:  
1st Value: **4.000**  
2nd Value:  
Value Percent:  
Continuous Index:  
Within 8" of Joint:  
Remarks:

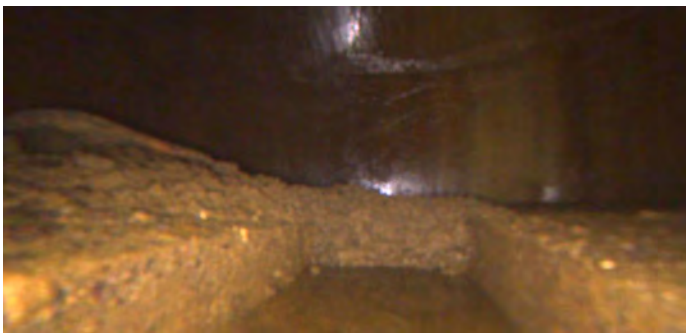
Code: **AMH**  
Description: **Manhole**

Distance (ft): **313.5**  
Structural Grade: **0**  
O&M Grade: **0**  
Clock Start/From:  
Clock To:  
1st Value:  
2nd Value:  
Value Percent:  
Continuous Index:  
Within 8" of Joint: **NO**  
Remarks: **M-1006-007**
