Profile/Photo Observation Report

Date:	04/12/2018	Weather:		Coding:	PACP 6.0
Pipe Length (ft):	316.6	Owner:	NA	Pre Clean:	Not Known
P.O.#:		Surveyor:	Jen Costello	PSR:	P-1006-007-006
Customer:		Clean Date:	01/01/1900	Shape:	C

Location Details:		Direction of Survey:	Downstream
US MH:	M-1006-006	DS MH:	M-1006-007
		Total Length Surveyed (ft):	313.5

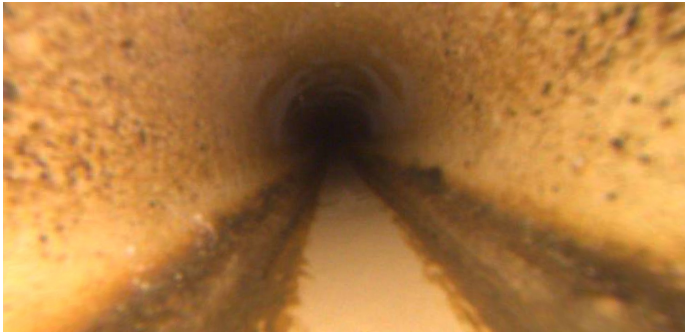
Code:	MWL
Description:	Water Level

Distance (ft):	.0
Structural Grade:	0
O&M Grade:	0
Clock Start/From:	
Clock To:	
1st Value:	
2nd Value:	
Value Percent:	5.000
Continuous Index:	
Within 8" of Joint:	NO
Remarks:

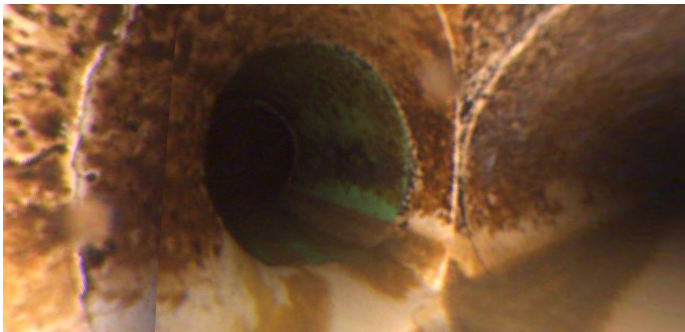
Code:	TF
Description:	Tap Factory

Distance (ft):	48.1
Structural Grade:	0
O&M Grade:	0
Clock Start/From:	9
Clock To:	
1st Value:	4.000
2nd Value:	
Value Percent:	
Continuous Index:	
Within 8" of Joint:	
Remarks:

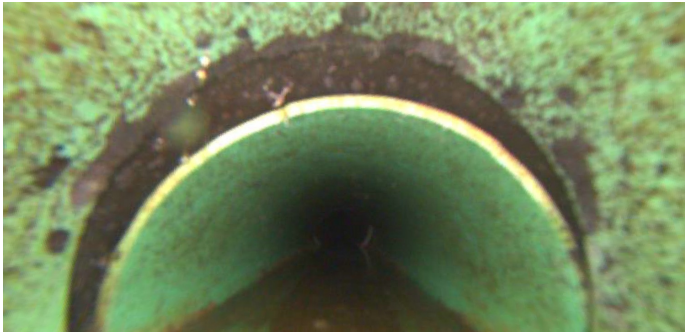
Code: **JOL**
Description: **Joint Offset Large**

Distance (ft): **98.9**
Structural Grade: **2**
O&M Grade: **0**
Clock Start/From:
Clock To:
1st Value:
2nd Value:
Value Percent:
Continuous Index:
Within 8" of Joint: **NO**
Remarks:

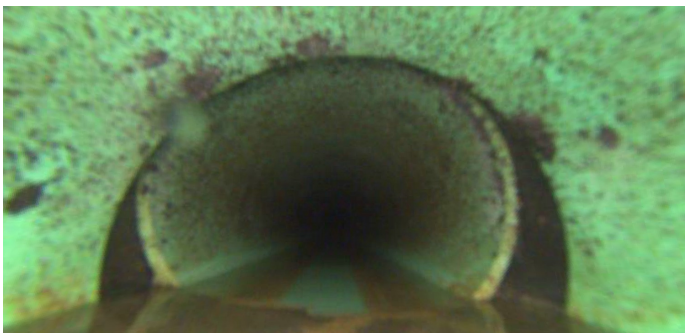
Code: **JOL**
Description: **Joint Offset Large**

Distance (ft): **101.8**
Structural Grade: **2**
O&M Grade: **0**
Clock Start/From:
Clock To:
1st Value:
2nd Value:
Value Percent:
Continuous Index:
Within 8" of Joint: **NO**
Remarks:

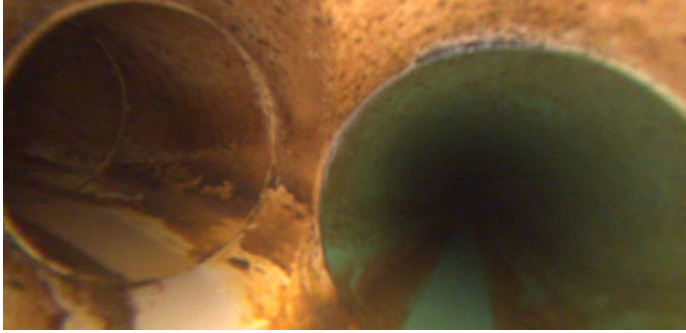
Code: **TFA**
Description: **Tap Factory Active**

Distance (ft): **139.4**
Structural Grade: **0**
O&M Grade: **0**
Clock Start/From: **9**
Clock To:
1st Value: **4.000**
2nd Value:
Value Percent:
Continuous Index:
Within 8" of Joint:
Remarks:

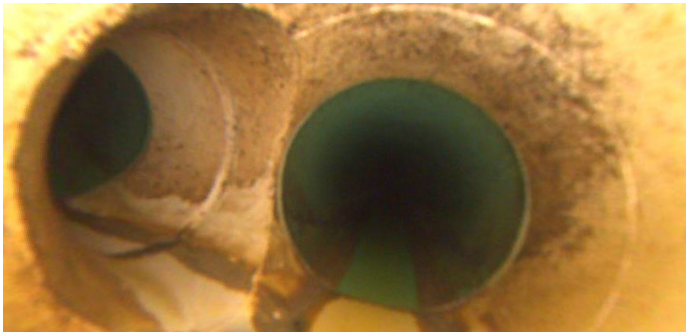
Code: **TFA**
Description: **Tap Factory Active**

Distance (ft): **257.7**
Structural Grade: **0**
O&M Grade: **0**
Clock Start/From: **9**
Clock To:
1st Value: **4.000**
2nd Value:
Value Percent:
Continuous Index:
Within 8" of Joint:
Remarks:

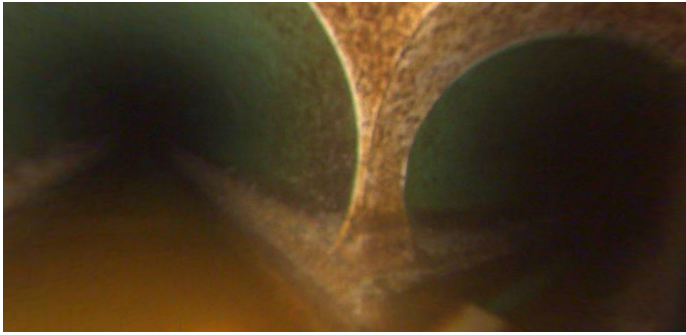
Code: **TFA**
Description: **Tap Factory Active**

Distance (ft): **266.4**
Structural Grade: **0**
O&M Grade: **0**
Clock Start/From: **3**
Clock To:
1st Value: **4.000**
2nd Value:
Value Percent:
Continuous Index:
Within 8" of Joint:
Remarks:

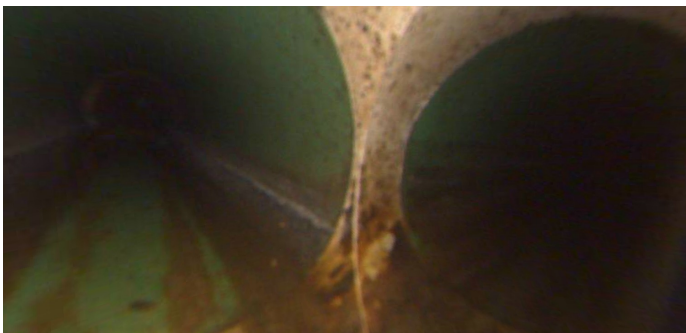
Code: **TFA**
Description: **Tap Factory Active**

Distance (ft): **306.7**
Structural Grade: **0**
O&M Grade: **0**
Clock Start/From: **3**
Clock To:
1st Value: **4.000**
2nd Value:
Value Percent:
Continuous Index:
Within 8" of Joint:
Remarks:

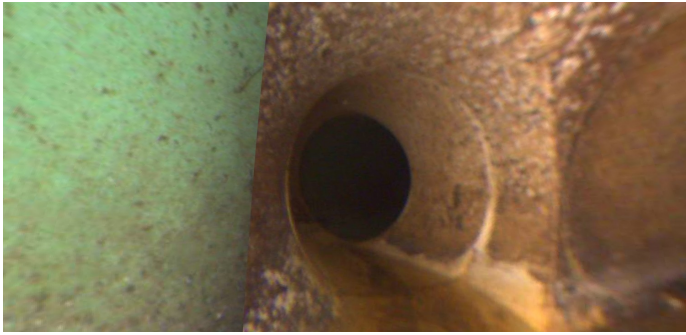
Code: **TFA**
Description: **Tap Factory Active**

Distance (ft): **309.6**
Structural Grade: **0**
O&M Grade: **0**
Clock Start/From: **9**
Clock To:
1st Value: **4.000**
2nd Value:
Value Percent:
Continuous Index:
Within 8" of Joint:
Remarks:

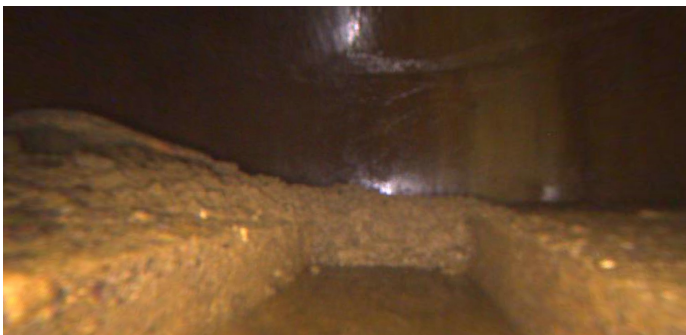
Code: **AMH**
Description: **Manhole**

Distance (ft): **313.5**
Structural Grade: **0**
O&M Grade: **0**
Clock Start/From:
Clock To:
1st Value:
2nd Value:
Value Percent:
Continuous Index:
Within 8" of Joint: **NO**
Remarks: **M-1006-007**
