Profile/Photo Observation Report

Location Details:		Direction of Survey:	Downstream
US MH:	M-1006-013	DS MH:	M-1006-012
		Total Length Surveyed (ft):	396.4

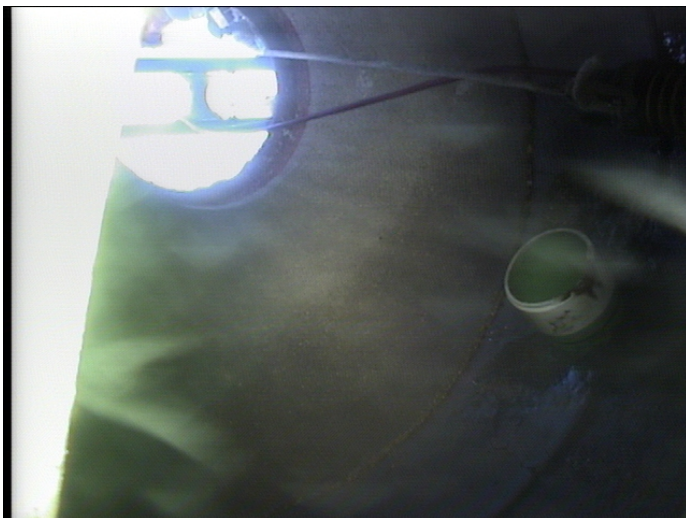
Code:	MWL
Description:	Water Level
Distance (ft):	.0
Structural Grade:	0
O&M Grade:	0
Clock Start/From:	
Clock To:	
1st Value:	
2nd Value:	
Value Percent:	5.000
Continuous Index:	
Within 8" of Joint:	NO
Remarks:

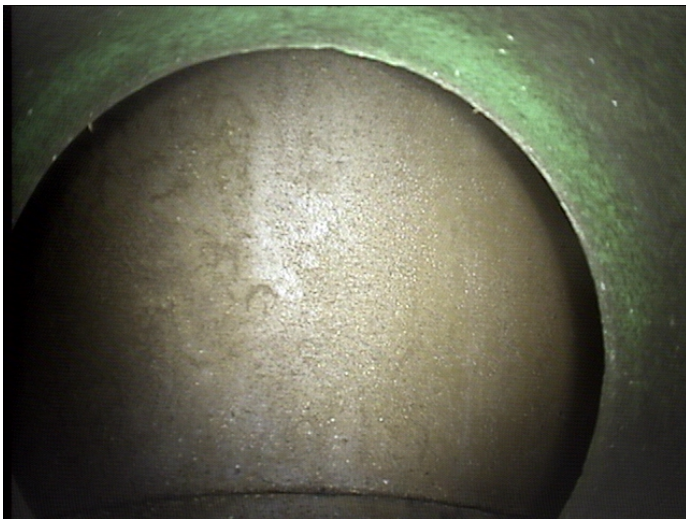
Code:	AMH
Description:	Manhole
Distance (ft):	396.4
Structural Grade:	0
O&M Grade:	0
Clock Start/From:	
Clock To:	
1st Value:	
2nd Value:	
Value Percent:	
Continuous Index:	
Within 8" of Joint:	NO
Remarks:	M-1006-013
