Profile/Photo Observation Report

Date:	10/16/2021	Weather:		Coding:	PACP 6.0
Pipe Length (ft):		Owner:	Hobart, IN	Pre Clean:	Not Known
P.O.#:	828_1	Surveyor:	M. Pielacha	PSR:	P-103-004-006
Customer:	Hobart, IN	Clean Date:		Shape:	C

Street:	Off Colbourne Street	Flow Control:	
City:	Hobart, IN	Year Renewed:	
Location:	Alley	Tape/Media #:	828
Purpose:	Routine Assessment	Dia/Height:	10"
Use:	Sanitary	Material:	VCP
Drain Area:		Lining:	
Category:	NA		
Comment:			
Location Details:		Direction of Survey:	Upstream
US MH:	M-103-6	DS MH:	M-103-4
		Total Length Surveyed (ft):	220.6

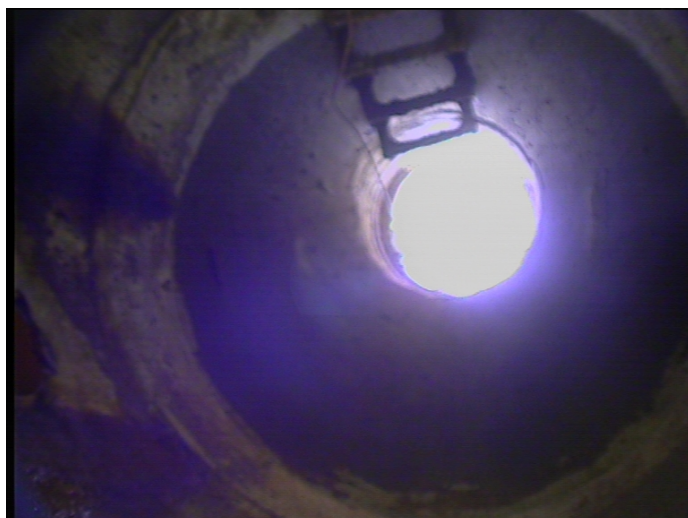
Code: **AMH**
 Description: **Manhole**

Distance (ft): **.0**
 Structural Grade: **0**
 O&M Grade: **0**
 Clock Start/From:
 Clock To:
 1st Value:
 2nd Value:
 Value Percent:
 Continuous Index:
 Within 8" of Joint: **NO**
 Remarks: **M-103-4**

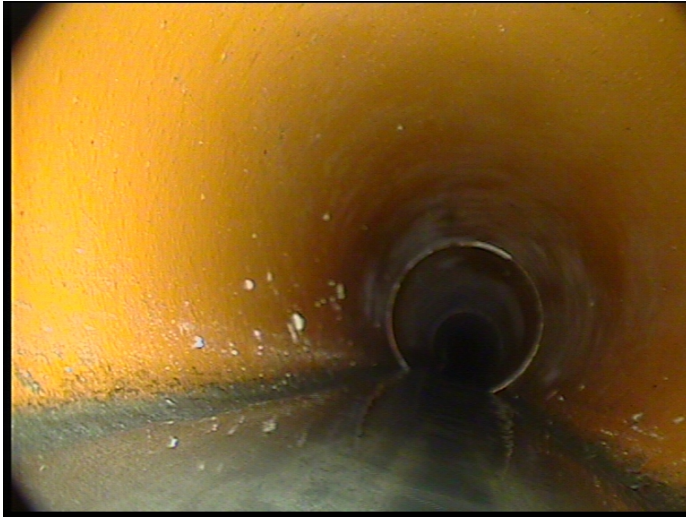
Code: **MWL**
Description: **Water Level**

Distance (ft): **.0**
Structural Grade: **0**
O&M Grade: **0**
Clock Start/From:
Clock To:
1st Value:
2nd Value:
Value Percent: **5.000**
Continuous Index:
Within 8" of Joint: **NO**
Remarks:

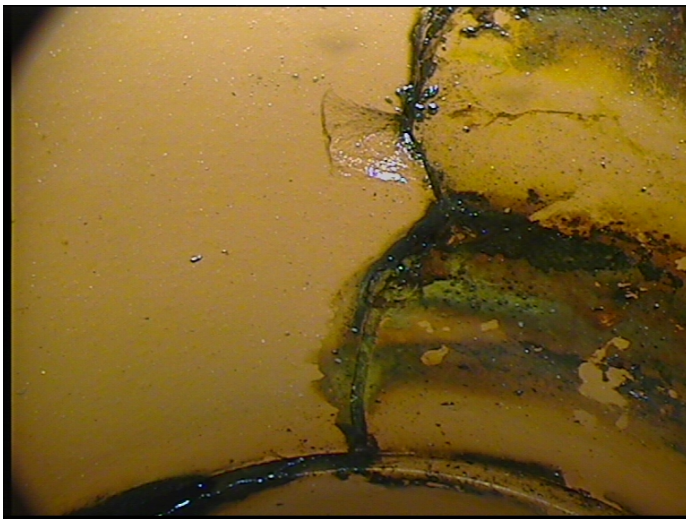
Code: **FL**
Description: **Fracture Longitudinal**

Distance (ft): **15.8**
Structural Grade: **3**
O&M Grade: **0**
Clock Start/From: **12**
Clock To:
1st Value:
2nd Value:
Value Percent:
Continuous Index:
Within 8" of Joint: **YES**
Remarks:

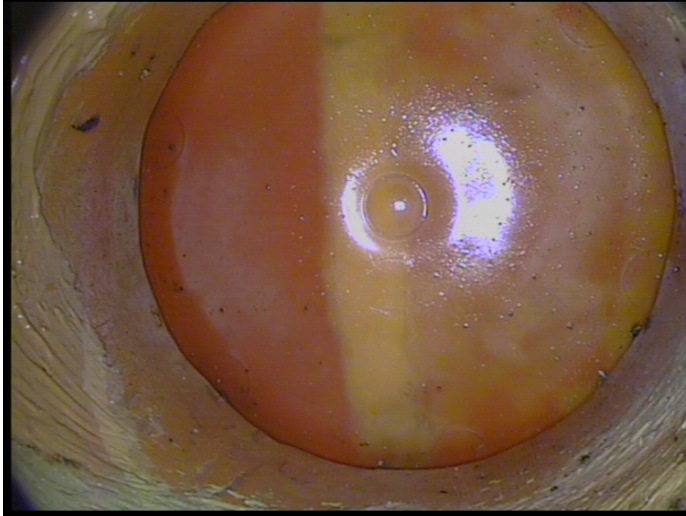
Code: **TFC**
Description: **Tap Factory Capped**

Distance (ft): **22.8**
Structural Grade: **0**
O&M Grade: **0**
Clock Start/From: **3**
Clock To:
1st Value: **4.000**
2nd Value:
Value Percent:
Continuous Index:
Within 8" of Joint: **NO**
Remarks:

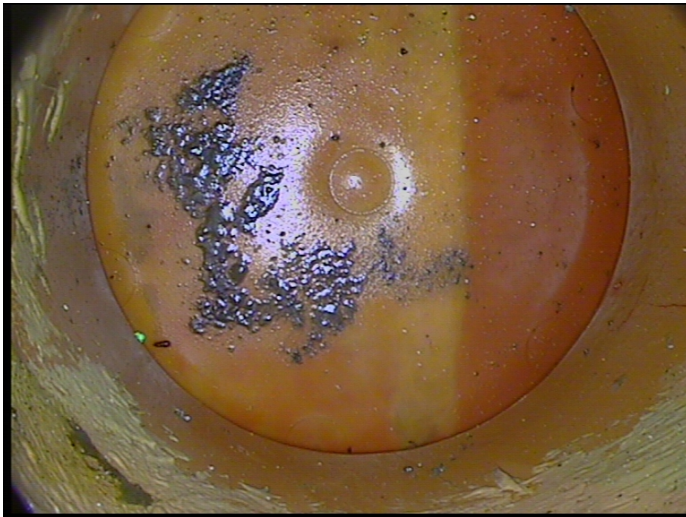
Code: **TFC**
Description: **Tap Factory Capped**

Distance (ft): **25.3**
Structural Grade: **0**
O&M Grade: **0**
Clock Start/From: **10**
Clock To:
1st Value: **4.000**
2nd Value:
Value Percent:
Continuous Index:
Within 8" of Joint: **NO**
Remarks:

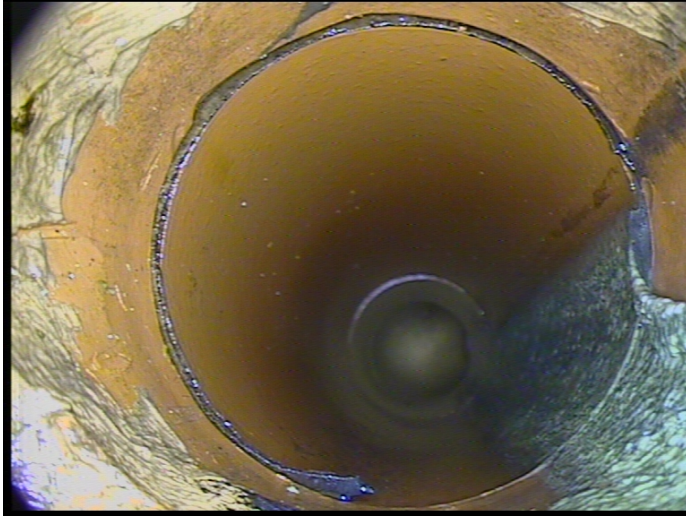
Code:	TFA
Description:	Tap Factory Active
Distance (ft):	87.7
Structural Grade:	0
O&M Grade:	0
Clock Start/From:	12
Clock To:	
1st Value:	4.000
2nd Value:	
Value Percent:	
Continuous Index:	
Within 8" of Joint:	NO
Remarks:

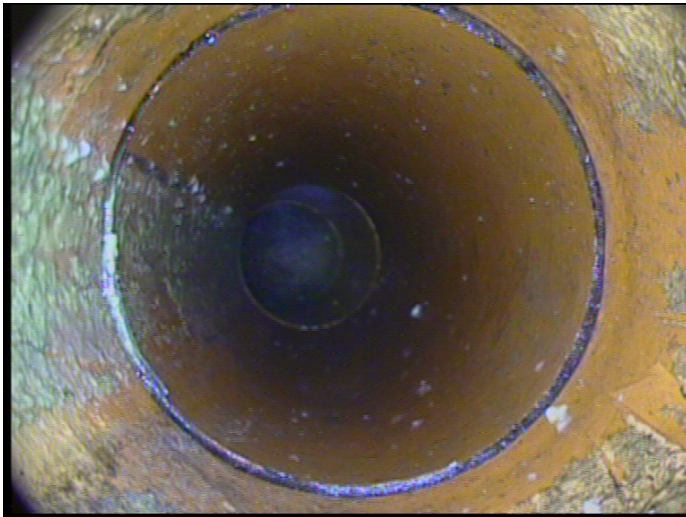
Code:	TF
Description:	Tap Factory
Distance (ft):	89.6
Structural Grade:	0
O&M Grade:	0
Clock Start/From:	11
Clock To:	
1st Value:	4.000
2nd Value:	
Value Percent:	
Continuous Index:	
Within 8" of Joint:	NO
Remarks:

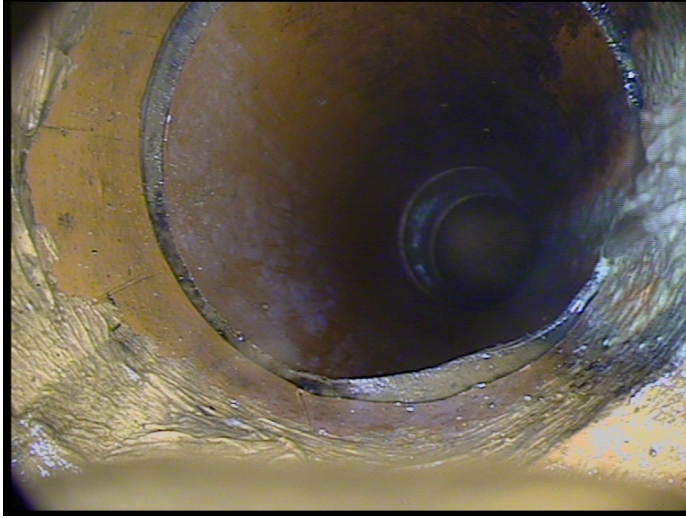
Code: **TFA**
Description: **Tap Factory Active**

Distance (ft): **122.6**
Structural Grade: **0**
O&M Grade: **0**
Clock Start/From: **2**
Clock To:
1st Value: **4.000**
2nd Value:
Value Percent:
Continuous Index:
Within 8" of Joint: **NO**
Remarks:

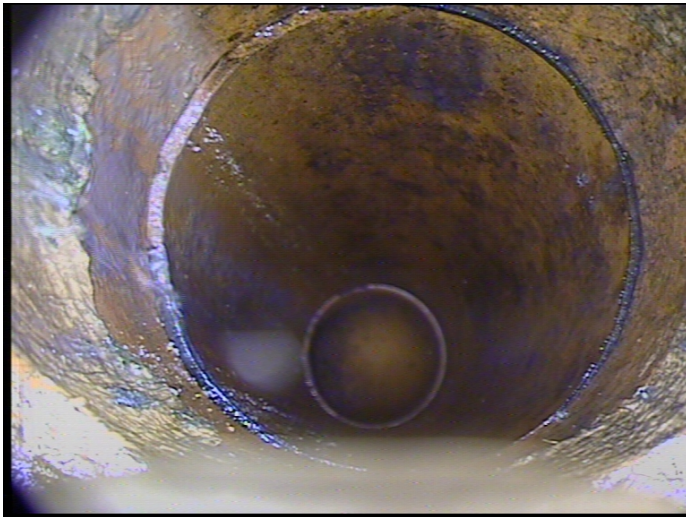
Code: **TFA**
Description: **Tap Factory Active**

Distance (ft): **124.8**
Structural Grade: **0**
O&M Grade: **0**
Clock Start/From: **11**
Clock To:
1st Value: **4.000**
2nd Value:
Value Percent:
Continuous Index:
Within 8" of Joint: **NO**
Remarks:

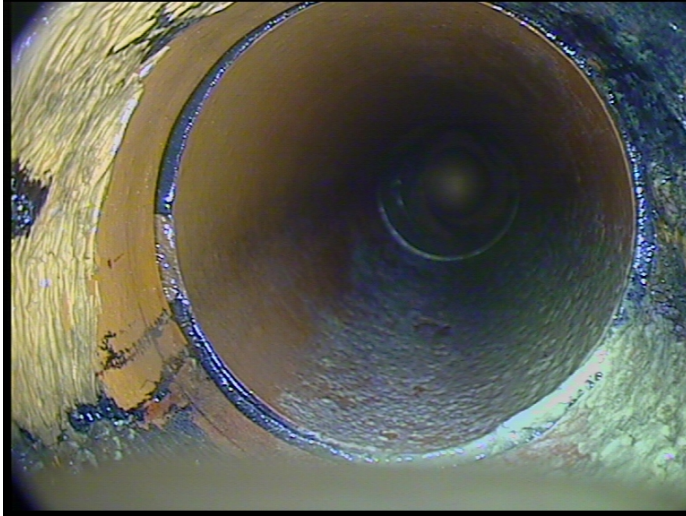
Code: **TF**
Description: **Tap Factory**

Distance (ft): **193.4**
Structural Grade: **0**
O&M Grade: **0**
Clock Start/From: **12**
Clock To:
1st Value: **4.000**
2nd Value:
Value Percent:
Continuous Index:
Within 8" of Joint: **NO**
Remarks:

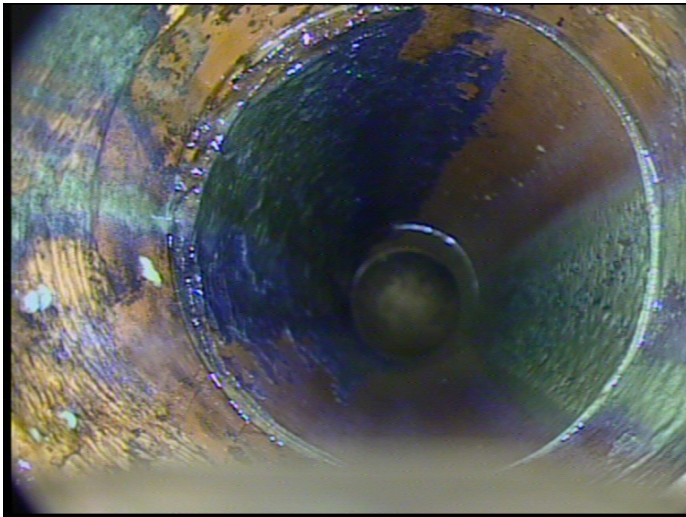
Code: **TF**
Description: **Tap Factory**

Distance (ft): **195.2**
Structural Grade: **0**
O&M Grade: **0**
Clock Start/From: **12**
Clock To:
1st Value: **4.000**
2nd Value:
Value Percent:
Continuous Index:
Within 8" of Joint: **NO**
Remarks:

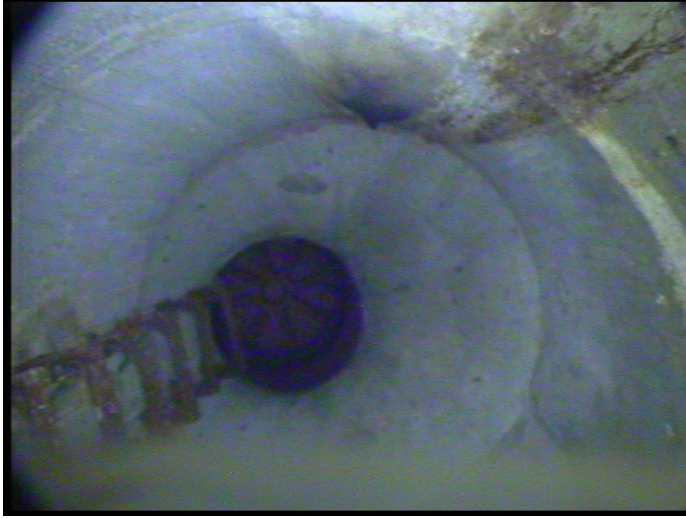
Code:	AMH
Description:	Manhole
Distance (ft):	220.6
Structural Grade:	0
O&M Grade:	0
Clock Start/From:	
Clock To:	
1st Value:	
2nd Value:	
Value Percent:	
Continuous Index:	
Within 8" of Joint:	NO
Remarks:	M-103-6
