Profile/Photo Observation Report

Date:	09/28/2018	Weather:		Coding:	PACP 6.0
Pipe Length (ft):	177.5	Owner:	NA	Pre Clean:	Not Known
P.O.#:		Surveyor:	Selasie Honu	PSR:	P-103-008-007
Customer:		Clean Date:	01/01/1900	Shape:	C

Street:	Willow St.	Flow Control:	Not Controlled
City:	Hobart, IN	Year Renewed:	
Location:	Light Highway	Tape/Media #:	
Purpose:	Routine Assessment	Dia/Height:	10"
Use:	Sanitary	Material:	VCP
Drain Area:	NA	Lining:	
Category:	NA		
Comment:

Location Details:		Direction of Survey:	Upstream
US MH:	M-103-007	DS MH:	M-103-008
		Total Length Surveyed (ft):	171.1

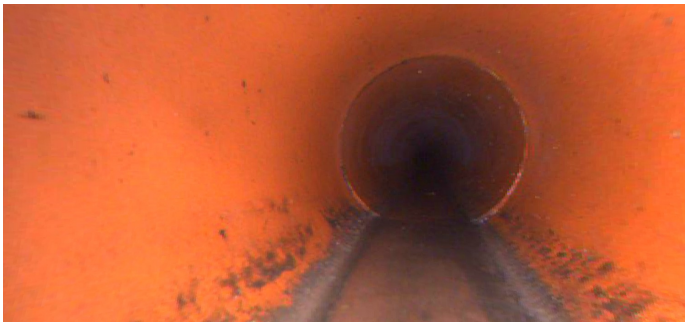
Code: **AMH**
Description: **Manhole**

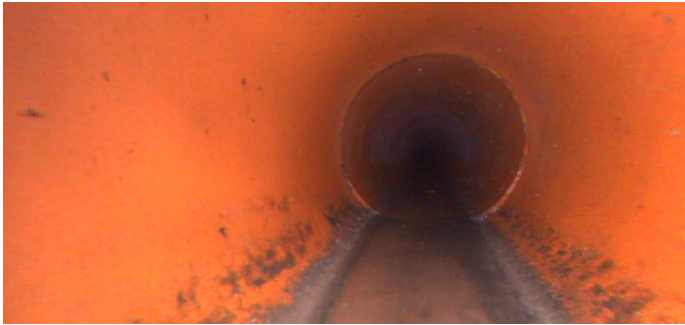
Code:	MWL
Description:	Water Level

Distance (ft):	.0
Structural Grade:	0
O&M Grade:	0
Clock Start/From:	
Clock To:	
1st Value:	
2nd Value:	
Value Percent:	5.000
Continuous Index:	
Within 8" of Joint:	NO
Remarks:

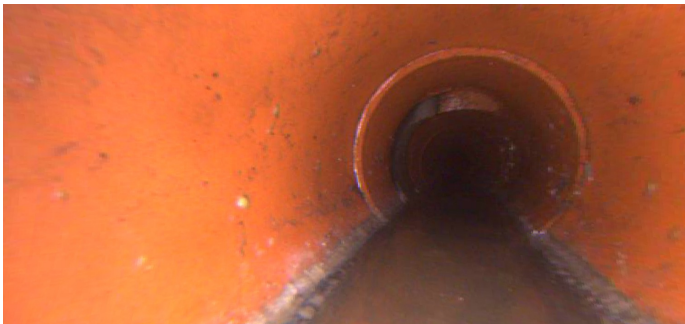
Code:	TF
Description:	Tap Factory

Distance (ft):	47.6
Structural Grade:	0
O&M Grade:	0
Clock Start/From:	12
Clock To:	
1st Value:	4.000
2nd Value:	
Value Percent:	
Continuous Index:	
Within 8" of Joint:	
Remarks:

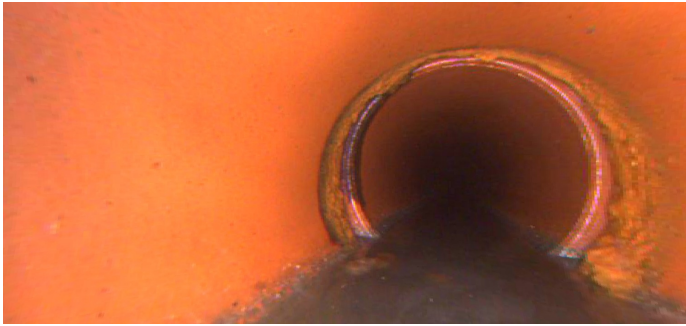
Code: **DAE**
Description: **Deposits Attached Encrustation**

Distance (ft): **54.9**
Structural Grade: **0**
O&M Grade: **2**
Clock Start/From: **8**
Clock To: **4**
1st Value:
2nd Value:
Value Percent: **10.000**
Continuous Index:
Within 8" of Joint: **YES**
Remarks:

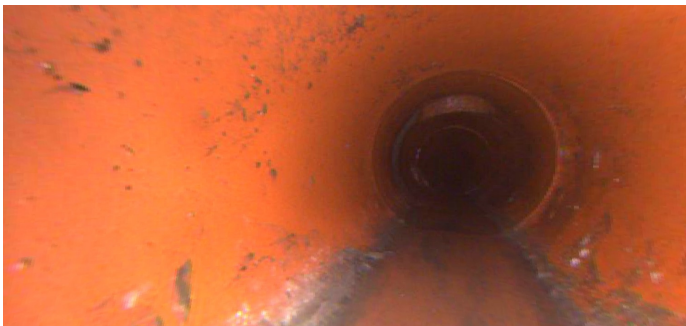
Code: **TF**
Description: **Tap Factory**

Distance (ft): **95.4**
Structural Grade: **0**
O&M Grade: **0**
Clock Start/From: **12**
Clock To:
1st Value: **4.000**
2nd Value:
Value Percent:
Continuous Index:
Within 8" of Joint:
Remarks:

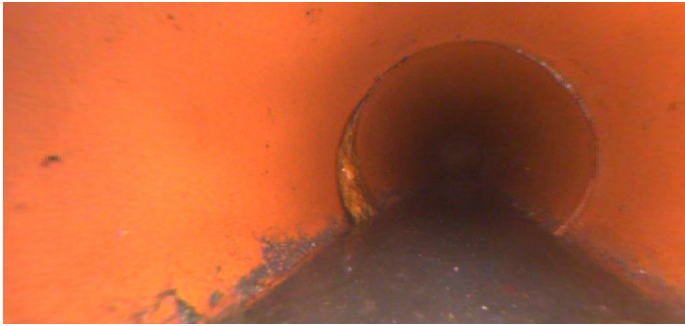
Code: **DAE**
Description: **Deposits Attached Encrustation**

Distance (ft): **164.3**
Structural Grade: **0**
O&M Grade: **3**
Clock Start/From: **8**
Clock To: **10**
1st Value:
2nd Value:
Value Percent: **15.000**
Continuous Index:
Within 8" of Joint: **YES**
Remarks:

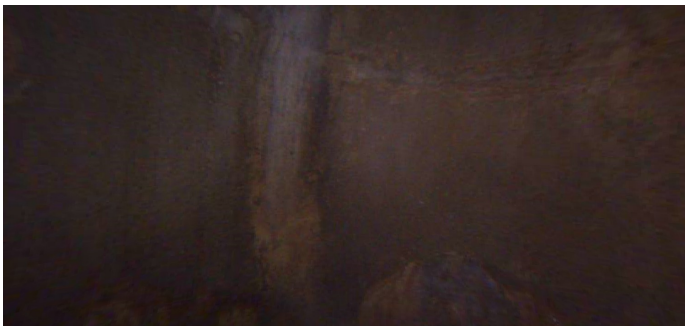
Code: **AMH**
Description: **Manhole**

Distance (ft): **171.1**
Structural Grade: **0**
O&M Grade: **0**
Clock Start/From:
Clock To:
1st Value:
2nd Value:
Value Percent:
Continuous Index:
Within 8" of Joint: **NO**
Remarks: **M-103-007**
