Profile/Photo Observation Report

Date:	09/29/2018	Weather:		Coding:	PACP 6.0
Pipe Length (ft):	231.0	Owner:	NA	Pre Clean:	Not Known
P.O.#:		Surveyor:	Justin Gonzales	PSR:	P-103-009-008
Customer:		Clean Date:	01/01/1900	Shape:	C

Street:	ALLEY BETWEEN HOWARD ST & WIL	Flow Control:	Not Controlled
City:	Hobart, IN	Year Renewed:	
Location:	Light Highway	Tape/Media #:	
Purpose:	Routine Assessment	Dia/Height:	10"
Use:	Sanitary	Material:	VCP
Drain Area:	NA	Lining:	
Category:	NA		
Comment:

Location Details:		Direction of Survey:	Upstream
US MH:	M-103-008	DS MH:	M-103-009
		Total Length Surveyed (ft):	225.2

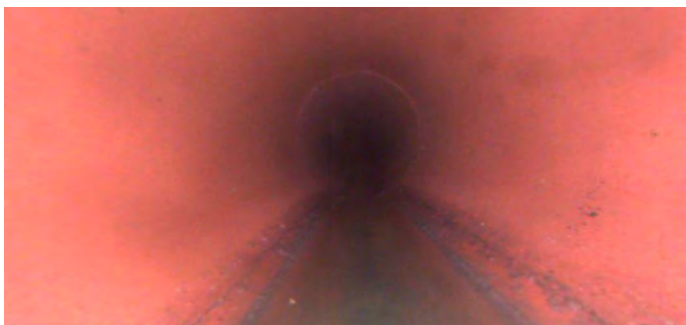
Code: **AMH**
Description: **Manhole**

Distance (ft): **.0**
Structural Grade: **0**
O&M Grade: **0**
Clock Start/From:
Clock To:
1st Value:
2nd Value:
Value Percent:
Continuous Index:
Within 8" of Joint: **NO**
Remarks: **M-103-009**

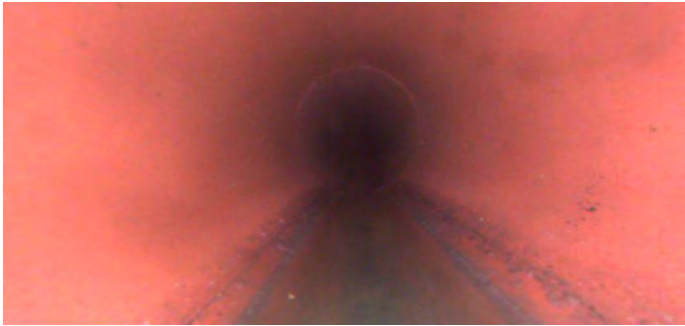
Code:	MWL
Description:	Water Level

Distance (ft):	.0
Structural Grade:	0
O&M Grade:	0
Clock Start/From:	
Clock To:	
1st Value:	
2nd Value:	
Value Percent:	5.000
Continuous Index:	
Within 8" of Joint:	NO
Remarks:

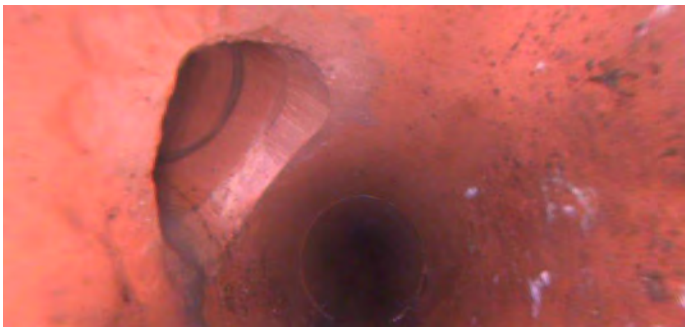
Code:	TF
Description:	Tap Factory

Distance (ft):	8.4
Structural Grade:	0
O&M Grade:	0
Clock Start/From:	10
Clock To:	
1st Value:	4.000
2nd Value:	
Value Percent:	
Continuous Index:	
Within 8" of Joint:	
Remarks:

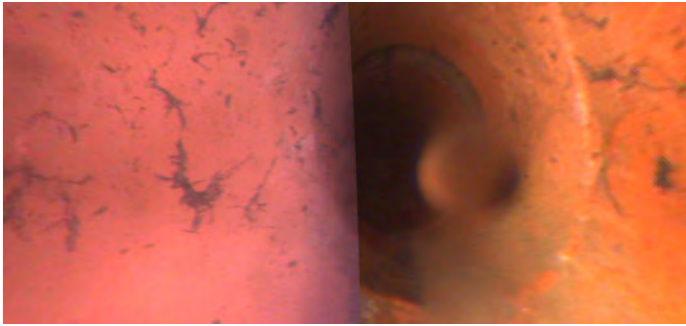
Code: **TF**
Description: **Tap Factory**

Distance (ft): **31.8**
Structural Grade: **0**
O&M Grade: **0**
Clock Start/From: **2**
Clock To:
1st Value: **4.000**
2nd Value:
Value Percent:
Continuous Index:
Within 8" of Joint:
Remarks:

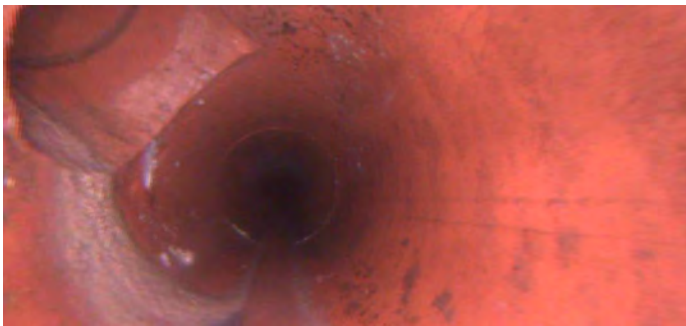
Code: **TF**
Description: **Tap Factory**

Distance (ft): **43.1**
Structural Grade: **0**
O&M Grade: **0**
Clock Start/From: **10**
Clock To:
1st Value: **4.000**
2nd Value:
Value Percent:
Continuous Index:
Within 8" of Joint:
Remarks:

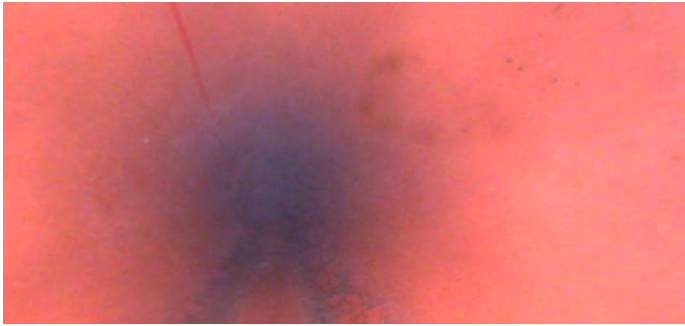
Code: **MGO**
Description: **General Observation**

Distance (ft): **72.7**
Structural Grade: **0**
O&M Grade: **0**
Clock Start/From:
Clock To:
1st Value:
2nd Value:
Value Percent:
Continuous Index:
Within 8" of Joint: **NO**
Remarks: **LIGHT FOG/STEAM**

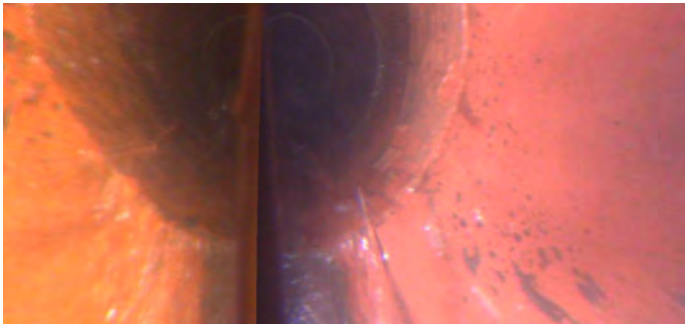
Code: **TFA**
Description: **Tap Factory Active**

Distance (ft): **86.4**
Structural Grade: **0**
O&M Grade: **0**
Clock Start/From: **10**
Clock To:
1st Value: **4.000**
2nd Value:
Value Percent:
Continuous Index:
Within 8" of Joint:
Remarks:

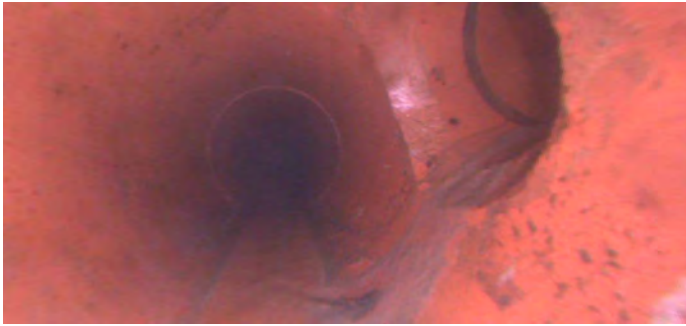
Code: **TF**
Description: **Tap Factory**

Distance (ft): **108.4**
Structural Grade: **0**
O&M Grade: **0**
Clock Start/From: **3**
Clock To:
1st Value: **4.000**
2nd Value:
Value Percent:
Continuous Index:
Within 8" of Joint:
Remarks:

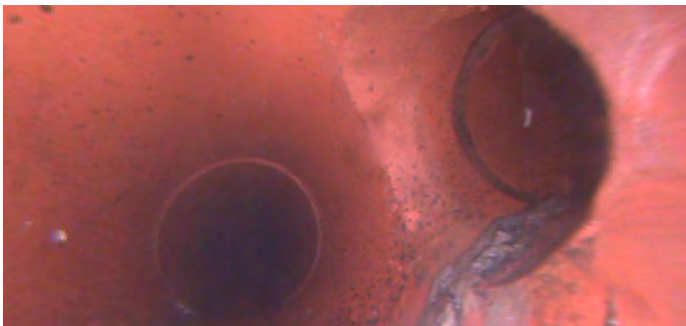
Code: **TF**
Description: **Tap Factory**

Distance (ft): **130.9**
Structural Grade: **0**
O&M Grade: **0**
Clock Start/From: **2**
Clock To:
1st Value: **4.000**
2nd Value:
Value Percent:
Continuous Index:
Within 8" of Joint:
Remarks:

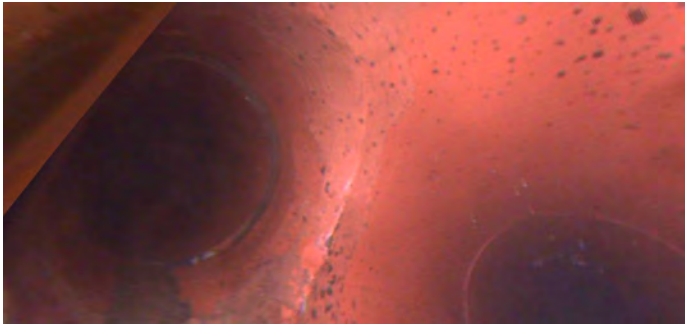
Code: **TF**
Description: **Tap Factory**

Distance (ft): **143.1**
Structural Grade: **0**
O&M Grade: **0**
Clock Start/From: **10**
Clock To:
1st Value: **4.000**
2nd Value:
Value Percent:
Continuous Index:
Within 8" of Joint:
Remarks:

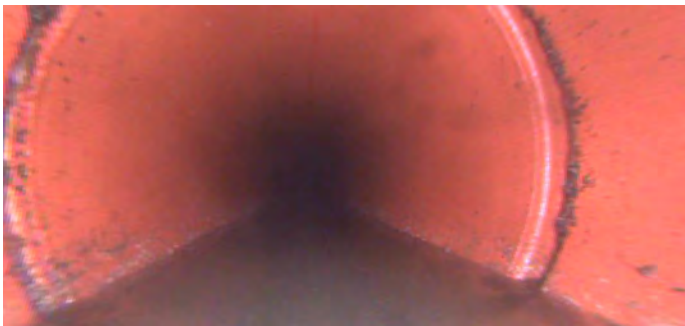
Code: **MWLS**
Description: **Water Level Sag**

Distance (ft): **159.3**
Structural Grade: **2**
O&M Grade: **3**
Clock Start/From:
Clock To:
1st Value:
2nd Value:
Value Percent: **10.000**
Continuous Index:
Within 8" of Joint: **NO**
Remarks:

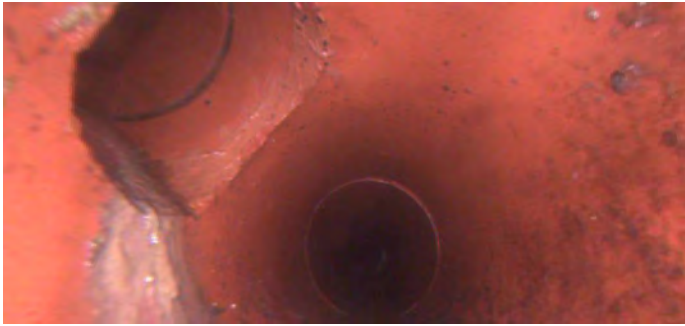
Code: **TF**
Description: **Tap Factory**

Distance (ft): **195.5**
Structural Grade: **0**
O&M Grade: **0**
Clock Start/From: **10**
Clock To:
1st Value: **4.000**
2nd Value:
Value Percent:
Continuous Index:
Within 8" of Joint:
Remarks:

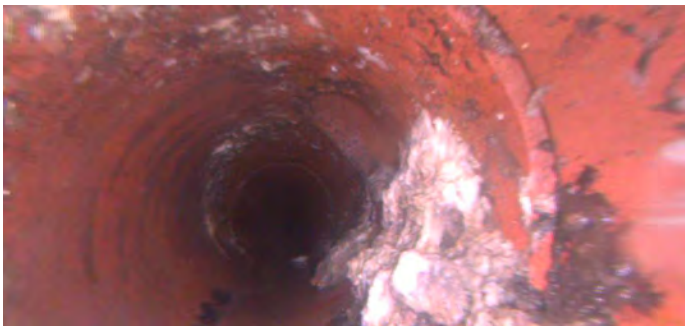
Code: **DAZ**
Description: **Deposits Attached Other**

Distance (ft): **201.9**
Structural Grade: **0**
O&M Grade: **2**
Clock Start/From: **7**
Clock To: **5**
1st Value:
2nd Value:
Value Percent: **5.000**
Continuous Index:
Within 8" of Joint: **NO**
Remarks:

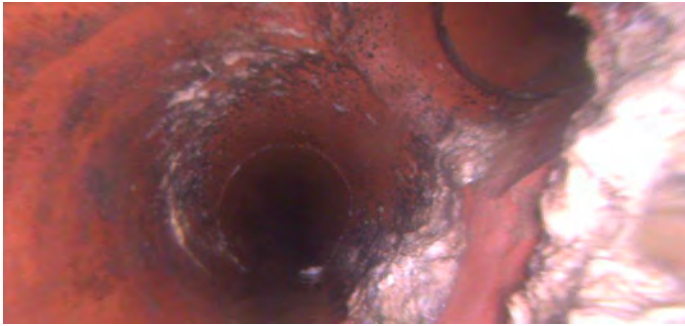
Code: **TF**
Description: **Tap Factory**

Distance (ft): **202.5**
Structural Grade: **0**
O&M Grade: **0**
Clock Start/From: **2**
Clock To:
1st Value: **4.000**
2nd Value:
Value Percent:
Continuous Index:
Within 8" of Joint:
Remarks:

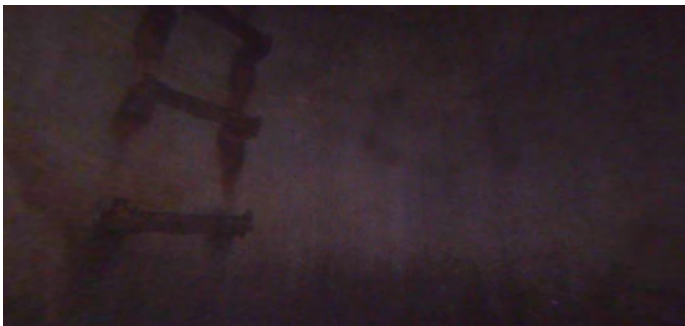
Code: **AMH**
Description: **Manhole**

Distance (ft): **225.2**
Structural Grade: **0**
O&M Grade: **0**
Clock Start/From:
Clock To:
1st Value:
2nd Value:
Value Percent:
Continuous Index:
Within 8" of Joint: **NO**
Remarks: **M-103-008**
