Profile/Photo Observation Report

Date:	04/06/2018	Weather:		Coding:	PACP 6.0
Pipe Length (ft):	190.6	Owner:	NA	Pre Clean:	Not Known
P.O.#:		Surveyor:	Mark Ruby	PSR:	P-103-018-008
Customer:		Clean Date:	01/01/1900	Shape:	C

Street:	WILLOW ST	Flow Control:	Not Controlled
City:	Hobart, IN	Year Renewed:	
Location:	Other	Tape/Media #:	
Purpose:	Not Known	Dia/Height:	10"
Use:	Sanitary	Material:	VCP
Drain Area:	NA	Lining:	
Category:	NA		
Comment:

Location Details:		Direction of Survey:	Upstream
US MH:	M-103-008	DS MH:	M-103-018
		Total Length Surveyed (ft):	177.3

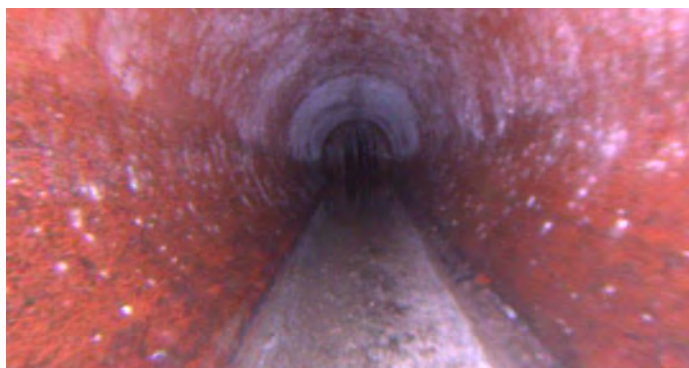
Code: **AMH**
Description: **Manhole**

Distance (ft): **.0**
Structural Grade: **0**
O&M Grade: **0**
Clock Start/From:
Clock To:
1st Value:
2nd Value:
Value Percent:
Continuous Index:
Within 8" of Joint: **NO**
Remarks: **M-103-018**

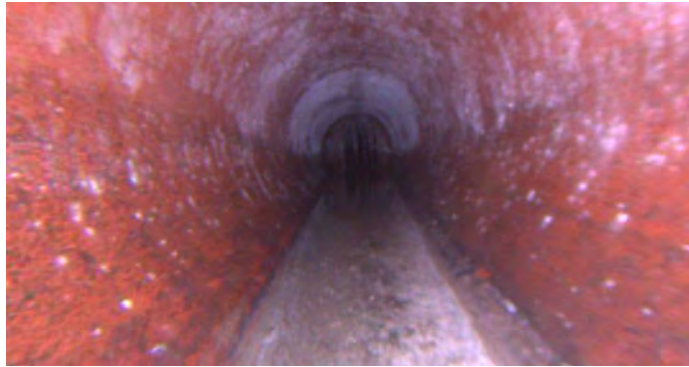
Code: **MWL**
Description: **Water Level**

Distance (ft): **.0**
Structural Grade: **0**
O&M Grade: **0**
Clock Start/From:
Clock To:
1st Value:
2nd Value:
Value Percent: **10.000**
Continuous Index:
Within 8" of Joint: **NO**
Remarks:

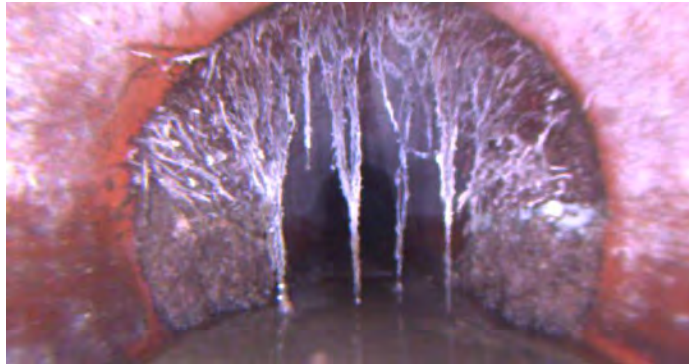
Code: **RMJ**
Description: **Roots Medium Joint**

Distance (ft): **4.1**
Structural Grade: **0**
O&M Grade: **3**
Clock Start/From: **7**
Clock To: **5**
1st Value:
2nd Value:
Value Percent: **20.000**
Continuous Index:
Within 8" of Joint: **YES**
Remarks:

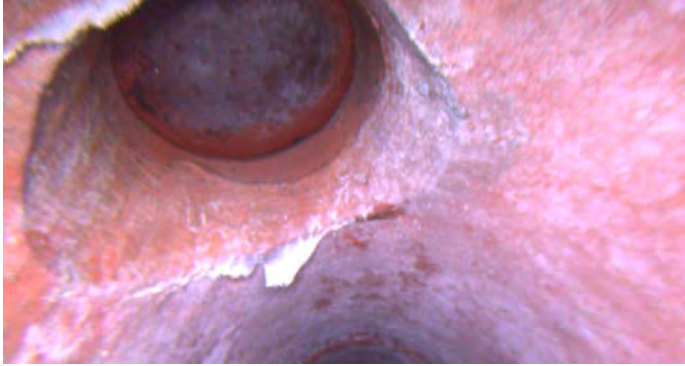
Code: **TFC**
Description: **Tap Factory Capped**

Distance (ft): **76.3**
Structural Grade: **0**
O&M Grade: **0**
Clock Start/From: **11**
Clock To:
1st Value: **4.000**
2nd Value:
Value Percent:
Continuous Index:
Within 8" of Joint:
Remarks:

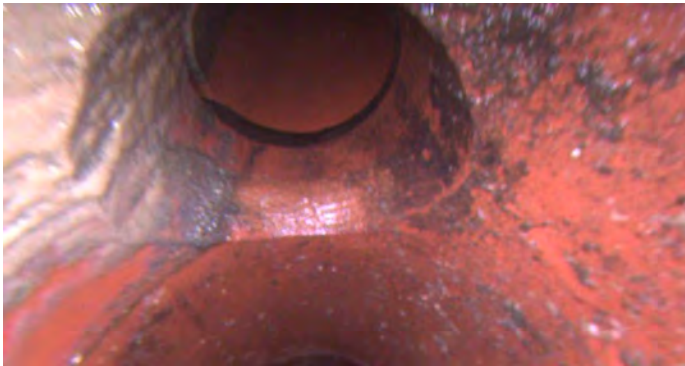
Code: **TF**
Description: **Tap Factory**

Distance (ft): **139.0**
Structural Grade: **0**
O&M Grade: **0**
Clock Start/From: **11**
Clock To:
1st Value: **4.000**
2nd Value:
Value Percent:
Continuous Index:
Within 8" of Joint:
Remarks:

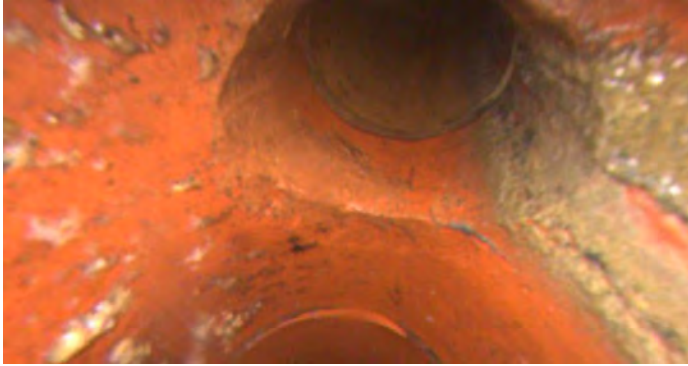
Code: **TF**
Description: **Tap Factory**

Distance (ft): **167.2**
Structural Grade: **0**
O&M Grade: **0**
Clock Start/From: **11**
Clock To:
1st Value: **4.000**
2nd Value:
Value Percent:
Continuous Index:
Within 8" of Joint:
Remarks:
