Profile/Photo Observation Report

Street:	willow st	Flow Control:	Not Controlled
City:	Hobart, IN	Year Renewed:	
Location:	Other	Tape/Media #:	
Purpose:	Not Known	Dia/Height:	10"
Use:	Sanitary	Material:	VCP
Drain Area:	NA	Lining:	
Category:	NA		
Comment:

Location Details:		Direction of Survey:	Upstream
US MH:	M-103-008	DS MH:	M-103-018
		Total Length Surveyed (ft):	177.3

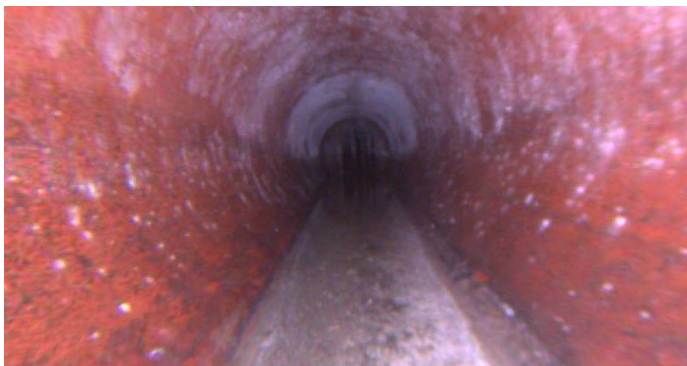
Code: **AMH**
 Description: **Manhole**

Distance (ft): **.0**
 Structural Grade: **0**
 O&M Grade: **0**
 Clock Start/From:
 Clock To:
 1st Value:
 2nd Value:
 Value Percent:
 Continuous Index:
 Within 8" of Joint: **NO**
 Remarks: **M-103-018**

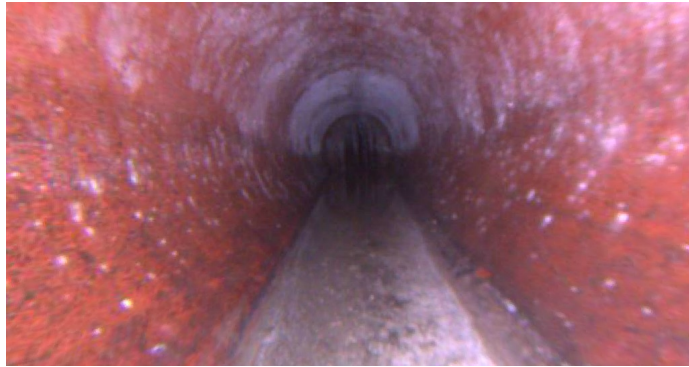
Code: **MWL**
Description: **Water Level**

Distance (ft): **.0**
Structural Grade: **0**
O&M Grade: **0**
Clock Start/From:
Clock To:
1st Value:
2nd Value:
Value Percent: **10.000**
Continuous Index:
Within 8" of Joint: **NO**
Remarks:

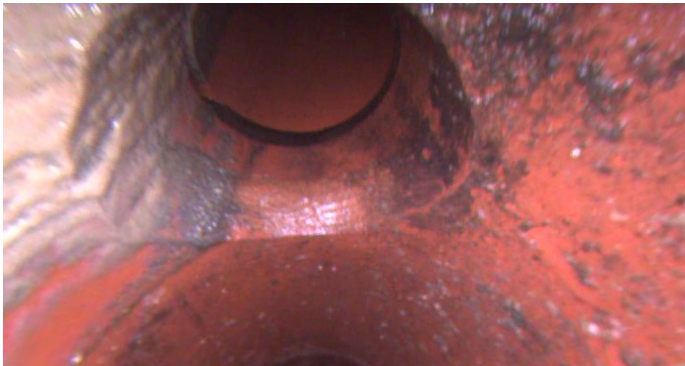
Code: **TF**
Description: **Tap Factory**

Distance (ft): **139.0**
Structural Grade: **0**
O&M Grade: **0**
Clock Start/From: **11**
Clock To:
1st Value: **4.000**
2nd Value:
Value Percent:
Continuous Index:
Within 8" of Joint:
Remarks:

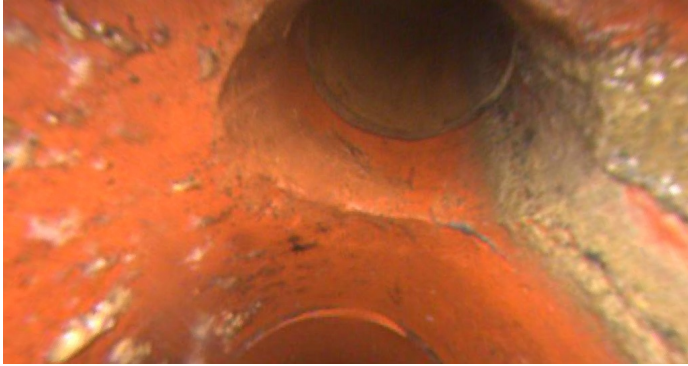
Code: **TF**
Description: **Tap Factory**

Distance (ft): **167.2**
Structural Grade: **0**
O&M Grade: **0**
Clock Start/From: **11**
Clock To:
1st Value: **4.000**
2nd Value:
Value Percent:
Continuous Index:
Within 8" of Joint:
Remarks:
