Profile/Photo Observation Report

Street:	E 40TH AVE	Flow Control:	Not Controlled
City:	Hobart, IN	Year Renewed:	
Location:	Other	Tape/Media #:	
Purpose:	Not Known	Dia/Height:	10"
Use:	Sanitary	Material:	VCP
Drain Area:	NA	Lining:	
Category:	NA		
Comment:

Location Details:		Direction of Survey:	Downstream
US MH:	M-103-009	DS MH:	M-103-010
		Total Length Surveyed (ft):	180.9

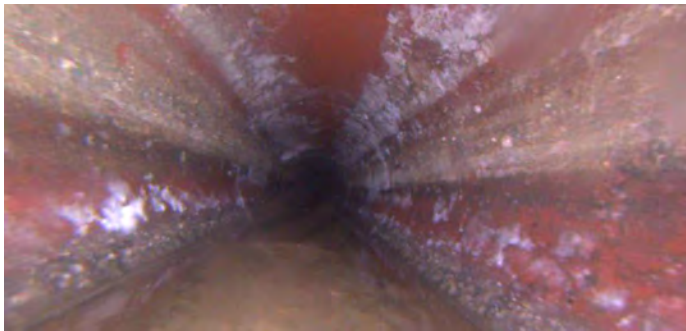
Code: **AMH**
Description: **Manhole**

Distance (ft): **.0**
Structural Grade: **0**
O&M Grade: **0**
Clock Start/From:
Clock To:
1st Value:
2nd Value:
Value Percent:
Continuous Index:
Within 8" of Joint: **NO**
Remarks: **M-103-009**

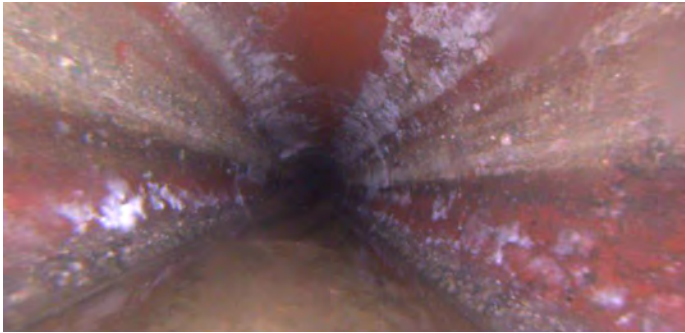
Code:	MWL
Description:	Water Level

Distance (ft):	.0
Structural Grade:	0
O&M Grade:	0
Clock Start/From:	
Clock To:	
1st Value:	
2nd Value:	
Value Percent:	10.000
Continuous Index:	
Within 8" of Joint:	NO
Remarks:

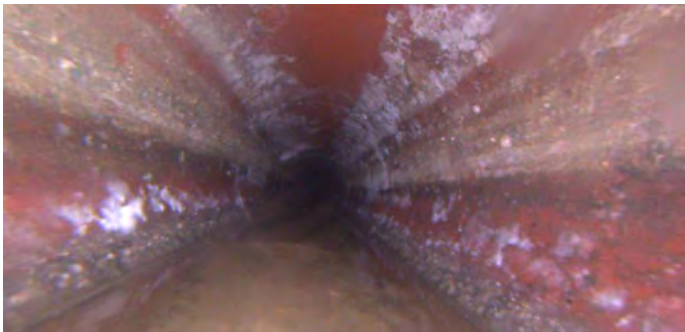
Code:	DAGS
Description:	Deposits Attached Grease

Distance (ft):	.0
Structural Grade:	0
O&M Grade:	2
Clock Start/From:	8
Clock To:	4
1st Value:	
2nd Value:	
Value Percent:	5.000
Continuous Index:	S01
Within 8" of Joint:	NO
Remarks:

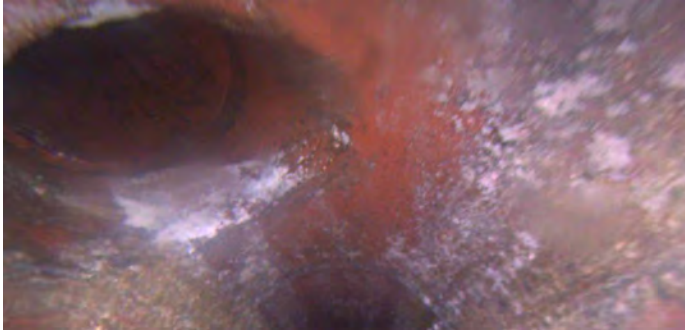
Code: **TF**
Description: **Tap Factory**

Distance (ft): **3.6**
Structural Grade: **0**
O&M Grade: **0**
Clock Start/From: **11**
Clock To:
1st Value: **4.000**
2nd Value:
Value Percent:
Continuous Index:
Within 8" of Joint:
Remarks:

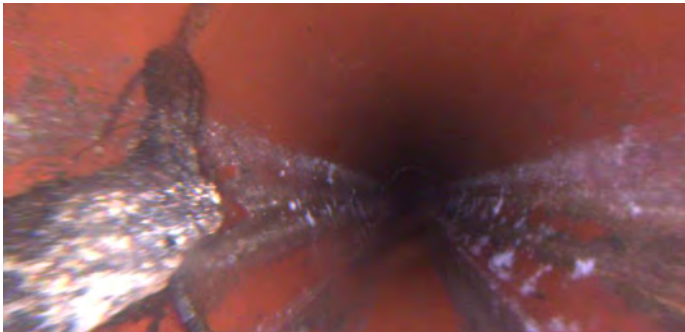
Code: **RMJ**
Description: **Roots Medium Joint**

Distance (ft): **19.4**
Structural Grade: **0**
O&M Grade: **3**
Clock Start/From: **8**
Clock To: **9**
1st Value:
2nd Value:
Value Percent: **5.000**
Continuous Index:
Within 8" of Joint: **YES**
Remarks:

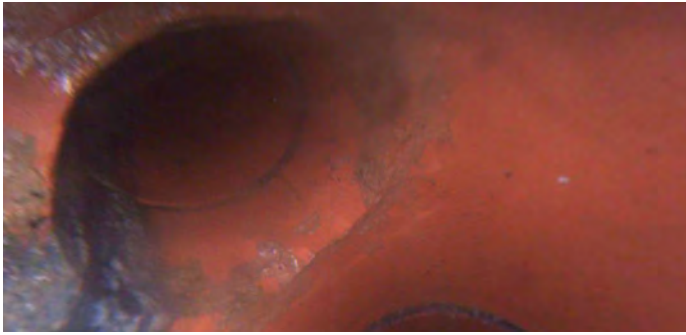
Code: **TF**
Description: **Tap Factory**

Distance (ft): **41.1**
Structural Grade: **0**
O&M Grade: **0**
Clock Start/From: **11**
Clock To:
1st Value: **4.000**
2nd Value:
Value Percent:
Continuous Index:
Within 8" of Joint:
Remarks:

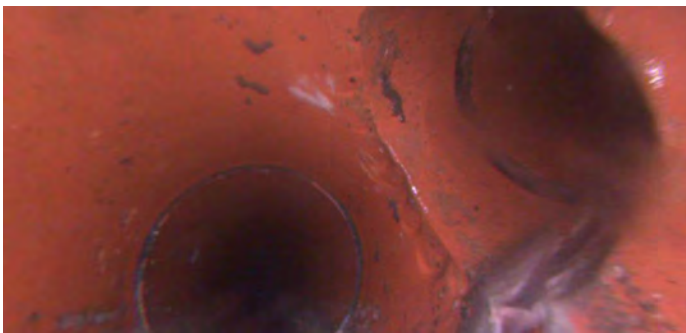
Code: **TFA**
Description: **Tap Factory Active**

Distance (ft): **58.2**
Structural Grade: **0**
O&M Grade: **0**
Clock Start/From: **2**
Clock To:
1st Value: **4.000**
2nd Value:
Value Percent:
Continuous Index:
Within 8" of Joint:
Remarks:

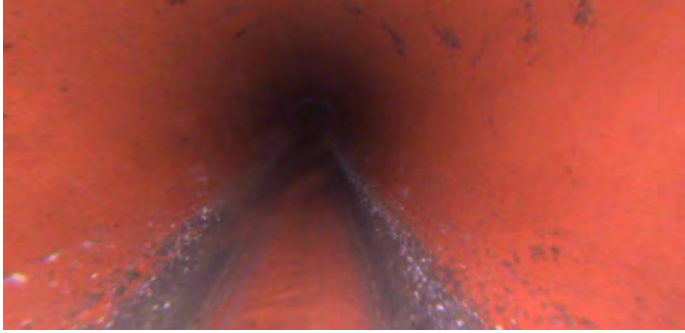
Code: **DAGS**
Description: **Deposits Attached Grease**

Distance (ft): **64.7**
Structural Grade: **0**
O&M Grade: **2**
Clock Start/From: **8**
Clock To: **4**
1st Value:
2nd Value:
Value Percent: **5.000**
Continuous Index: **F01**
Within 8" of Joint: **NO**
Remarks:

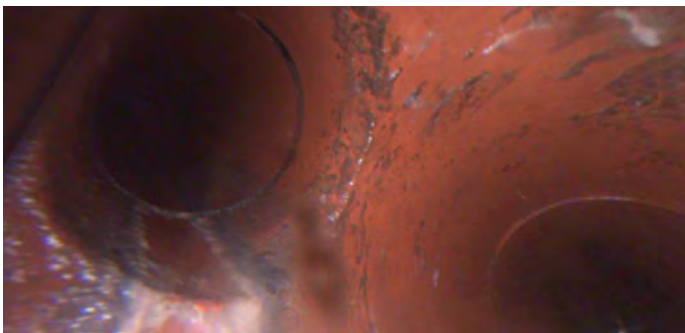
Code: **TFA**
Description: **Tap Factory Active**

Distance (ft): **96.7**
Structural Grade: **0**
O&M Grade: **0**
Clock Start/From: **2**
Clock To:
1st Value: **4.000**
2nd Value:
Value Percent:
Continuous Index:
Within 8" of Joint:
Remarks:

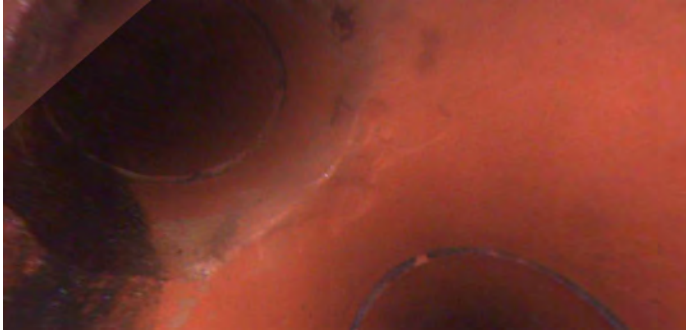
Code: **TF**
Description: **Tap Factory**

Distance (ft): **108.5**
Structural Grade: **0**
O&M Grade: **0**
Clock Start/From: **10**
Clock To:
1st Value: **4.000**
2nd Value:
Value Percent:
Continuous Index:
Within 8" of Joint:
Remarks:

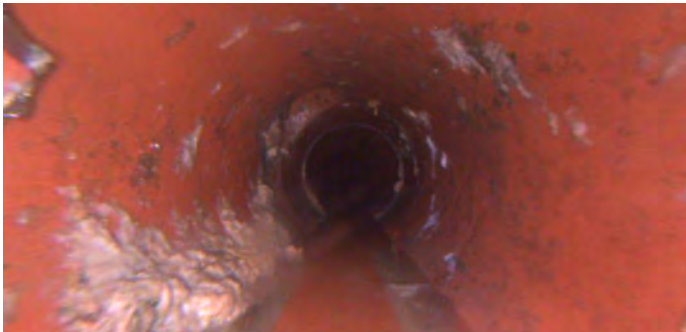
Code: **DAGS**
Description: **Deposits Attached Grease**

Distance (ft): **150.2**
Structural Grade: **0**
O&M Grade: **2**
Clock Start/From: **8**
Clock To: **4**
1st Value:
2nd Value:
Value Percent: **5.000**
Continuous Index:
Within 8" of Joint: **NO**
Remarks:

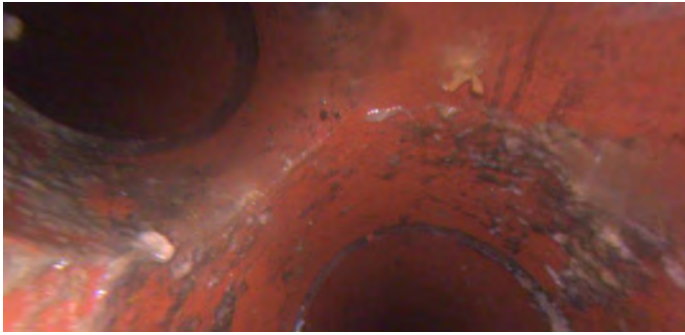
Code: **TF**
Description: **Tap Factory**

Distance (ft): **151.5**
Structural Grade: **0**
O&M Grade: **0**
Clock Start/From: **10**
Clock To:
1st Value: **4.000**
2nd Value:
Value Percent:
Continuous Index:
Within 8" of Joint:
Remarks:

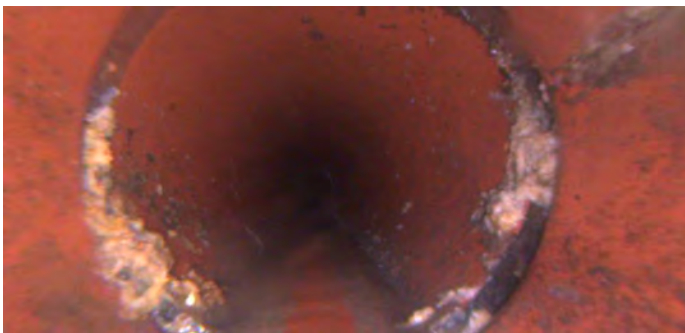
Code: **DAGS**
Description: **Deposits Attached Grease**

Distance (ft): **152.1**
Structural Grade: **0**
O&M Grade: **2**
Clock Start/From: **8**
Clock To: **4**
1st Value:
2nd Value:
Value Percent: **5.000**
Continuous Index:
Within 8" of Joint: **YES**
Remarks:

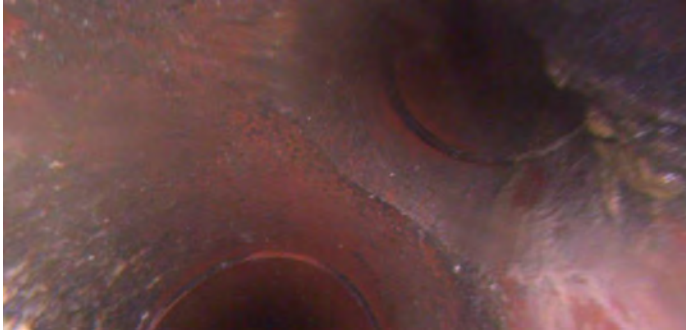
Code: **TF**
Description: **Tap Factory**

Distance (ft): **158.6**
Structural Grade: **0**
O&M Grade: **0**
Clock Start/From: **2**
Clock To:
1st Value: **4.000**
2nd Value:
Value Percent:
Continuous Index:
Within 8" of Joint:
Remarks:
