Profile/Photo Observation Report

Date:	09/27/2018	Weather:		Coding:	PACP 6.0
Pipe Length (ft):	367.5	Owner:	NA	Pre Clean:	Not Known
P.O.#:		Surveyor:	Justin Gonzales	PSR:	P-103-012-011
Customer:		Clean Date:	01/01/1900	Shape:	C

Location Details:		Direction of Survey:	Upstream
US MH:	M-103-011	DS MH:	M-103-012
		Total Length Surveyed (ft):	365.4

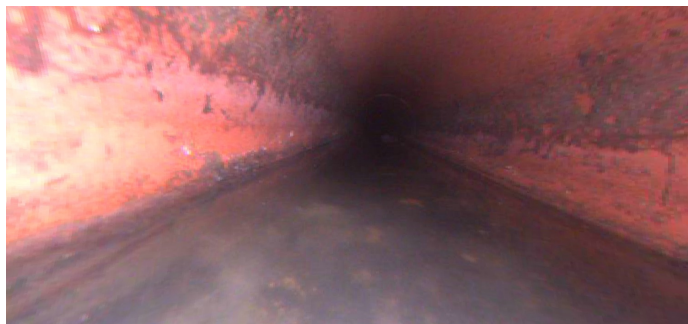
Code: **AMH**
Description: **Manhole**

Distance (ft): **.0**
Structural Grade: **0**
O&M Grade: **0**
Clock Start/From:
Clock To:
1st Value:
2nd Value:
Value Percent:
Continuous Index:
Within 8" of Joint: **NO**
Remarks: **M-103-012**

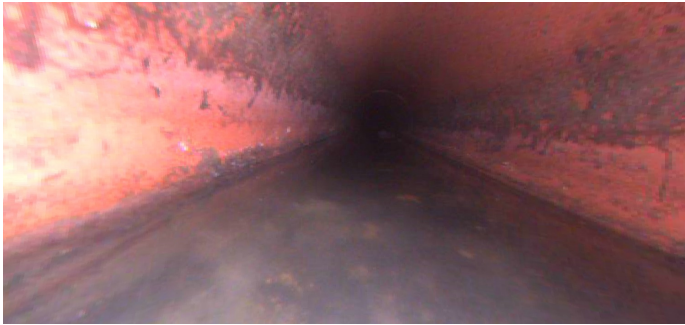
Code:	MWL
Description:	Water Level

Distance (ft):	.0
Structural Grade:	0
O&M Grade:	0
Clock Start/From:	
Clock To:	
1st Value:	
2nd Value:	
Value Percent:	15.000
Continuous Index:	
Within 8" of Joint:	NO
Remarks:

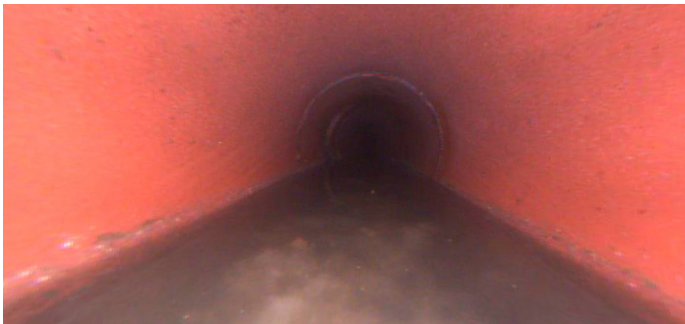
Code:	MWLS
Description:	Water Level Sag

Distance (ft):	49.1
Structural Grade:	2
O&M Grade:	3
Clock Start/From:	
Clock To:	
1st Value:	
2nd Value:	
Value Percent:	10.000
Continuous Index:	
Within 8" of Joint:	NO
Remarks:

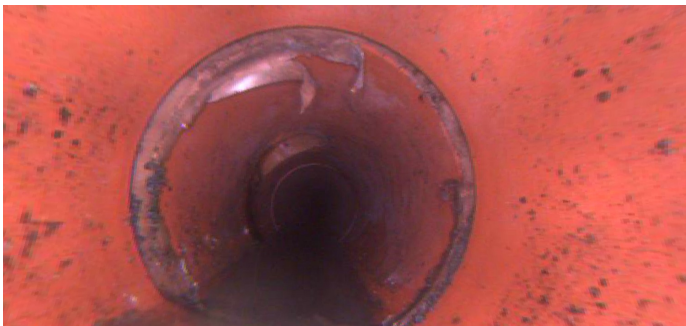
Code: **ISSRH**
Description: **Intruding Sealing Ring Hanging**

Distance (ft): **144.4**
Structural Grade: **0**
O&M Grade: **2**
Clock Start/From: **7**
Clock To: **1**
1st Value:
2nd Value:
Value Percent: **5.000**
Continuous Index:
Within 8" of Joint: **NO**
Remarks:

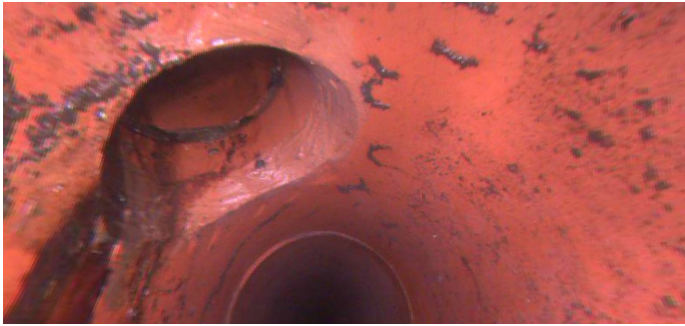
Code: **TF**
Description: **Tap Factory**

Distance (ft): **145.8**
Structural Grade: **0**
O&M Grade: **0**
Clock Start/From: **11**
Clock To:
1st Value: **4.000**
2nd Value:
Value Percent:
Continuous Index:
Within 8" of Joint:
Remarks:

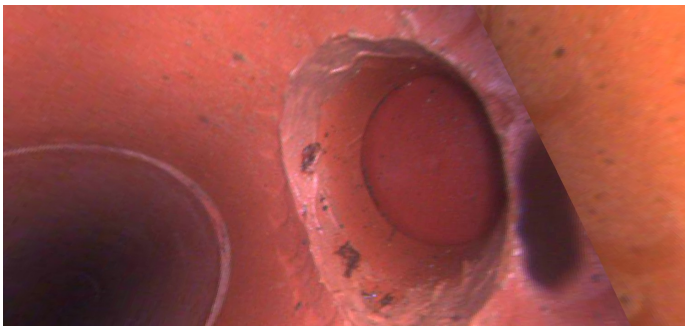
Code: **TFC**
Description: **Tap Factory Capped**

Distance (ft): **158.5**
Structural Grade: **0**
O&M Grade: **0**
Clock Start/From: **2**
Clock To:
1st Value: **4.000**
2nd Value:
Value Percent:
Continuous Index:
Within 8" of Joint:
Remarks:

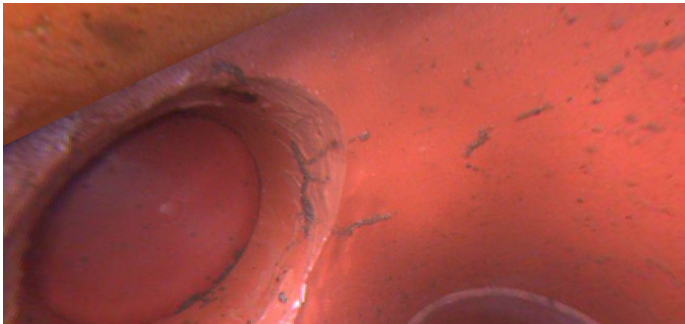
Code: **TFC**
Description: **Tap Factory Capped**

Distance (ft): **234.6**
Structural Grade: **0**
O&M Grade: **0**
Clock Start/From: **10**
Clock To:
1st Value: **4.000**
2nd Value:
Value Percent:
Continuous Index:
Within 8" of Joint:
Remarks:

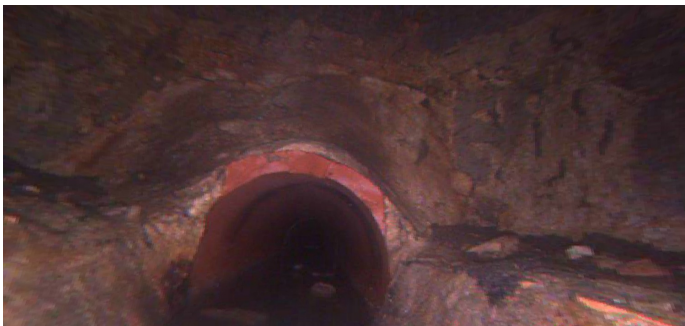
Code: **AMH**
Description: **Manhole**

Distance (ft): **365.4**
Structural Grade: **0**
O&M Grade: **0**
Clock Start/From:
Clock To:
1st Value:
2nd Value:
Value Percent:
Continuous Index:
Within 8" of Joint: **NO**
Remarks: **M-103-011**
