Profile/Photo Observation Report

Street:	WILLOW ST	Flow Control:	Not Controlled
City:	Hobart, IN	Year Renewed:	
Location:	Light Highway	Tape/Media #:	
Purpose:	Routine Assessment	Dia/Height:	10"
Use:	Sanitary	Material:	VCP
Drain Area:	NA	Lining:	
Category:	NA		
Comment:

Location Details:		Direction of Survey:	Upstream
US MH:	M-103-018	DS MH:	M-103-017
		Total Length Surveyed (ft):	36.6

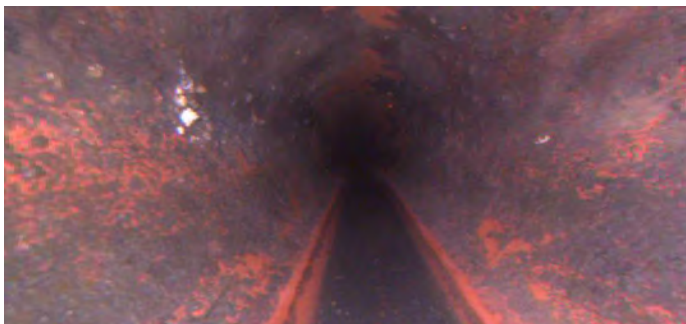
Code: **AMH**
Description: **Manhole**

Distance (ft): **.0**
Structural Grade: **0**
O&M Grade: **0**
Clock Start/From:
Clock To:
1st Value:
2nd Value:
Value Percent:
Continuous Index:
Within 8" of Joint: **NO**
Remarks: **M-103-017**

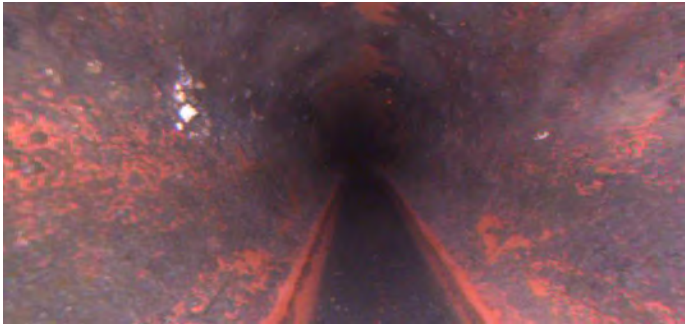
Code:	MWL
Description:	Water Level

Distance (ft):	.0
Structural Grade:	0
O&M Grade:	0
Clock Start/From:	
Clock To:	
1st Value:	
2nd Value:	
Value Percent:	5.000
Continuous Index:	
Within 8" of Joint:	NO
Remarks:

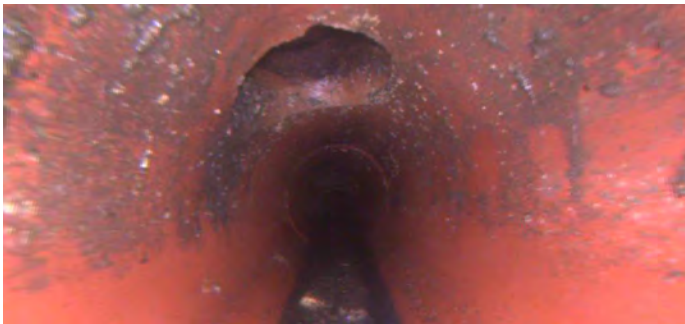
Code:	TF
Description:	Tap Factory

Distance (ft):	23.8
Structural Grade:	0
O&M Grade:	0
Clock Start/From:	12
Clock To:	
1st Value:	4.000
2nd Value:	
Value Percent:	
Continuous Index:	
Within 8" of Joint:	
Remarks:

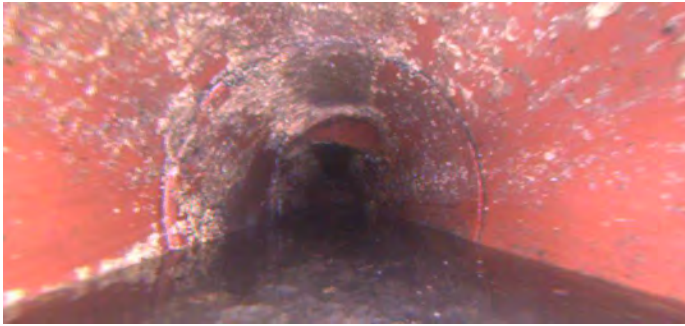
Code: **TF**
Description: **Tap Factory**

Distance (ft): **30.4**
Structural Grade: **0**
O&M Grade: **0**
Clock Start/From: **12**
Clock To:
1st Value: **4.000**
2nd Value:
Value Percent:
Continuous Index:
Within 8" of Joint:
Remarks:

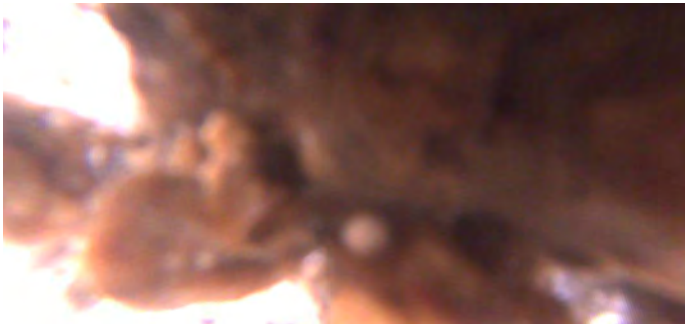
Code: **MSA**
Description: **Abandoned Survey**

Distance (ft): **36.6**
Structural Grade: **0**
O&M Grade: **0**
Clock Start/From:
Clock To:
1st Value:
2nd Value:
Value Percent:
Continuous Index:
Within 8" of Joint: **NO**
Remarks: **deposit settled grease**
