Profile/Photo Observation Report

Date:	03/29/2018	Weather:		Coding:	PACP 6.0
Pipe Length (ft):	335.0	Owner:	NA	Pre Clean:	Not Known
P.O.#:		Surveyor:	Jen Costello	PSR:	P-103-019-020
Customer:		Clean Date:	01/01/1900	Shape:	C

Street:	MISSOURI ST	Flow Control:	Not Controlled
City:	Hobart, IN	Year Renewed:	
Location:	Other	Tape/Media #:	
Purpose:	Not Known	Dia/Height:	8"
Use:	Sanitary	Material:	PVC
Drain Area:	NA	Lining:	
Category:	NA		
Comment:

Location Details:		Direction of Survey:	Downstream
US MH:	M-103-020	DS MH:	M-103-019
		Total Length Surveyed (ft):	326.6

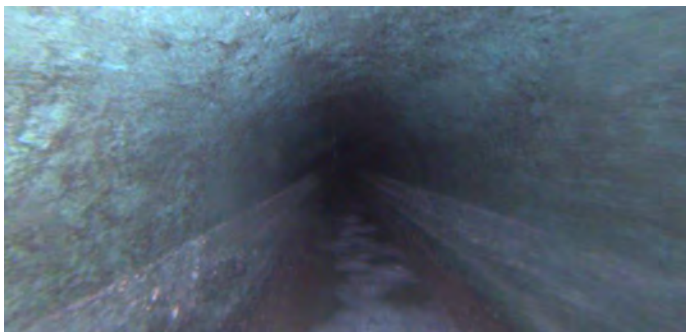
Code: **AMH**
Description: **Manhole**

Distance (ft): **.0**
Structural Grade: **0**
O&M Grade: **0**
Clock Start/From:
Clock To:
1st Value:
2nd Value:
Value Percent:
Continuous Index:
Within 8" of Joint: **NO**
Remarks: **M-103-020**

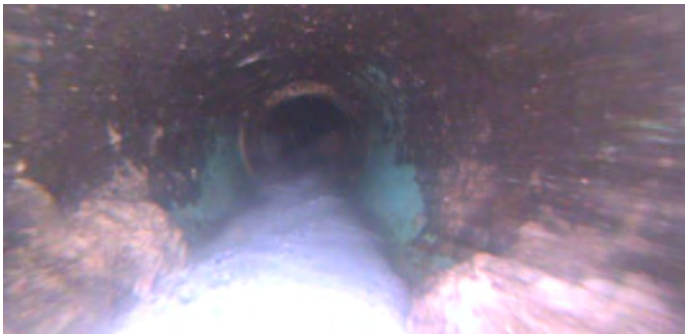
Code:	DAGS
Description:	Deposits Attached Grease

Distance (ft):	12.4
Structural Grade:	0
O&M Grade:	2
Clock Start/From:	8
Clock To:	4
1st Value:	
2nd Value:	
Value Percent:	5.000
Continuous Index:	
Within 8" of Joint:	NO
Remarks:

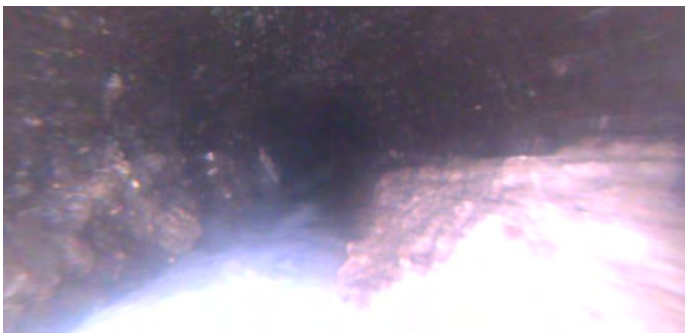
Code: **DAGS**
Description: **Deposits Attached Grease**

Distance (ft): **15.0**
Structural Grade: **0**
O&M Grade: **3**
Clock Start/From: **7**
Clock To: **5**
1st Value:
2nd Value:
Value Percent: **15.000**
Continuous Index: **S01**
Within 8" of Joint: **NO**
Remarks:

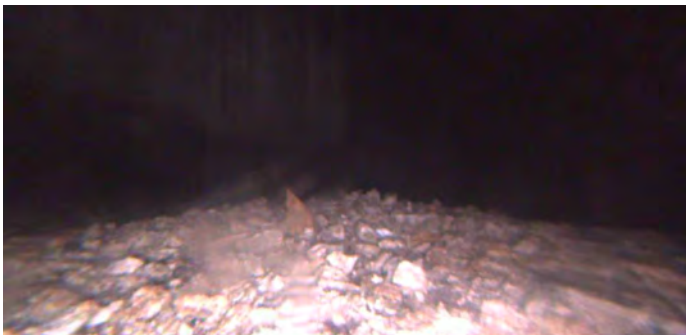
Code: **AMH**
Description: **Manhole**

Distance (ft): **326.6**
Structural Grade: **0**
O&M Grade: **0**
Clock Start/From:
Clock To:
1st Value:
2nd Value:
Value Percent:
Continuous Index:
Within 8" of Joint: **NO**
Remarks: **M-103-019**

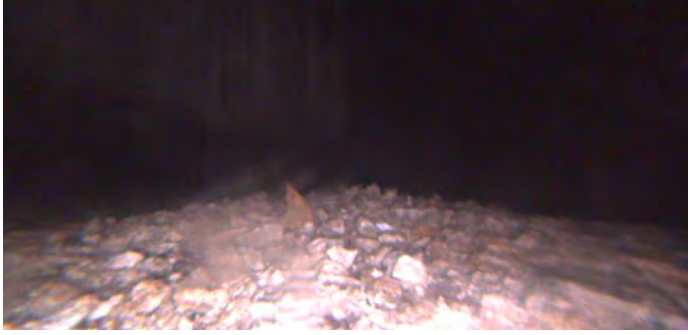
Code:	DAGS
Description:	Deposits Attached Grease
Distance (ft):	326.6
Structural Grade:	0
O&M Grade:	2
Clock Start/From:	4
Clock To:	8
1st Value:	
2nd Value:	
Value Percent:	5.000
Continuous Index:	F02
Within 8" of Joint:	NO
Remarks:
