Profile/Photo Observation Report

Street:	MISSOURI ST	Flow Control:	Not Controlled
City:	Hobart, IN	Year Renewed:	
Location:	Other	Tape/Media #:	
Purpose:	Not Known	Dia/Height:	8"
Use:	Sanitary	Material:	PVC
Drain Area:	NA	Lining:	
Category:	NA		
Comment:

Location Details:		Direction of Survey:	Downstream
US MH:	M-103-020	DS MH:	M-103-019
		Total Length Surveyed (ft):	326.6

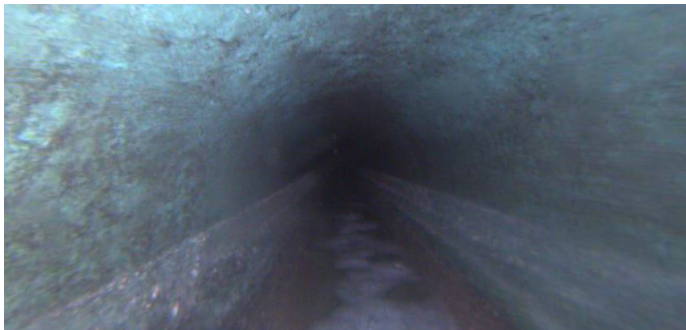
Code: **AMH**
Description: **Manhole**

Distance (ft): **.0**
Structural Grade: **0**
O&M Grade: **0**
Clock Start/From:
Clock To:
1st Value:
2nd Value:
Value Percent:
Continuous Index:
Within 8" of Joint: **NO**
Remarks: **M-103-020**

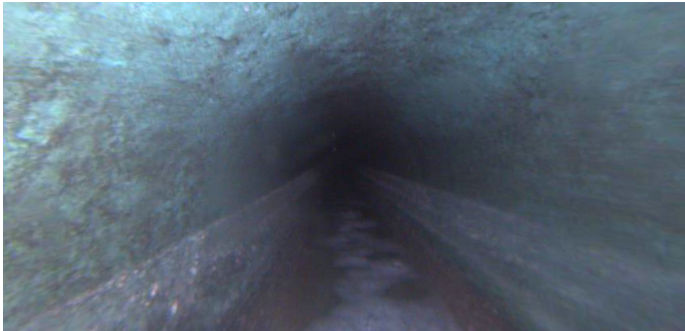
Code:	MWL
Description:	Water Level

Distance (ft):	.0
Structural Grade:	0
O&M Grade:	0
Clock Start/From:	
Clock To:	
1st Value:	
2nd Value:	
Value Percent:	5.000
Continuous Index:	
Within 8" of Joint:	NO
Remarks:

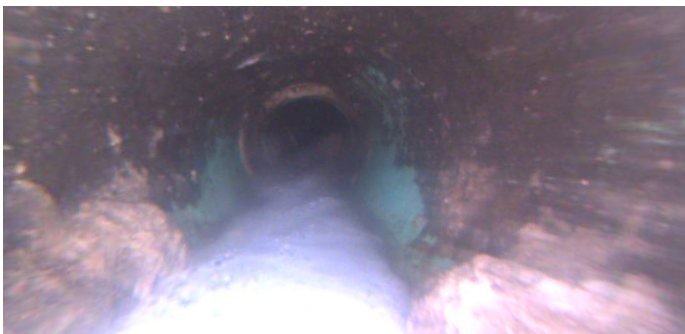
Code:	DAGS
Description:	Deposits Attached Grease

Distance (ft):	12.4
Structural Grade:	0
O&M Grade:	2
Clock Start/From:	8
Clock To:	4
1st Value:	
2nd Value:	
Value Percent:	5.000
Continuous Index:	
Within 8" of Joint:	NO
Remarks:

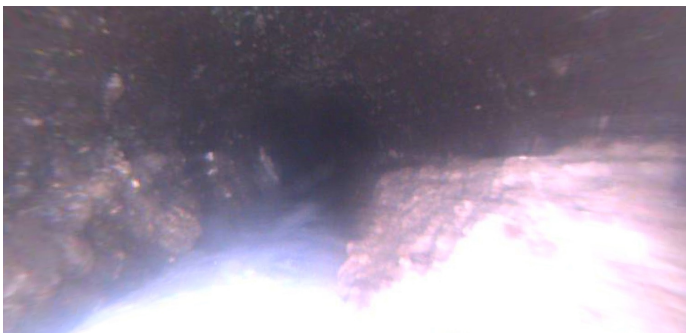
Code: **DAGS**
Description: **Deposits Attached Grease**

Distance (ft): **15.0**
Structural Grade: **0**
O&M Grade: **3**
Clock Start/From: **7**
Clock To: **5**
1st Value:
2nd Value:
Value Percent: **15.000**
Continuous Index: **S01**
Within 8" of Joint: **NO**
Remarks:

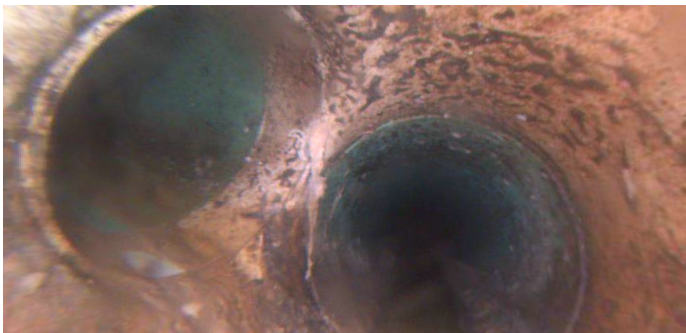
Code: **TF**
Description: **Tap Factory**

Distance (ft): **314.7**
Structural Grade: **0**
O&M Grade: **0**
Clock Start/From: **9**
Clock To:
1st Value: **4.000**
2nd Value:
Value Percent:
Continuous Index:
Within 8" of Joint:
Remarks:

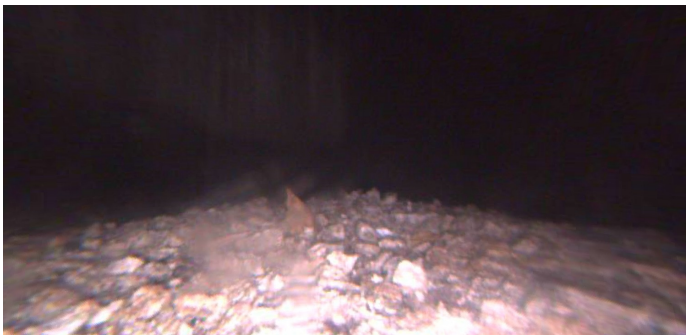
Code: **AMH**
Description: **Manhole**

Distance (ft): **326.6**
Structural Grade: **0**
O&M Grade: **0**
Clock Start/From:
Clock To:
1st Value:
2nd Value:
Value Percent:
Continuous Index:
Within 8" of Joint: **NO**
Remarks: **M-103-019**

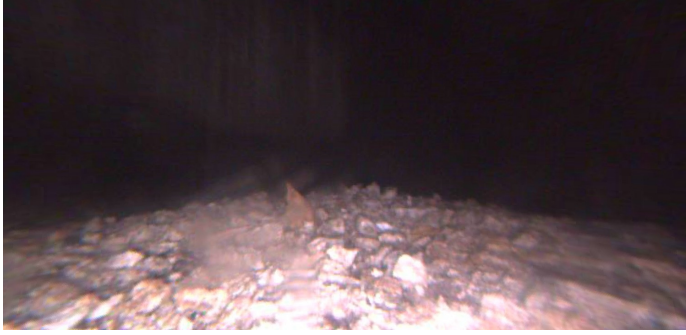
Code:	DAGS
Description:	Deposits Attached Grease
Distance (ft):	326.6
Structural Grade:	0
O&M Grade:	2
Clock Start/From:	4
Clock To:	8
1st Value:	
2nd Value:	
Value Percent:	5.000
Continuous Index:	F02
Within 8" of Joint:	NO
Remarks:
