Profile/Photo Observation Report

Street:	MISSOURI ST	Flow Control:	Not Controlled
City:	Hobart, IN	Year Renewed:	
Location:	Other	Tape/Media #:	
Purpose:	Not Known	Dia/Height:	8"
Use:	Sanitary	Material:	PVC
Drain Area:	NA	Lining:	
Category:	NA		
Comment:

Location Details:		Direction of Survey:	Downstream
US MH:	M-103-021	DS MH:	M-103-020
		Total Length Surveyed (ft):	295.7

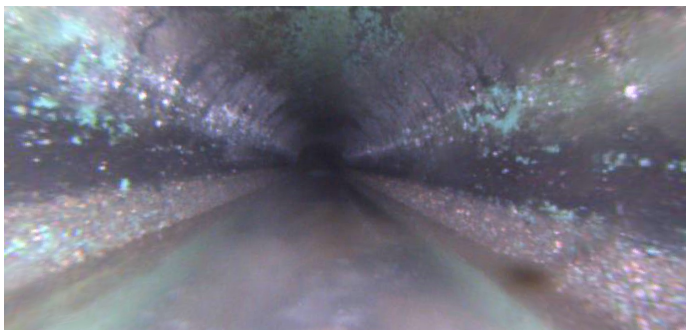
Code: **AMH**
Description: **Manhole**

Distance (ft): **.0**
Structural Grade: **0**
O&M Grade: **0**
Clock Start/From:
Clock To:
1st Value:
2nd Value:
Value Percent:
Continuous Index:
Within 8" of Joint: **NO**
Remarks: **M-103-021**

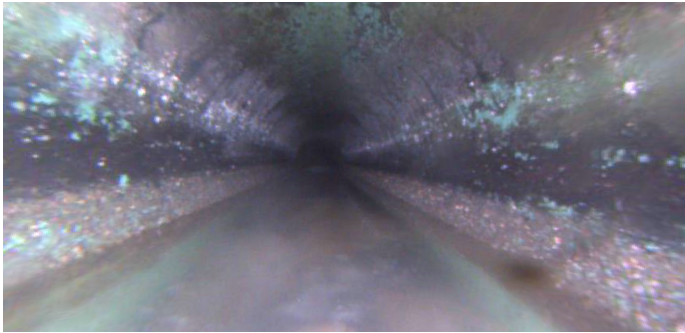
Code:	MWL
Description:	Water Level

Distance (ft):	.0
Structural Grade:	0
O&M Grade:	0
Clock Start/From:	
Clock To:	
1st Value:	
2nd Value:	
Value Percent:	20.000
Continuous Index:	
Within 8" of Joint:	NO
Remarks:

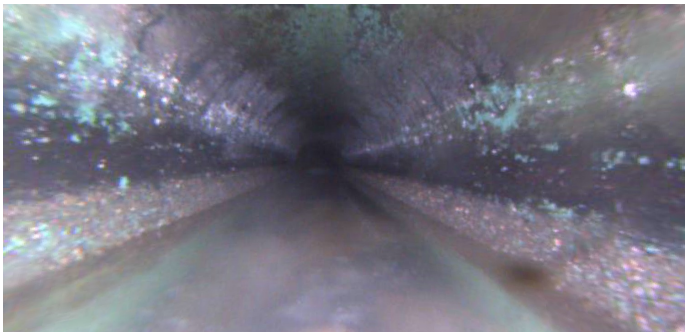
Code:	DAGS
Description:	Deposits Attached Grease

Distance (ft):	.0
Structural Grade:	0
O&M Grade:	2
Clock Start/From:	8
Clock To:	4
1st Value:	
2nd Value:	
Value Percent:	5.000
Continuous Index:	S01
Within 8" of Joint:	NO
Remarks:

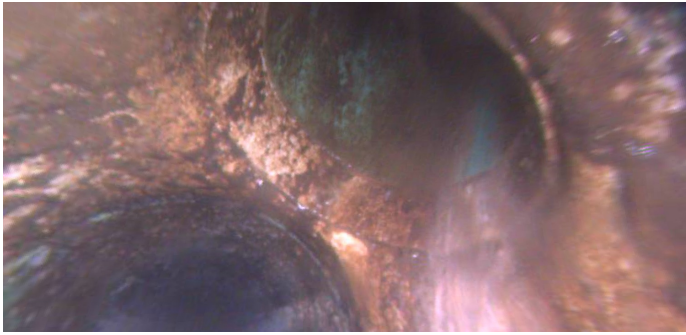
Code: **TFA**
Description: **Tap Factory Active**

Distance (ft): **5.1**
Structural Grade: **0**
O&M Grade: **0**
Clock Start/From: **1**
Clock To:
1st Value: **4.000**
2nd Value:
Value Percent:
Continuous Index:
Within 8" of Joint:
Remarks:

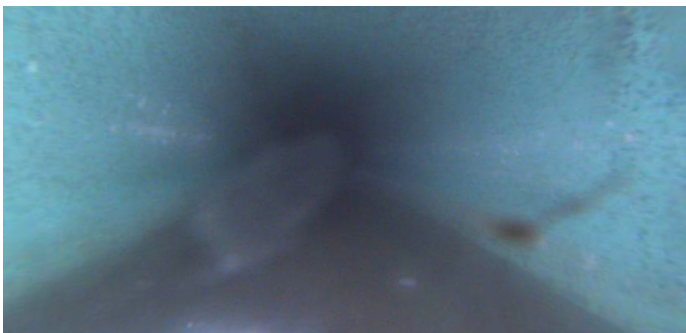
Code: **DAGS**
Description: **Deposits Attached Grease**

Distance (ft): **15.0**
Structural Grade: **0**
O&M Grade: **2**
Clock Start/From: **8**
Clock To: **4**
1st Value:
2nd Value:
Value Percent: **5.000**
Continuous Index: **F01**
Within 8" of Joint: **NO**
Remarks:

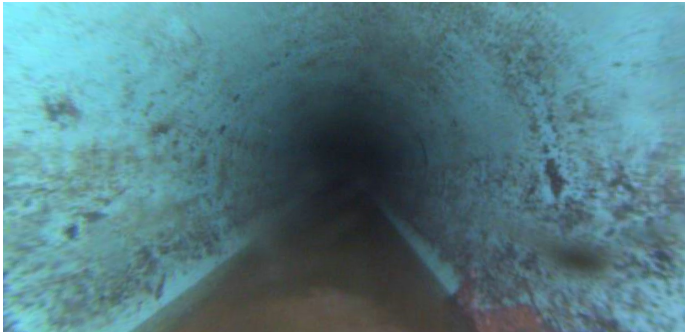
Code: **MWL**
Description: **Water Level**

Distance (ft): **104.2**
Structural Grade: **0**
O&M Grade: **0**
Clock Start/From:
Clock To:
1st Value:
2nd Value:
Value Percent: **5.000**
Continuous Index:
Within 8" of Joint: **NO**
Remarks:

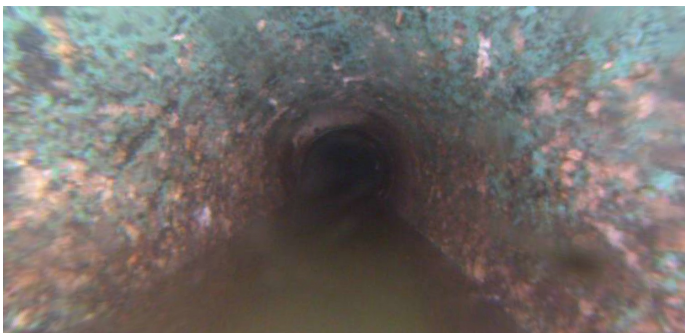
Code: **DAGS**
Description: **Deposits Attached Grease**

Distance (ft): **113.9**
Structural Grade: **0**
O&M Grade: **2**
Clock Start/From: **8**
Clock To: **4**
1st Value:
2nd Value:
Value Percent: **5.000**
Continuous Index: **S02**
Within 8" of Joint: **NO**
Remarks:

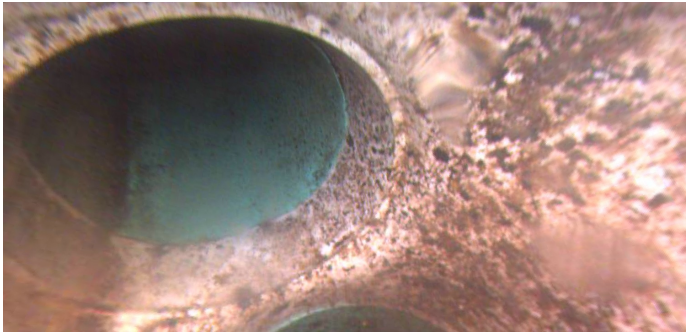
Code: **TF**
Description: **Tap Factory**

Distance (ft): **115.3**
Structural Grade: **0**
O&M Grade: **0**
Clock Start/From: **11**
Clock To:
1st Value: **4.000**
2nd Value:
Value Percent:
Continuous Index:
Within 8" of Joint:
Remarks:

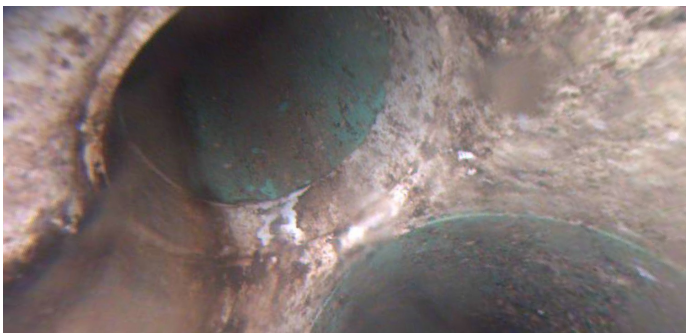
Code: **TF**
Description: **Tap Factory**

Distance (ft): **121.0**
Structural Grade: **0**
O&M Grade: **0**
Clock Start/From: **1**
Clock To:
1st Value: **4.000**
2nd Value:
Value Percent:
Continuous Index:
Within 8" of Joint:
Remarks:

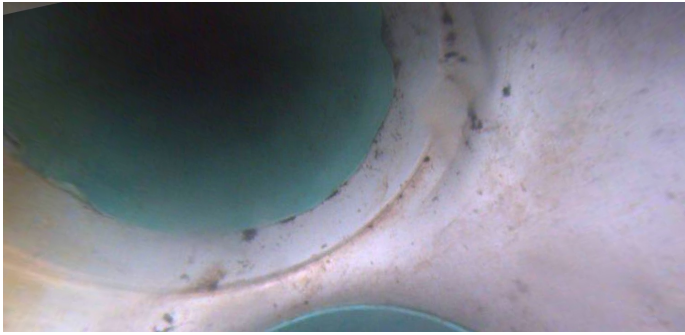
Code: **TF**
Description: **Tap Factory**

Distance (ft): **126.2**
Structural Grade: **0**
O&M Grade: **0**
Clock Start/From: **11**
Clock To:
1st Value: **4.000**
2nd Value:
Value Percent:
Continuous Index:
Within 8" of Joint:
Remarks:

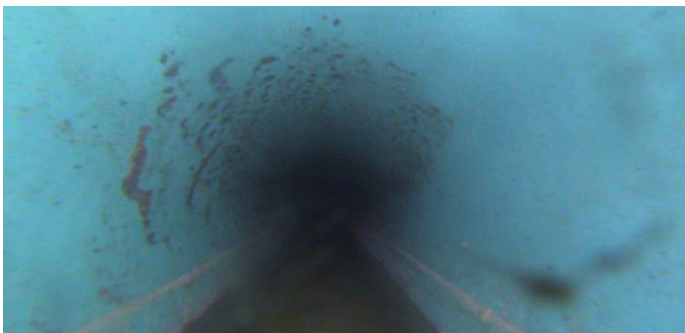
Code: **DAGS**
Description: **Deposits Attached Grease**

Distance (ft): **126.8**
Structural Grade: **0**
O&M Grade: **2**
Clock Start/From: **8**
Clock To: **4**
1st Value:
2nd Value:
Value Percent: **5.000**
Continuous Index: **F02**
Within 8" of Joint: **NO**
Remarks:

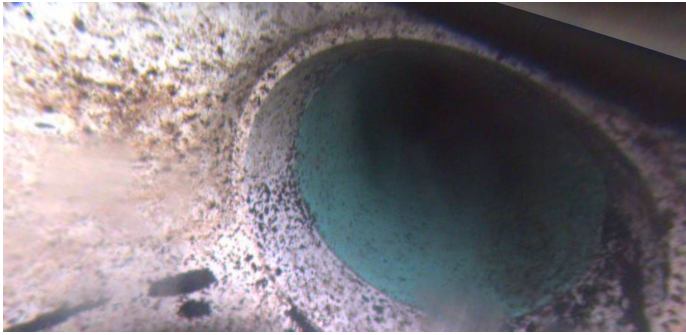
Code: **TF**
Description: **Tap Factory**

Distance (ft): **151.2**
Structural Grade: **0**
O&M Grade: **0**
Clock Start/From: **1**
Clock To:
1st Value: **4.000**
2nd Value:
Value Percent:
Continuous Index:
Within 8" of Joint:
Remarks:

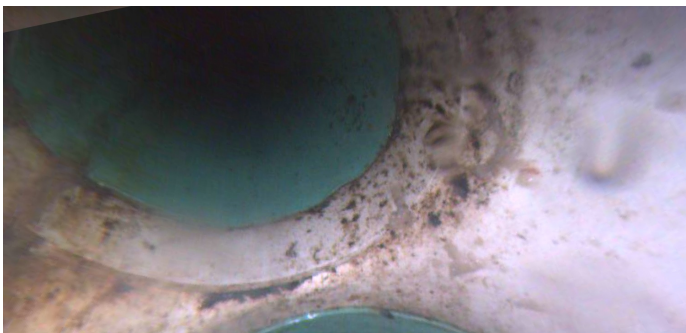
Code: **TF**
Description: **Tap Factory**

Distance (ft): **213.0**
Structural Grade: **0**
O&M Grade: **0**
Clock Start/From: **11**
Clock To:
1st Value: **4.000**
2nd Value:
Value Percent:
Continuous Index:
Within 8" of Joint:
Remarks:

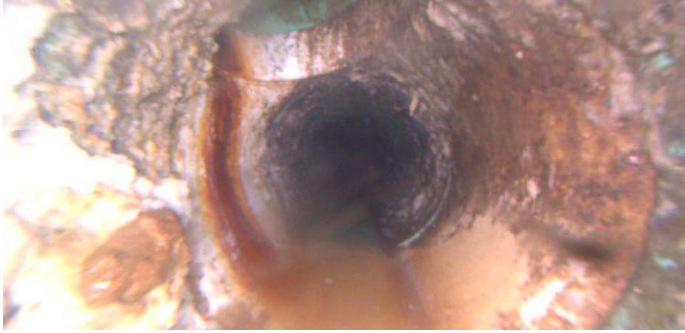
Code: **DAGS**
Description: **Deposits Attached Grease**

Distance (ft): **218.7**
Structural Grade: **0**
O&M Grade: **2**
Clock Start/From: **8**
Clock To: **4**
1st Value:
2nd Value:
Value Percent: **5.000**
Continuous Index: **S03**
Within 8" of Joint: **NO**
Remarks:

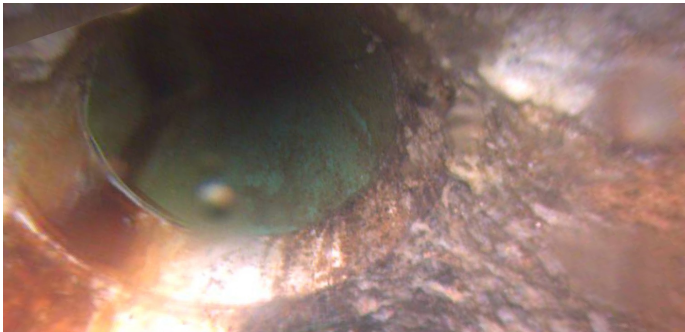
Code: **TF**
Description: **Tap Factory**

Distance (ft): **219.1**
Structural Grade: **0**
O&M Grade: **0**
Clock Start/From: **11**
Clock To:
1st Value: **4.000**
2nd Value:
Value Percent:
Continuous Index:
Within 8" of Joint:
Remarks:

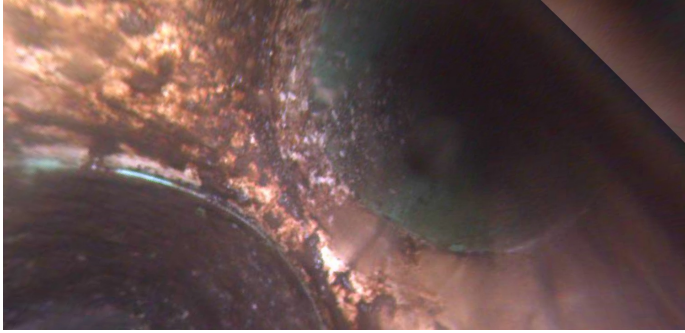
Code: **TF**
Description: **Tap Factory**

Distance (ft): **225.8**
Structural Grade: **0**
O&M Grade: **0**
Clock Start/From: **2**
Clock To:
1st Value: **4.000**
2nd Value:
Value Percent:
Continuous Index:
Within 8" of Joint:
Remarks:

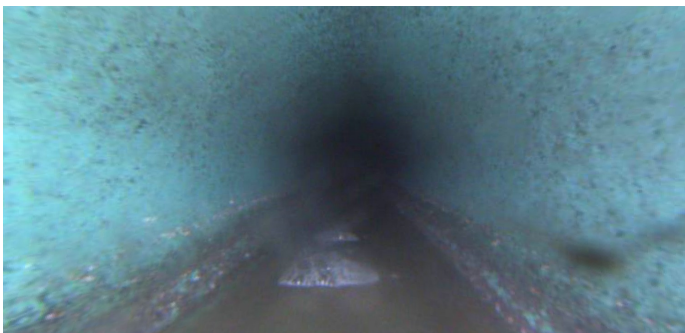
Code: **DAGS**
Description: **Deposits Attached Grease**

Distance (ft): **230.7**
Structural Grade: **0**
O&M Grade: **2**
Clock Start/From: **8**
Clock To: **4**
1st Value:
2nd Value:
Value Percent: **5.000**
Continuous Index: **F03**
Within 8" of Joint: **NO**
Remarks:

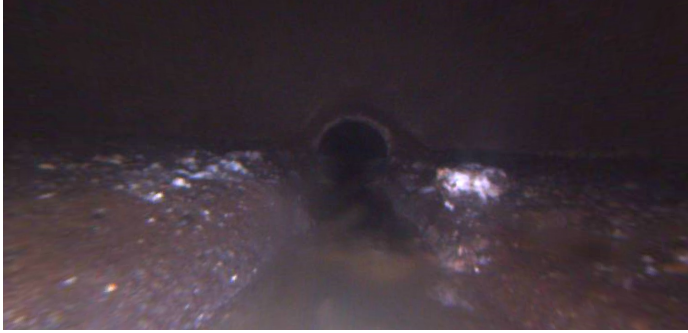
Code:	AMH
Description:	Manhole
Distance (ft):	295.7
Structural Grade:	0
O&M Grade:	0
Clock Start/From:	
Clock To:	
1st Value:	
2nd Value:	
Value Percent:	
Continuous Index:	
Within 8" of Joint:	NO
Remarks:	M-103-020
