Profile/Photo Observation Report

Date:	03/29/2018	Weather:		Coding:	PACP 6.0
Pipe Length (ft):	338.6	Owner:	NA	Pre Clean:	Not Known
P.O.#:		Surveyor:	Mark Ruby	PSR:	P-103-022-023
Customer:		Clean Date:	01/01/1900	Shape:	C

Street:	MISSOURI ST	Flow Control:	Not Controlled
City:	Hobart, IN	Year Renewed:	
Location:	Other	Tape/Media #:	
Purpose:	Not Known	Dia/Height:	8"
Use:	Sanitary	Material:	PVC
Drain Area:	NA	Lining:	
Category:	NA		
Comment:

Location Details:		Direction of Survey:	Downstream
US MH:	M-103-023	DS MH:	M-103-022
		Total Length Surveyed (ft):	334.3

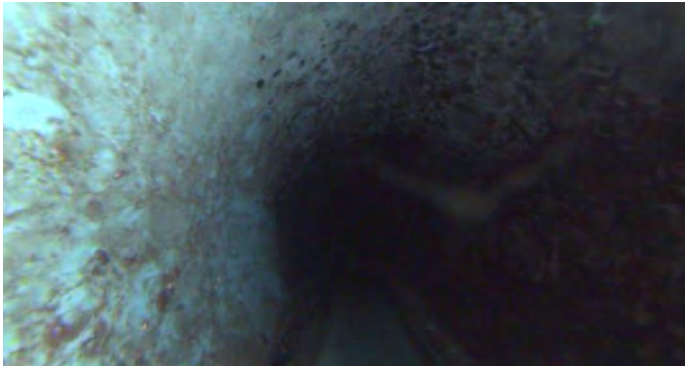
Code:	MWL
Description:	Water Level

Distance (ft):	.0
Structural Grade:	0
O&M Grade:	0
Clock Start/From:	
Clock To:	
1st Value:	
2nd Value:	
Value Percent:	10.000
Continuous Index:	
Within 8" of Joint:	NO
Remarks:

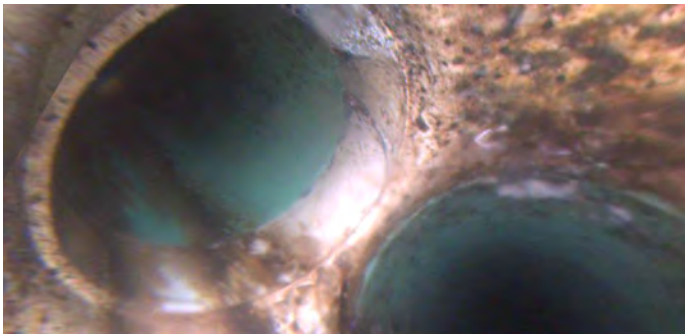
Code:	TF
Description:	Tap Factory

Distance (ft):	79.3
Structural Grade:	0
O&M Grade:	0
Clock Start/From:	10
Clock To:	
1st Value:	4.000
2nd Value:	
Value Percent:	
Continuous Index:	
Within 8" of Joint:	
Remarks:

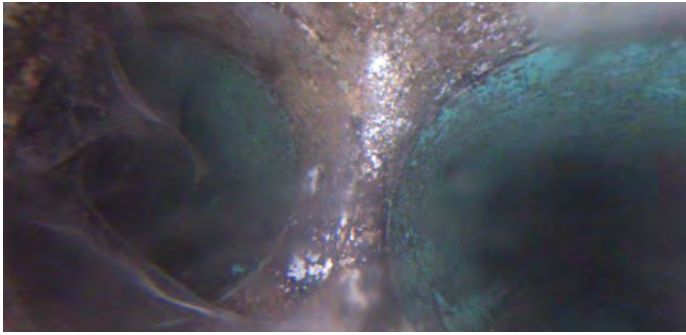
Code: **TF**
Description: **Tap Factory**

Distance (ft): **100.2**
Structural Grade: **0**
O&M Grade: **0**
Clock Start/From: **3**
Clock To:
1st Value: **4.000**
2nd Value:
Value Percent:
Continuous Index:
Within 8" of Joint:
Remarks:

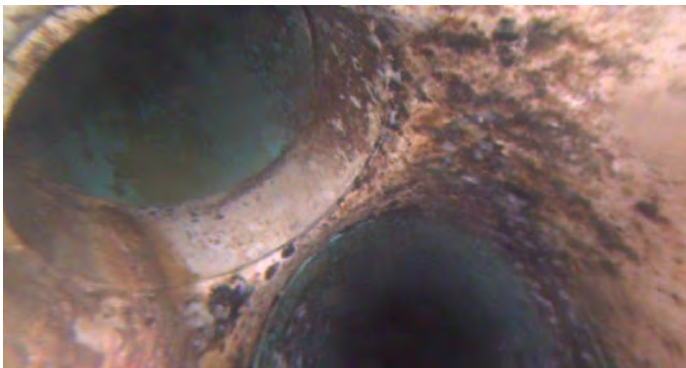
Code: **TF**
Description: **Tap Factory**

Distance (ft): **159.3**
Structural Grade: **0**
O&M Grade: **0**
Clock Start/From: **10**
Clock To:
1st Value: **4.000**
2nd Value:
Value Percent:
Continuous Index:
Within 8" of Joint:
Remarks:

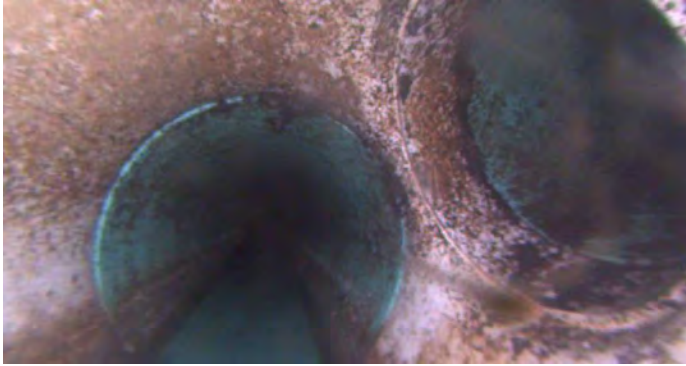
Code: **TF**
Description: **Tap Factory**

Distance (ft): **206.6**
Structural Grade: **0**
O&M Grade: **0**
Clock Start/From: **3**
Clock To:
1st Value: **4.000**
2nd Value:
Value Percent:
Continuous Index:
Within 8" of Joint:
Remarks:

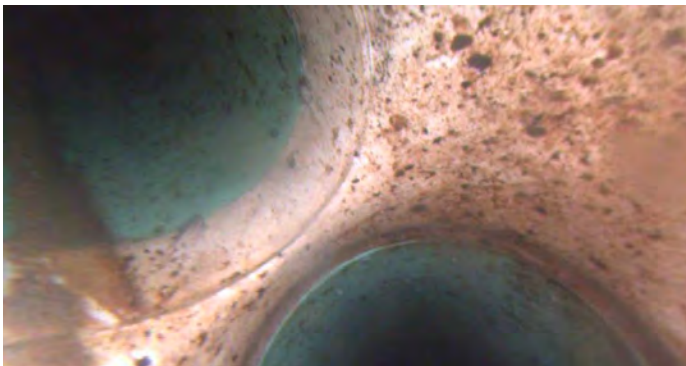
Code: **TF**
Description: **Tap Factory**

Distance (ft): **223.7**
Structural Grade: **0**
O&M Grade: **0**
Clock Start/From: **10**
Clock To:
1st Value: **4.000**
2nd Value:
Value Percent:
Continuous Index:
Within 8" of Joint:
Remarks:

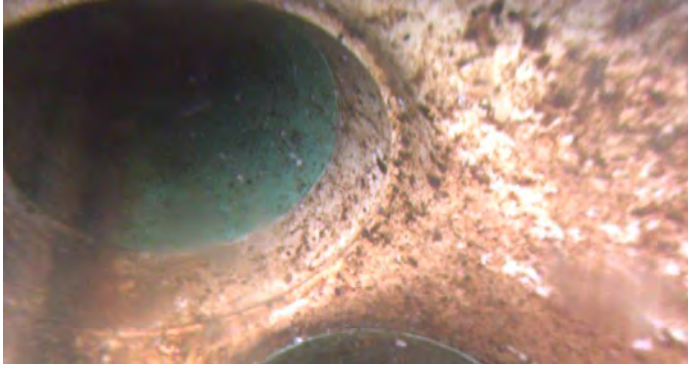
Code: **TF**
Description: **Tap Factory**

Distance (ft): **250.1**
Structural Grade: **0**
O&M Grade: **0**
Clock Start/From: **10**
Clock To:
1st Value: **4.000**
2nd Value:
Value Percent:
Continuous Index:
Within 8" of Joint:
Remarks:

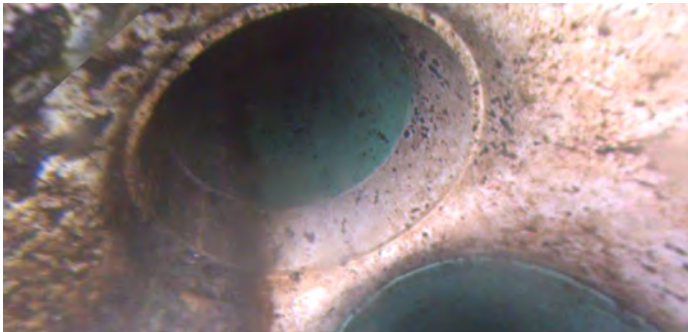
Code: **TF**
Description: **Tap Factory**

Distance (ft): **292.8**
Structural Grade: **0**
O&M Grade: **0**
Clock Start/From: **11**
Clock To:
1st Value: **4.000**
2nd Value:
Value Percent:
Continuous Index:
Within 8" of Joint:
Remarks:

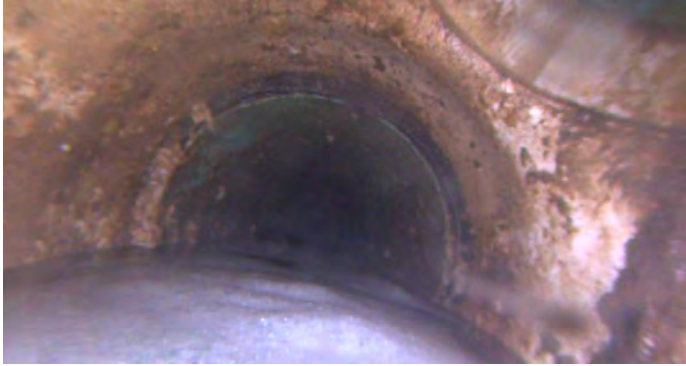
Code: **TF**
Description: **Tap Factory**

Distance (ft): **324.1**
Structural Grade: **0**
O&M Grade: **0**
Clock Start/From: **2**
Clock To:
1st Value: **4.000**
2nd Value:
Value Percent:
Continuous Index:
Within 8" of Joint:
Remarks:

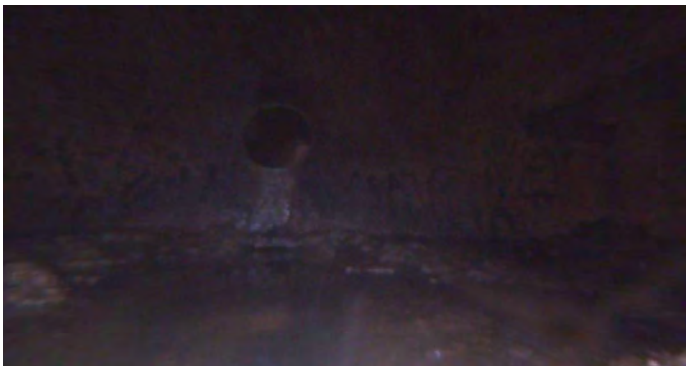
Code: **AMH**
Description: **Manhole**

Distance (ft): **334.3**
Structural Grade: **0**
O&M Grade: **0**
Clock Start/From:
Clock To:
1st Value:
2nd Value:
Value Percent:
Continuous Index:
Within 8" of Joint: **NO**
Remarks: **M-103-022**
