Profile/Photo Observation Report

Date:	03/29/2018	Weather:		Coding:	PACP 6.0
Pipe Length (ft):	338.6	Owner:	NA	Pre Clean:	Not Known
P.O.#:		Surveyor:	Mark Ruby	PSR:	P-103-022-023
Customer:		Clean Date:	01/01/1900	Shape:	C

Street:	MISSOURI ST	Flow Control:	Not Controlled
City:	Hobart, IN	Year Renewed:	
Location:	Other	Tape/Media #:	
Purpose:	Not Known	Dia/Height:	8"
Use:	Sanitary	Material:	PVC
Drain Area:	NA	Lining:	
Category:	NA		
Comment:

Location Details:		Direction of Survey:	Downstream
US MH:	M-103-023	DS MH:	M-103-022
		Total Length Surveyed (ft):	334.3

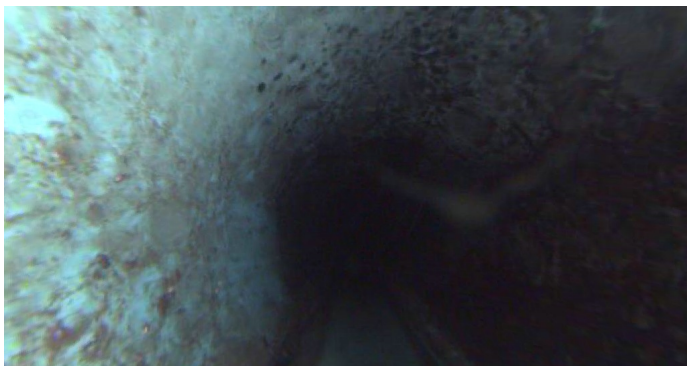
Code: **AMH**
Description: **Manhole**

Distance (ft): **.0**
Structural Grade: **0**
O&M Grade: **0**
Clock Start/From:
Clock To:
1st Value:
2nd Value:
Value Percent:
Continuous Index:
Within 8" of Joint: **NO**
Remarks: **M-103-023**

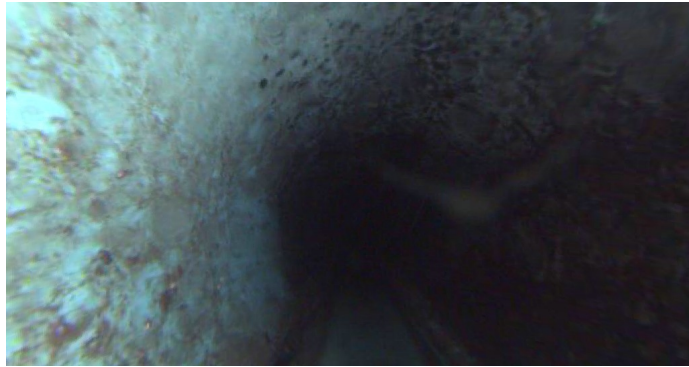
Code: **MWL**
Description: **Water Level**

Distance (ft): **.0**
Structural Grade: **0**
O&M Grade: **0**
Clock Start/From:
Clock To:
1st Value:
2nd Value:
Value Percent: **10.000**
Continuous Index:
Within 8" of Joint: **NO**
Remarks:

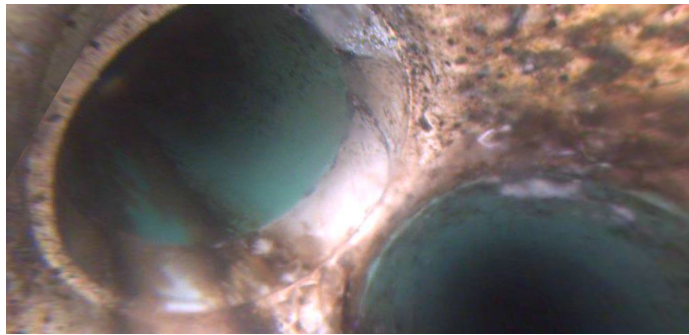
Code: **TF**
Description: **Tap Factory**

Distance (ft): **79.3**
Structural Grade: **0**
O&M Grade: **0**
Clock Start/From: **10**
Clock To:
1st Value: **4.000**
2nd Value:
Value Percent:
Continuous Index:
Within 8" of Joint:
Remarks:

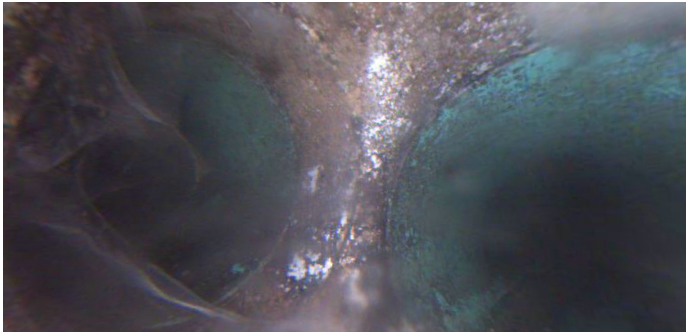
Code: **TF**
Description: **Tap Factory**

Distance (ft): **100.2**
Structural Grade: **0**
O&M Grade: **0**
Clock Start/From: **3**
Clock To:
1st Value: **4.000**
2nd Value:
Value Percent:
Continuous Index:
Within 8" of Joint:
Remarks:

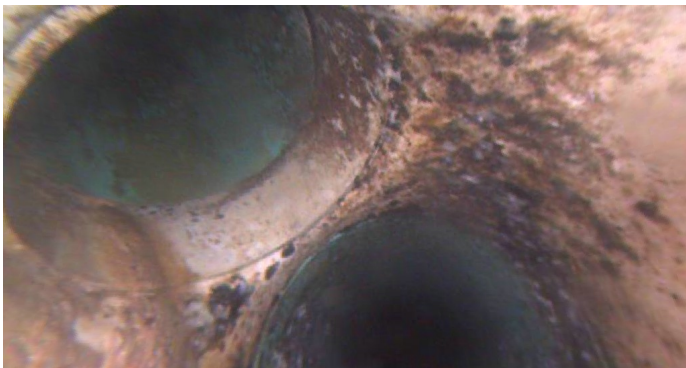
Code: **TF**
Description: **Tap Factory**

Distance (ft): **159.3**
Structural Grade: **0**
O&M Grade: **0**
Clock Start/From: **10**
Clock To:
1st Value: **4.000**
2nd Value:
Value Percent:
Continuous Index:
Within 8" of Joint:
Remarks:

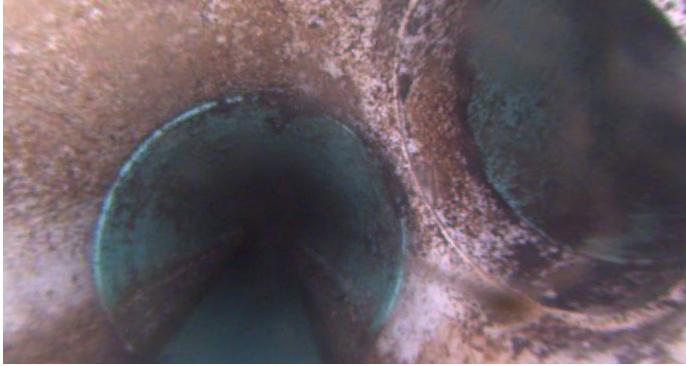
Code: **TF**
Description: **Tap Factory**

Distance (ft): **206.6**
Structural Grade: **0**
O&M Grade: **0**
Clock Start/From: **3**
Clock To:
1st Value: **4.000**
2nd Value:
Value Percent:
Continuous Index:
Within 8" of Joint:
Remarks:

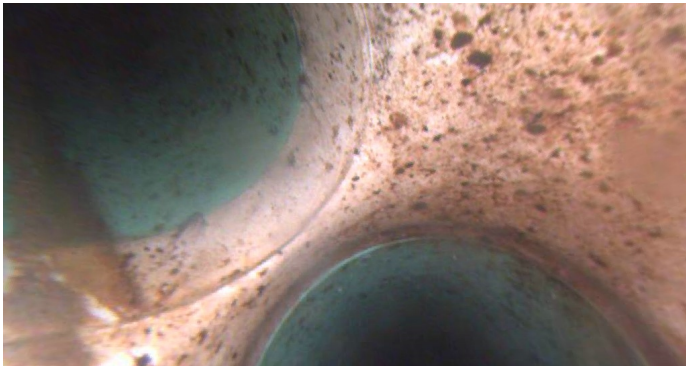
Code: **TF**
Description: **Tap Factory**

Distance (ft): **223.7**
Structural Grade: **0**
O&M Grade: **0**
Clock Start/From: **10**
Clock To:
1st Value: **4.000**
2nd Value:
Value Percent:
Continuous Index:
Within 8" of Joint:
Remarks:

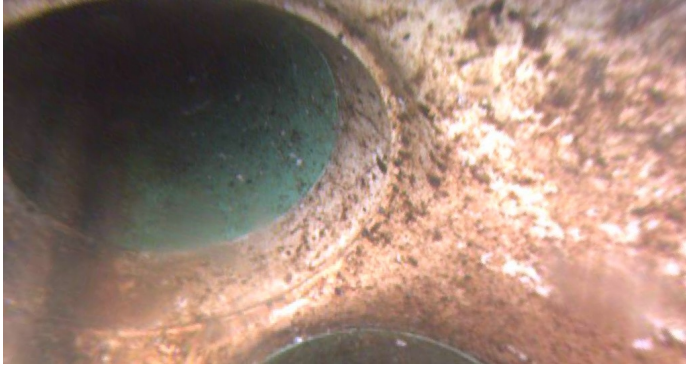
Code: **TF**
Description: **Tap Factory**

Distance (ft): **250.1**
Structural Grade: **0**
O&M Grade: **0**
Clock Start/From: **10**
Clock To:
1st Value: **4.000**
2nd Value:
Value Percent:
Continuous Index:
Within 8" of Joint:
Remarks:

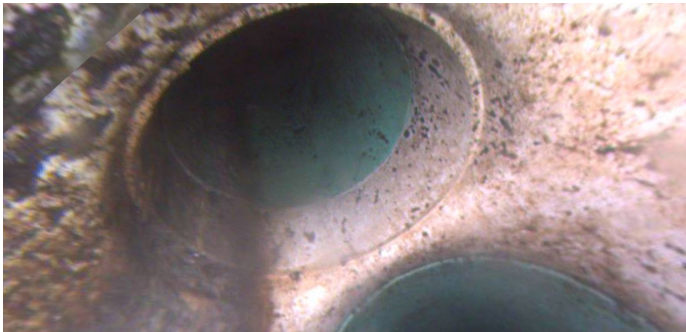
Code: **TF**
Description: **Tap Factory**

Distance (ft): **292.8**
Structural Grade: **0**
O&M Grade: **0**
Clock Start/From: **11**
Clock To:
1st Value: **4.000**
2nd Value:
Value Percent:
Continuous Index:
Within 8" of Joint:
Remarks:

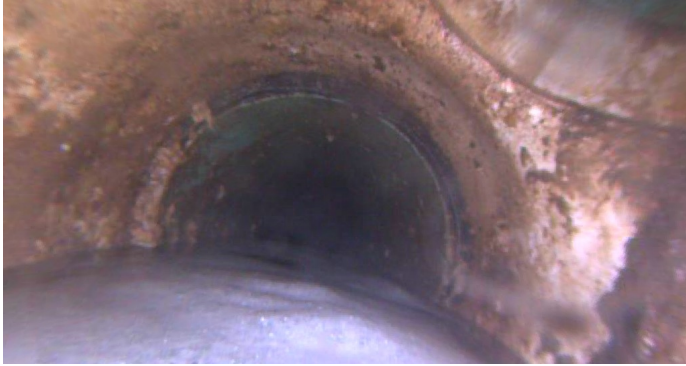
Code: **TF**
Description: **Tap Factory**

Distance (ft): **324.1**
Structural Grade: **0**
O&M Grade: **0**
Clock Start/From: **2**
Clock To:
1st Value: **4.000**
2nd Value:
Value Percent:
Continuous Index:
Within 8" of Joint:
Remarks:

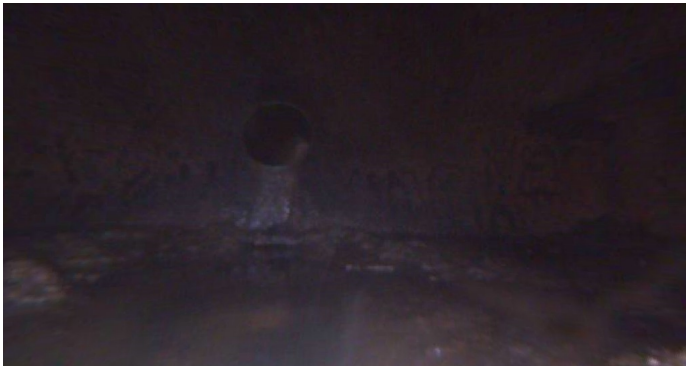
Code: **AMH**
Description: **Manhole**

Distance (ft): **334.3**
Structural Grade: **0**
O&M Grade: **0**
Clock Start/From:
Clock To:
1st Value:
2nd Value:
Value Percent:
Continuous Index:
Within 8" of Joint: **NO**
Remarks: **M-103-022**
