## Profile/Photo Observation Report

Street:	<b>MISSOURI ST</b>	Flow Control:	<b>Not Controlled</b>
City:	<b>Hobart, IN</b>	Year Renewed:	
Location:	<b>Other</b>	Tape/Media #:	
Purpose:	<b>Not Known</b>	Dia/Height:	<b>8"</b>
Use:	<b>Sanitary</b>	Material:	<b>PVC</b>
Drain Area:	<b>NA</b>	Lining:	
Category:	<b>NA</b>		
Comment:

Location Details:		Direction of Survey:	<b>Downstream</b>
US MH:	<b>M-103-023</b>	DS MH:	<b>M-103-024</b>
		Total Length Surveyed (ft):	<b>124.9</b>

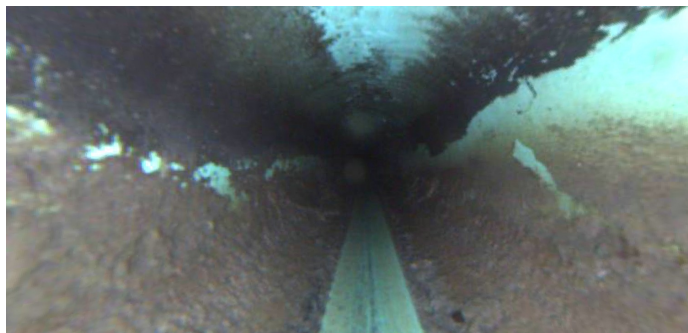
Code: **AMH**  
 Description: **Manhole**

Distance (ft): **.0**  
 Structural Grade: **0**  
 O&M Grade: **0**  
 Clock Start/From:  
 Clock To:  
 1st Value:  
 2nd Value:  
 Value Percent:  
 Continuous Index:  
 Within 8" of Joint: **NO**  
 Remarks: **M-103-023**

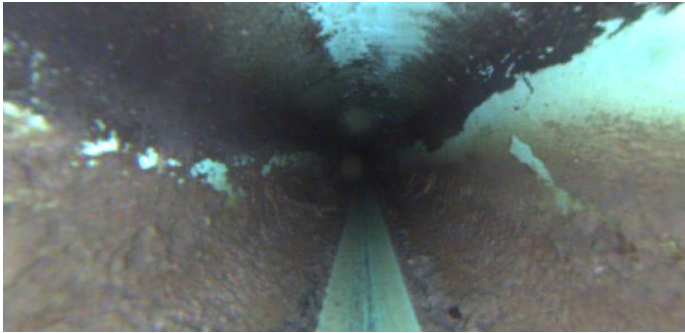
Code:	<b>MWL</b>
Description:	<b>Water Level</b>

Distance (ft):	<b>.0</b>
Structural Grade:	<b>0</b>
O&M Grade:	<b>0</b>
Clock Start/From:	
Clock To:	
1st Value:	
2nd Value:	
Value Percent:	<b>5.000</b>
Continuous Index:	
Within 8" of Joint:	<b>NO</b>
Remarks:

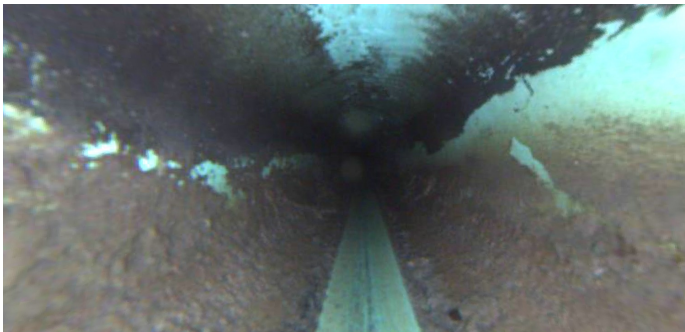
Code:	<b>DAGS</b>
Description:	<b>Deposits Attached Grease</b>

Distance (ft):	<b>.0</b>
Structural Grade:	<b>0</b>
O&M Grade:	<b>2</b>
Clock Start/From:	<b>7</b>
Clock To:	<b>5</b>
1st Value:	
2nd Value:	
Value Percent:	<b>5.000</b>
Continuous Index:	<b>S01</b>
Within 8" of Joint:	<b>NO</b>
Remarks:

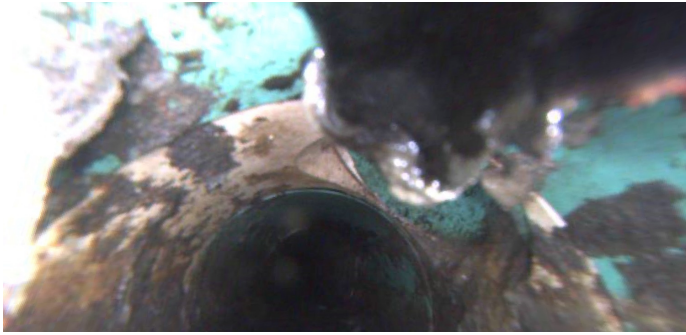
Code: **TF**  
Description: **Tap Factory**

Distance (ft): **122.9**  
Structural Grade: **0**  
O&M Grade: **0**  
Clock Start/From: **2**  
Clock To:  
1st Value: **4.000**  
2nd Value:  
Value Percent:  
Continuous Index:  
Within 8" of Joint:  
Remarks:

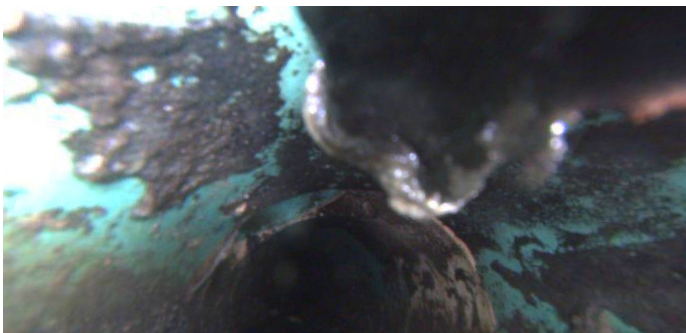
Code: **MSA**  
Description: **Abandoned Survey**

Distance (ft): **124.9**  
Structural Grade: **0**  
O&M Grade: **0**  
Clock Start/From:  
Clock To:  
1st Value:  
2nd Value:  
Value Percent:  
Continuous Index:  
Within 8" of Joint: **NO**  
Remarks: **DAGS**

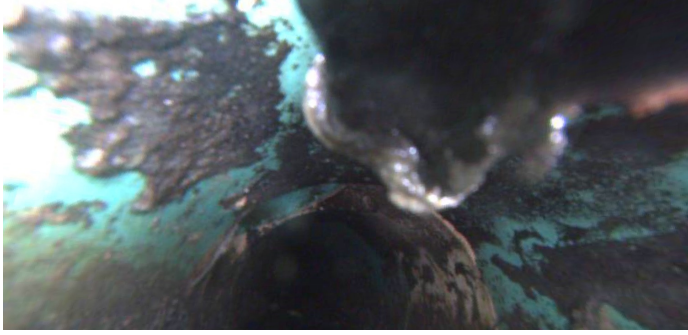
Code:	<b>DAGS</b>
Description:	<b>Deposits Attached Grease</b>
Distance (ft):	<b>124.9</b>
Structural Grade:	<b>0</b>
O&M Grade:	<b>2</b>
Clock Start/From:	<b>7</b>
Clock To:	<b>5</b>
1st Value:	
2nd Value:	
Value Percent:	<b>5.000</b>
Continuous Index:	<b>F01</b>
Within 8" of Joint:	<b>NO</b>
Remarks:
