Profile/Photo Observation Report

Date:	09/29/2018	Weather:		Coding:	PACP 6.0
Pipe Length (ft):	199.5	Owner:	NA	Pre Clean:	Not Known
P.O.#:		Surveyor:	Selasie Honu	PSR:	P-103-023-024
Customer:		Clean Date:	01/01/1900	Shape:	C

Street:	W 39TH AVE	Flow Control:	Not Controlled
City:	Hobart, IN	Year Renewed:	
Location:	Light Highway	Tape/Media #:	
Purpose:	Routine Assessment	Dia/Height:	8"
Use:	Sanitary	Material:	PVC
Drain Area:	NA	Lining:	
Category:	NA		
Comment:

Location Details:		Direction of Survey:	Downstream
US MH:	M-103-023	DS MH:	M-103-024
		Total Length Surveyed (ft):	194.4

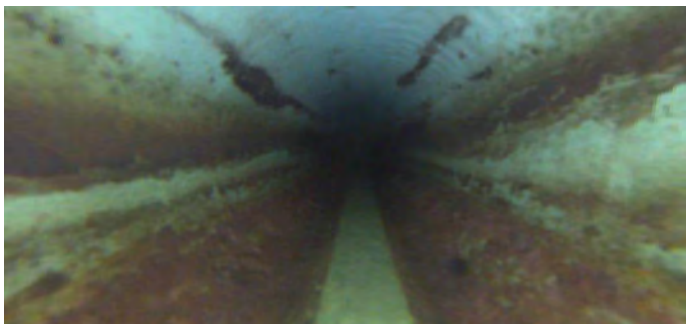
Code: **AMH**
Description: **Manhole**

Distance (ft): **.0**
Structural Grade: **0**
O&M Grade: **0**
Clock Start/From:
Clock To:
1st Value:
2nd Value:
Value Percent:
Continuous Index:
Within 8" of Joint: **NO**
Remarks: **M-103-023**

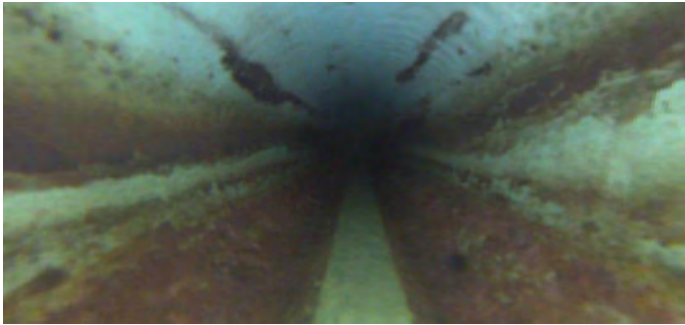
Code:	MWL
Description:	Water Level

Distance (ft):	.0
Structural Grade:	0
O&M Grade:	0
Clock Start/From:	
Clock To:	
1st Value:	
2nd Value:	
Value Percent:	5.000
Continuous Index:	
Within 8" of Joint:	NO
Remarks:

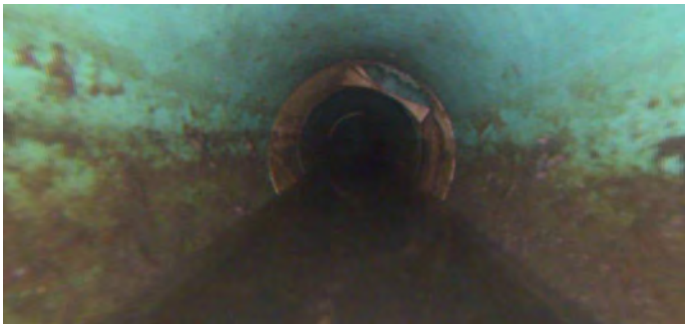
Code:	TF
Description:	Tap Factory

Distance (ft):	123.6
Structural Grade:	0
O&M Grade:	0
Clock Start/From:	1
Clock To:	
1st Value:	4.000
2nd Value:	
Value Percent:	
Continuous Index:	
Within 8" of Joint:	
Remarks:

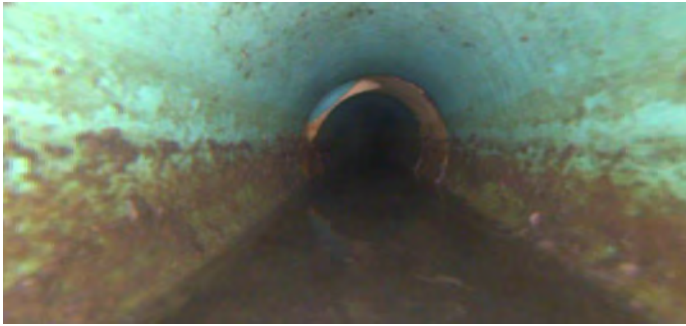
Code: **TF**
Description: **Tap Factory**

Distance (ft): **125.2**
Structural Grade: **0**
O&M Grade: **0**
Clock Start/From: **10**
Clock To:
1st Value: **4.000**
2nd Value:
Value Percent:
Continuous Index:
Within 8" of Joint:
Remarks:

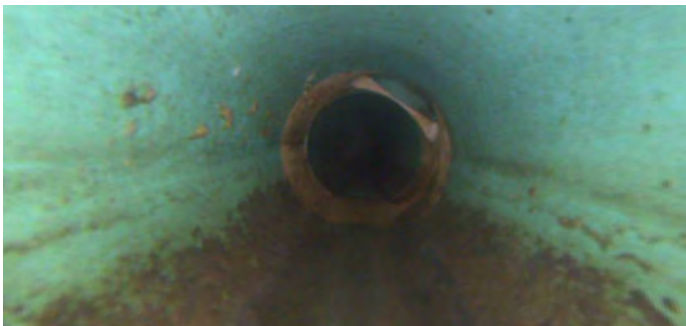
Code: **TF**
Description: **Tap Factory**

Distance (ft): **166.9**
Structural Grade: **0**
O&M Grade: **0**
Clock Start/From: **1**
Clock To:
1st Value: **4.000**
2nd Value:
Value Percent:
Continuous Index:
Within 8" of Joint:
Remarks:

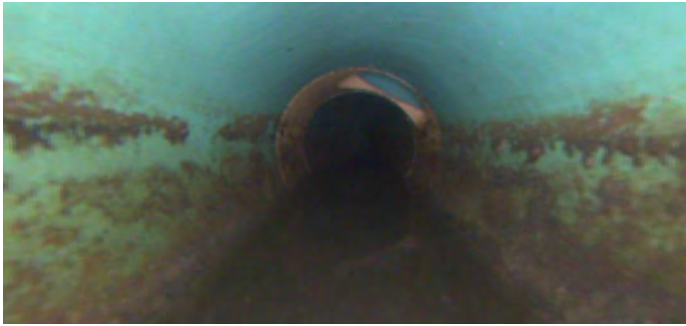
Code: **TF**
Description: **Tap Factory**

Distance (ft): **175.4**
Structural Grade: **0**
O&M Grade: **0**
Clock Start/From: **1**
Clock To:
1st Value: **4.000**
2nd Value:
Value Percent:
Continuous Index:
Within 8" of Joint:
Remarks:

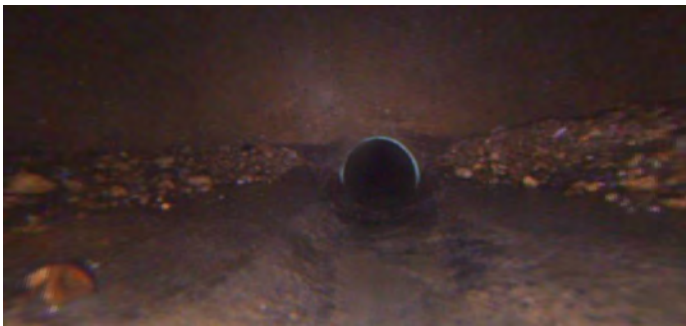
Code: **AMH**
Description: **Manhole**

Distance (ft): **194.4**
Structural Grade: **0**
O&M Grade: **0**
Clock Start/From:
Clock To:
1st Value:
2nd Value:
Value Percent:
Continuous Index:
Within 8" of Joint: **NO**
Remarks: **M-103-024**
