## Profile/Photo Observation Report

Street:	<b>39th. Ave.</b>	Flow Control:	<b>Not Controlled</b>
City:	<b>Hobart, IN</b>	Year Renewed:	
Location:	<b>Light Highway</b>	Tape/Media #:	
Purpose:	<b>Routine Assessment</b>	Dia/Height:	<b>8"</b>
Use:	<b>Sanitary</b>	Material:	<b>PVC</b>
Drain Area:	<b>NA</b>	Lining:	
Category:	<b>NA</b>		
Comment:

Location Details:		Direction of Survey:	<b>Downstream</b>
US MH:	<b>M-103-023</b>	DS MH:	<b>M-103-024</b>
		Total Length Surveyed (ft):	<b>194.4</b>

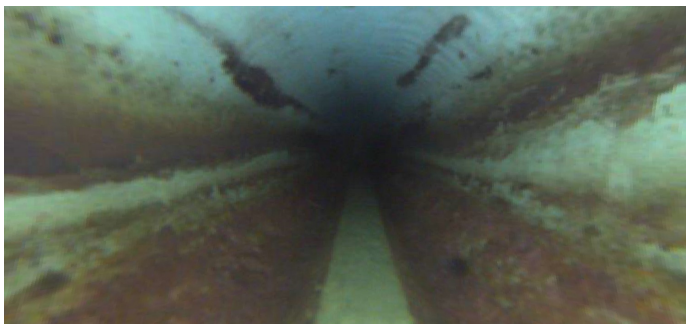
Code: **AMH**  
Description: **Manhole**

Distance (ft): **.0**  
Structural Grade: **0**  
O&M Grade: **0**  
Clock Start/From:  
Clock To:  
1st Value:  
2nd Value:  
Value Percent:  
Continuous Index:  
Within 8" of Joint: **NO**  
Remarks: **M-103-023**

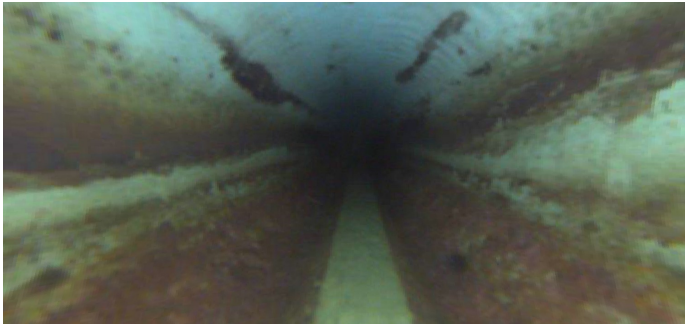
Code:	<b>MWL</b>
Description:	<b>Water Level</b>

Distance (ft):	<b>.0</b>
Structural Grade:	<b>0</b>
O&M Grade:	<b>0</b>
Clock Start/From:	
Clock To:	
1st Value:	
2nd Value:	
Value Percent:	<b>5.000</b>
Continuous Index:	
Within 8" of Joint:	<b>NO</b>
Remarks:

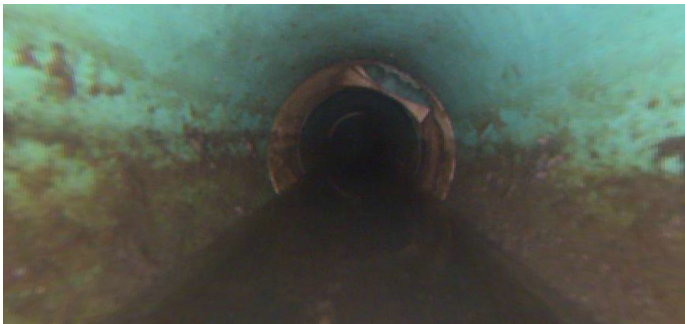
Code:	<b>TF</b>
Description:	<b>Tap Factory</b>

Distance (ft):	<b>123.6</b>
Structural Grade:	<b>0</b>
O&M Grade:	<b>0</b>
Clock Start/From:	<b>1</b>
Clock To:	
1st Value:	<b>4.000</b>
2nd Value:	
Value Percent:	
Continuous Index:	
Within 8" of Joint:	
Remarks:

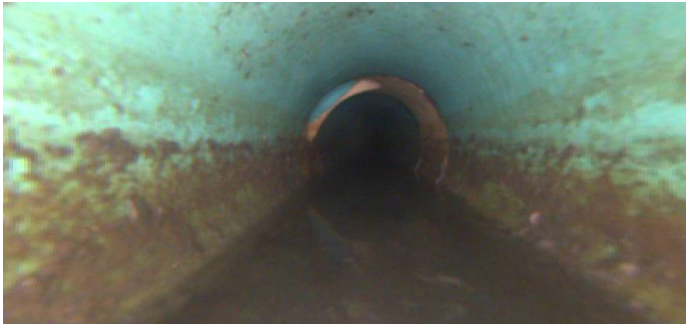
Code: **TF**  
Description: **Tap Factory**

Distance (ft): **125.2**  
Structural Grade: **0**  
O&M Grade: **0**  
Clock Start/From: **10**  
Clock To:  
1st Value: **4.000**  
2nd Value:  
Value Percent:  
Continuous Index:  
Within 8" of Joint:  
Remarks:

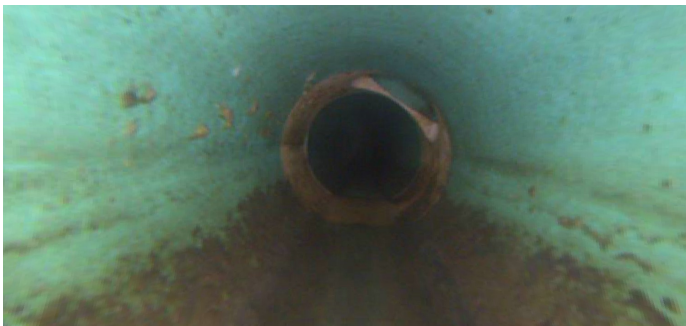
Code: **TF**  
Description: **Tap Factory**

Distance (ft): **166.9**  
Structural Grade: **0**  
O&M Grade: **0**  
Clock Start/From: **1**  
Clock To:  
1st Value: **4.000**  
2nd Value:  
Value Percent:  
Continuous Index:  
Within 8" of Joint:  
Remarks:

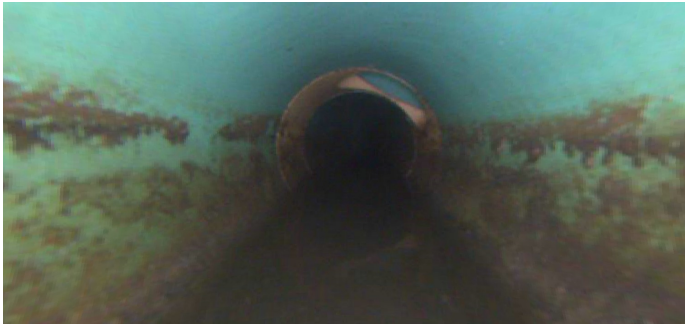
Code: **TF**  
Description: **Tap Factory**

Distance (ft): **175.4**  
Structural Grade: **0**  
O&M Grade: **0**  
Clock Start/From: **1**  
Clock To:  
1st Value: **4.000**  
2nd Value:  
Value Percent:  
Continuous Index:  
Within 8" of Joint:  
Remarks:

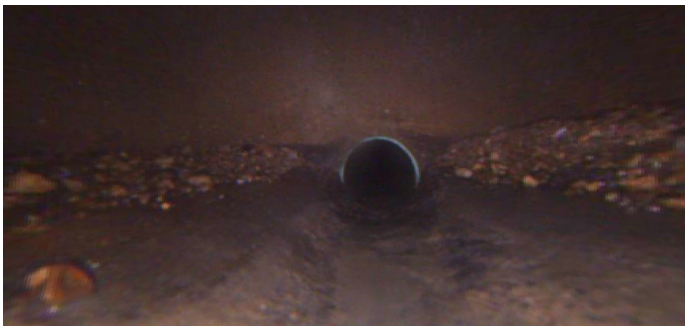
Code: **AMH**  
Description: **Manhole**

Distance (ft): **194.4**  
Structural Grade: **0**  
O&M Grade: **0**  
Clock Start/From:  
Clock To:  
1st Value:  
2nd Value:  
Value Percent:  
Continuous Index:  
Within 8" of Joint: **NO**  
Remarks: **M-103-024**
