Profile/Photo Observation Report

Street:	W 39TH AVE	Flow Control:	Not Controlled
City:	Hobart, IN	Year Renewed:	
Location:	Other	Tape/Media #:	
Purpose:	Not Known	Dia/Height:	10"
Use:	Sanitary	Material:	PVC
Drain Area:	NA	Lining:	
Category:	NA		
Comment:

Location Details:		Direction of Survey:	Upstream
US MH:	M-103-024	DS MH:	M-103-025
		Total Length Surveyed (ft):	298.2

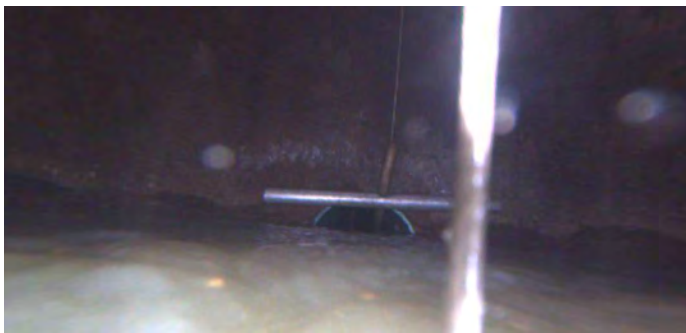
Code: **AMH**
Description: **Manhole**

Distance (ft): **.0**
Structural Grade: **0**
O&M Grade: **0**
Clock Start/From:
Clock To:
1st Value:
2nd Value:
Value Percent:
Continuous Index:
Within 8" of Joint: **NO**
Remarks: **M-103-025**

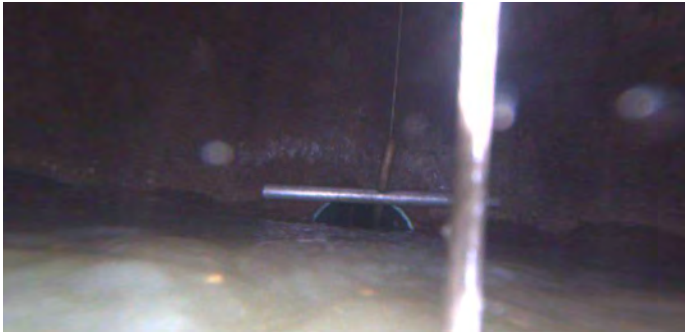
Code:	MWL
Description:	Water Level

Distance (ft):	.0
Structural Grade:	0
O&M Grade:	0
Clock Start/From:	
Clock To:	
1st Value:	
2nd Value:	
Value Percent:	30.000
Continuous Index:	
Within 8" of Joint:	NO
Remarks:

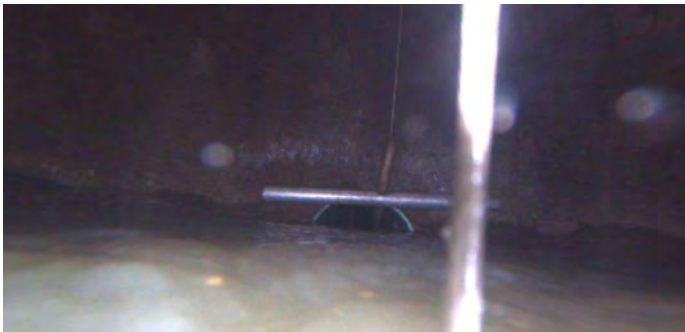
Code:	MGO
Description:	General Observation

Distance (ft):	.0
Structural Grade:	0
O&M Grade:	0
Clock Start/From:	
Clock To:	
1st Value:	
2nd Value:	
Value Percent:	
Continuous Index:	
Within 8" of Joint:	NO
Remarks:	REAR CAMERA

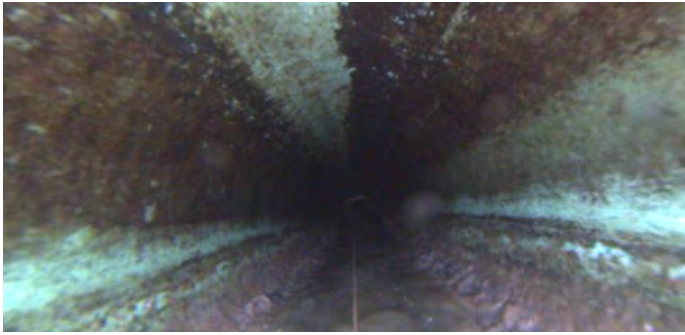
Code: **DAGS**
Description: **Deposits Attached Grease**

Distance (ft): **6.8**
Structural Grade: **0**
O&M Grade: **2**
Clock Start/From: **7**
Clock To: **5**
1st Value:
2nd Value:
Value Percent: **5.000**
Continuous Index: **S01**
Within 8" of Joint: **NO**
Remarks:

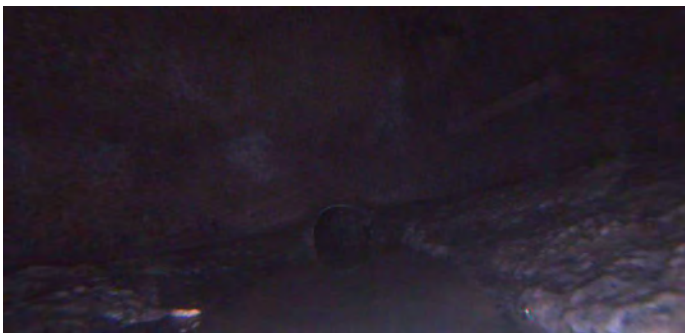
Code: **AMH**
Description: **Manhole**

Distance (ft): **298.2**
Structural Grade: **0**
O&M Grade: **0**
Clock Start/From:
Clock To:
1st Value:
2nd Value:
Value Percent:
Continuous Index:
Within 8" of Joint: **NO**
Remarks: **M-103-024**

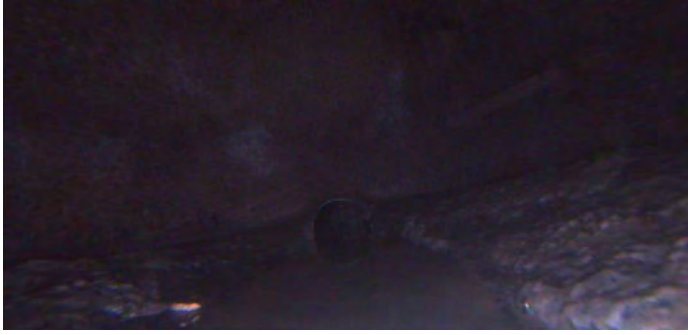
Code:	DAGS
Description:	Deposits Attached Grease
Distance (ft):	298.2
Structural Grade:	0
O&M Grade:	2
Clock Start/From:	7
Clock To:	5
1st Value:	
2nd Value:	
Value Percent:	5.000
Continuous Index:	F01
Within 8" of Joint:	NO
Remarks:
