Profile/Photo Observation Report

Street:	W 39TH AVE	Flow Control:	Not Controlled
City:	Hobart, IN	Year Renewed:	
Location:	Other	Tape/Media #:	
Purpose:	Not Known	Dia/Height:	10"
Use:	Sanitary	Material:	VCP
Drain Area:	NA	Lining:	
Category:	NA		
Comment:

Location Details:		Direction of Survey:	Downstream
US MH:	M-103-026	DS MH:	M-103-027
		Total Length Surveyed (ft):	4.2

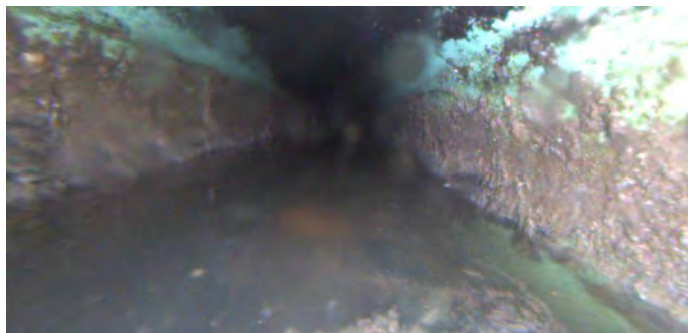
Code: **AMH**
Description: **Manhole**

Distance (ft): **.0**
Structural Grade: **0**
O&M Grade: **0**
Clock Start/From:
Clock To:
1st Value:
2nd Value:
Value Percent:
Continuous Index:
Within 8" of Joint: **NO**
Remarks: **M-103-026**

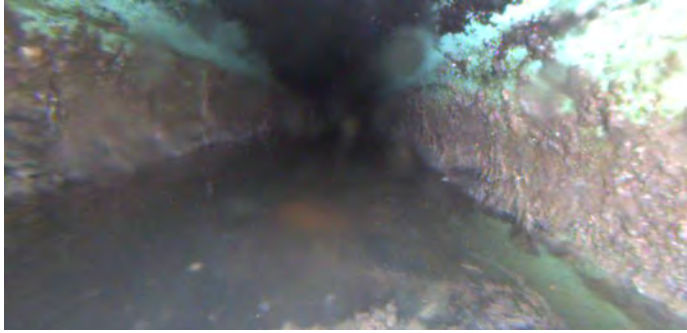
Code: **MWL**
Description: **Water Level**

Distance (ft): **.0**
Structural Grade: **0**
O&M Grade: **0**
Clock Start/From:
Clock To:
1st Value:
2nd Value:
Value Percent: **30.000**
Continuous Index:
Within 8" of Joint: **NO**
Remarks:

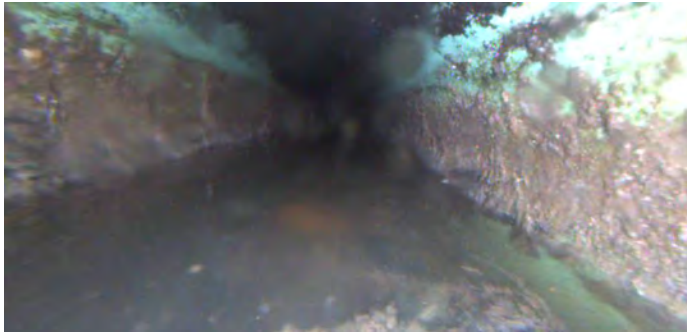
Code: **DAGS**
Description: **Deposits Attached Grease**

Distance (ft): **.0**
Structural Grade: **0**
O&M Grade: **2**
Clock Start/From: **8**
Clock To: **4**
1st Value:
2nd Value:
Value Percent: **5.000**
Continuous Index: **S01**
Within 8" of Joint: **NO**
Remarks:

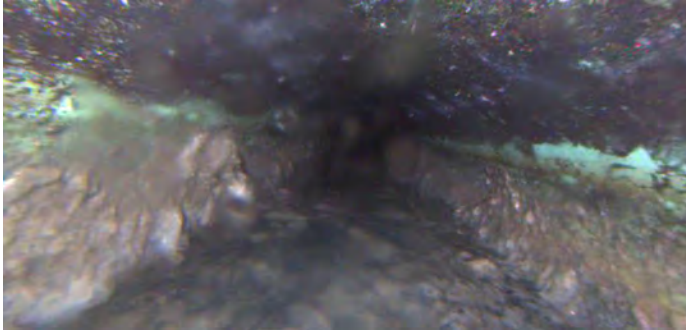
Code: **MSA**
Description: **Abandoned Survey**

Distance (ft): **4.2**
Structural Grade: **0**
O&M Grade: **0**
Clock Start/From:
Clock To:
1st Value:
2nd Value:
Value Percent:
Continuous Index:
Within 8" of Joint: **NO**
Remarks: **debris under water**

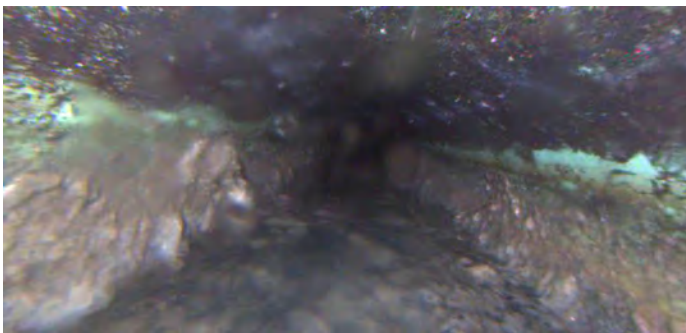
Code: **DAGS**
Description: **Deposits Attached Grease**

Distance (ft): **4.2**
Structural Grade: **0**
O&M Grade: **2**
Clock Start/From: **8**
Clock To: **4**
1st Value:
2nd Value:
Value Percent: **5.000**
Continuous Index: **F01**
Within 8" of Joint: **NO**
Remarks:
