Profile/Photo Observation Report

Date:	04/03/2018	Weather:		Coding:	PACP 6.0
Pipe Length (ft):	331.6	Owner:	NA	Pre Clean:	Not Known
P.O.#:		Surveyor:	Jen Costello	PSR:	P-103-026-027
Customer:		Clean Date:	01/01/1900	Shape:	C

Location Details:		Direction of Survey:	Downstream
US MH:	M-103-026	DS MH:	M-103-027
		Total Length Surveyed (ft):	4.2

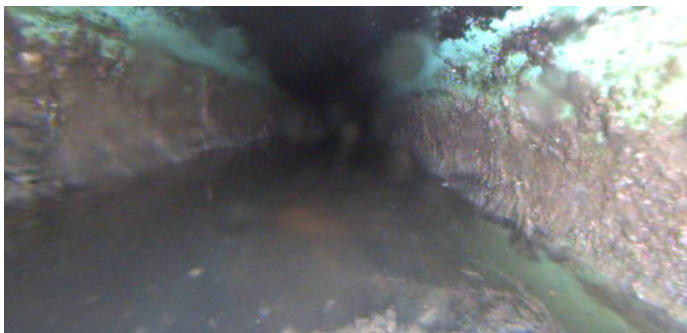
Code: **AMH**
 Description: **Manhole**

Distance (ft): **.0**
 Structural Grade: **0**
 O&M Grade: **0**
 Clock Start/From:
 Clock To:
 1st Value:
 2nd Value:
 Value Percent:
 Continuous Index:
 Within 8" of Joint: **NO**
 Remarks: **M-103-026**

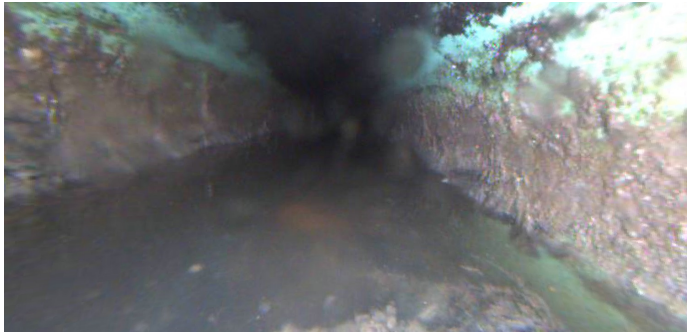
Code: **MWL**
Description: **Water Level**

Distance (ft): **.0**
Structural Grade: **0**
O&M Grade: **0**
Clock Start/From:
Clock To:
1st Value:
2nd Value:
Value Percent: **30.000**
Continuous Index:
Within 8" of Joint: **NO**
Remarks:

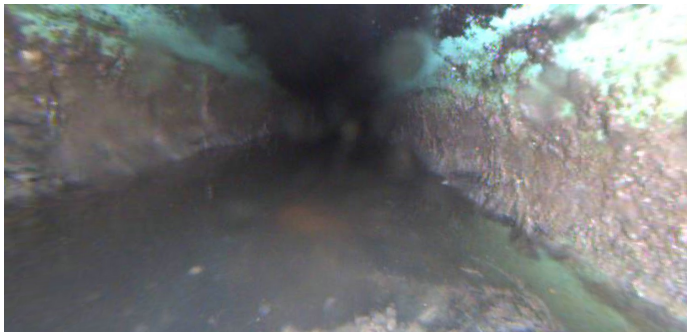
Code: **DAGS**
Description: **Deposits Attached Grease**

Distance (ft): **.0**
Structural Grade: **0**
O&M Grade: **2**
Clock Start/From: **8**
Clock To: **4**
1st Value:
2nd Value:
Value Percent: **5.000**
Continuous Index: **S01**
Within 8" of Joint: **NO**
Remarks:

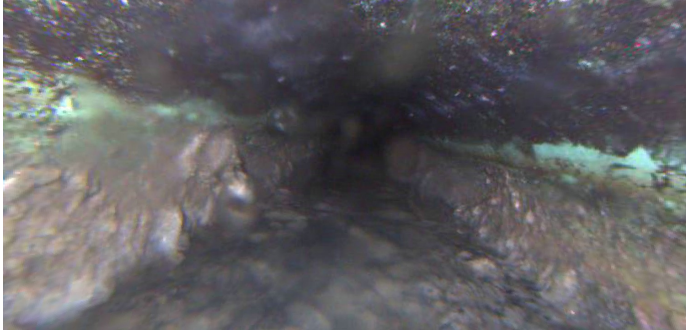
Code: **MSA**
Description: **Abandoned Survey**

Distance (ft): **4.2**
Structural Grade: **0**
O&M Grade: **0**
Clock Start/From:
Clock To:
1st Value:
2nd Value:
Value Percent:
Continuous Index:
Within 8" of Joint: **NO**
Remarks: **debris under water**

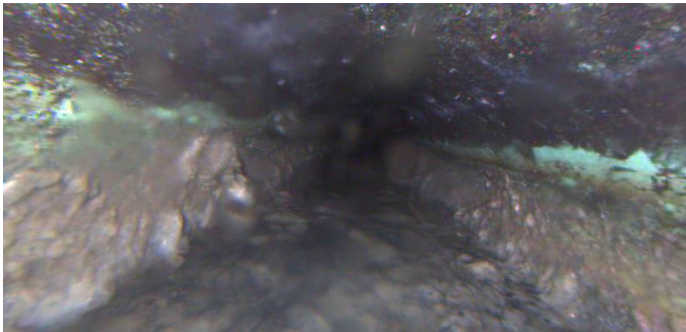
Code: **DAGS**
Description: **Deposits Attached Grease**

Distance (ft): **4.2**
Structural Grade: **0**
O&M Grade: **2**
Clock Start/From: **8**
Clock To: **4**
1st Value:
2nd Value:
Value Percent: **5.000**
Continuous Index: **F01**
Within 8" of Joint: **NO**
Remarks:
