Profile/Photo Observation Report

Date:	09/28/2018	Weather:		Coding:	PACP 6.0
Pipe Length (ft):	331.6	Owner:	NA	Pre Clean:	Not Known
P.O.#:		Surveyor:	Justin Gonzales	PSR:	P-103-026-027
Customer:		Clean Date:	01/01/1900	Shape:	C

Street:	39th. Ave.	Flow Control:	Not Controlled
City:	Hobart, IN	Year Renewed:	
Location:	Light Highway	Tape/Media #:	
Purpose:	Routine Assessment	Dia/Height:	8"
Use:	Sanitary	Material:	VCP
Drain Area:	NA	Lining:	
Category:	NA		
Comment:

Location Details:		Direction of Survey:	Downstream
US MH:	M-103-026	DS MH:	M-103-027
		Total Length Surveyed (ft):	327.8

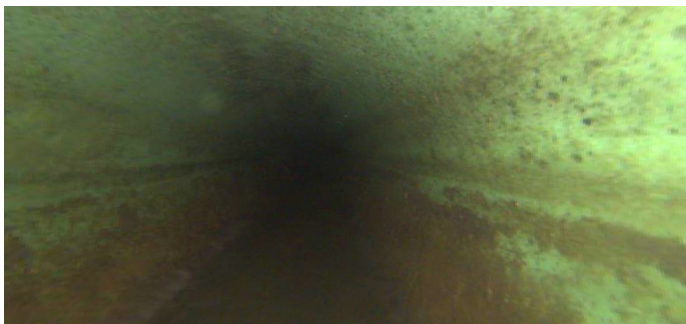
Code: **AMH**
Description: **Manhole**

Distance (ft): **.0**
Structural Grade: **0**
O&M Grade: **0**
Clock Start/From:
Clock To:
1st Value:
2nd Value:
Value Percent:
Continuous Index:
Within 8" of Joint: **NO**
Remarks: **M-103-026**

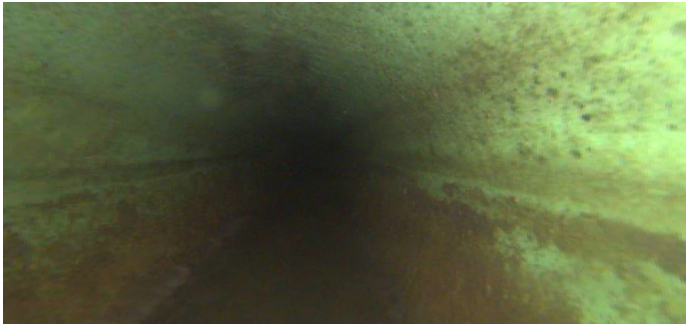
Code:	MWL
Description:	Water Level

Distance (ft):	.0
Structural Grade:	0
O&M Grade:	0
Clock Start/From:	
Clock To:	
1st Value:	
2nd Value:	
Value Percent:	5.000
Continuous Index:	
Within 8" of Joint:	NO
Remarks:

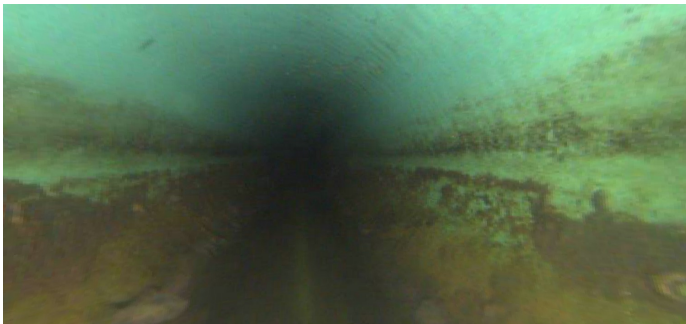
Code:	DAZ
Description:	Deposits Attached Other

Distance (ft):	6.7
Structural Grade:	0
O&M Grade:	2
Clock Start/From:	7
Clock To:	5
1st Value:	
2nd Value:	
Value Percent:	5.000
Continuous Index:	S01
Within 8" of Joint:	YES
Remarks:	WANDER

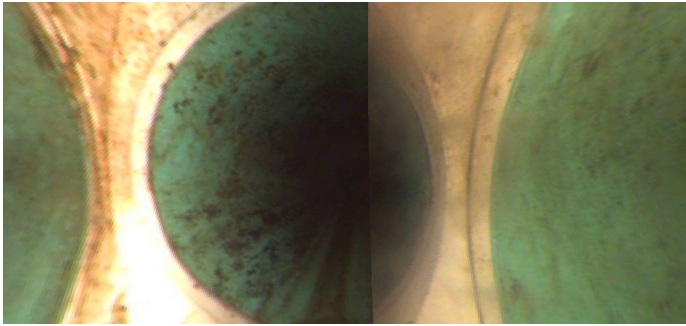
Code: **TF**
Description: **Tap Factory**

Distance (ft): **129.7**
Structural Grade: **0**
O&M Grade: **0**
Clock Start/From: **9**
Clock To:
1st Value: **4.000**
2nd Value:
Value Percent:
Continuous Index:
Within 8" of Joint:
Remarks:

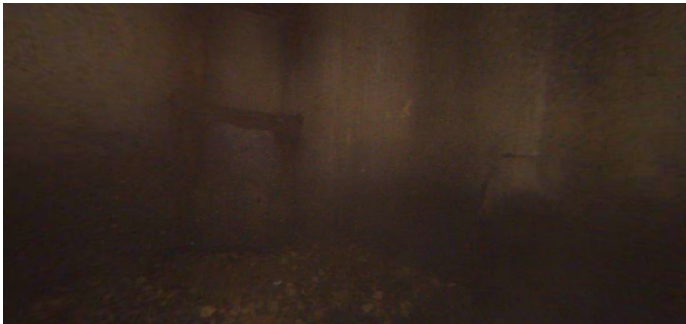
Code: **AMH**
Description: **Manhole**

Distance (ft): **327.8**
Structural Grade: **0**
O&M Grade: **0**
Clock Start/From:
Clock To:
1st Value:
2nd Value:
Value Percent:
Continuous Index:
Within 8" of Joint: **NO**
Remarks: **M-103-027**

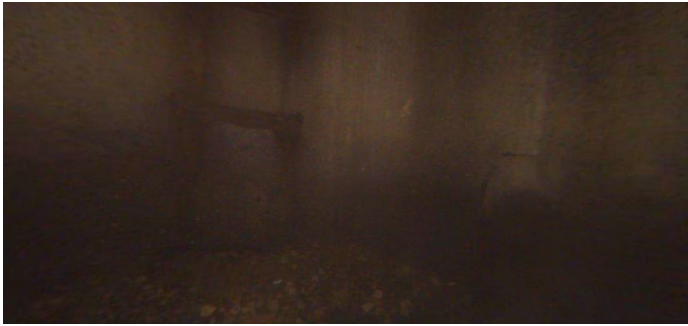
Code:	DAZ
Description:	Deposits Attached Other
Distance (ft):	327.8
Structural Grade:	0
O&M Grade:	2
Clock Start/From:	7
Clock To:	5
1st Value:	
2nd Value:	
Value Percent:	5.000
Continuous Index:	F01
Within 8" of Joint:	YES
Remarks:	WANDER
