Profile/Photo Observation Report

Date:	10/14/2021	Weather:		Coding:	PACP 6.0
Pipe Length (ft):		Owner:	Hobart, IN	Pre Clean:	Not Known
P.O.#:	800_1	Surveyor:	M. Pielacha	PSR:	P-103-029-030
Customer:	Hobart, IN	Clean Date:		Shape:	C

Street:	Off Colbourne Street	Flow Control:	
City:	Hobart, IN	Year Renewed:	
Location:	Light Highway	Tape/Media #:	800
Purpose:	Routine Assessment	Dia/Height:	12"
Use:	Sanitary	Material:	VCP
Drain Area:		Lining:	
Category:	NA

US MH: **M-103-29** DS MH: **M-103-30** Total Length Surveyed (ft): **246.6**

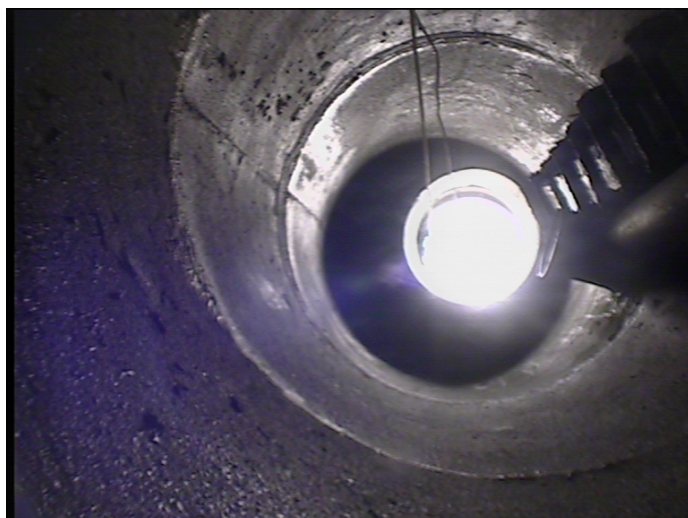
Code: **AMH**
 Description: **Manhole**

Distance (ft): **.0**
 Structural Grade: **0**
 O&M Grade: **0**
 Clock Start/From:
 Clock To:
 1st Value:
 2nd Value:
 Value Percent:
 Continuous Index:
 Within 8" of Joint: **NO**
 Remarks: **M-103-29**

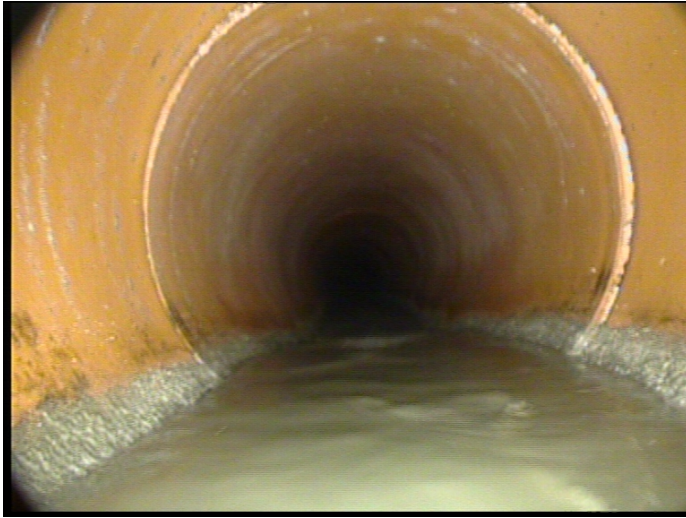
Code: **MWL**
Description: **Water Level**

Distance (ft): **.0**
Structural Grade: **0**
O&M Grade: **0**
Clock Start/From:
Clock To:
1st Value:
2nd Value:
Value Percent: **5.000**
Continuous Index:
Within 8" of Joint: **NO**
Remarks:

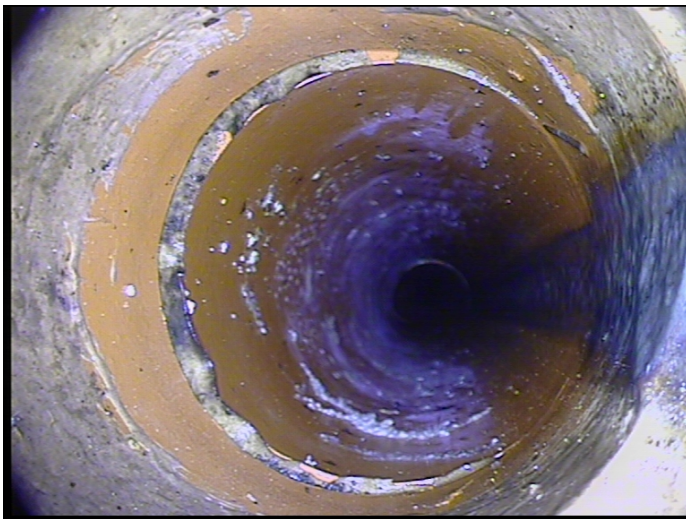
Code: **TF**
Description: **Tap Factory**

Distance (ft): **44.0**
Structural Grade: **0**
O&M Grade: **0**
Clock Start/From: **3**
Clock To:
1st Value: **4.000**
2nd Value:
Value Percent:
Continuous Index:
Within 8" of Joint: **NO**
Remarks:

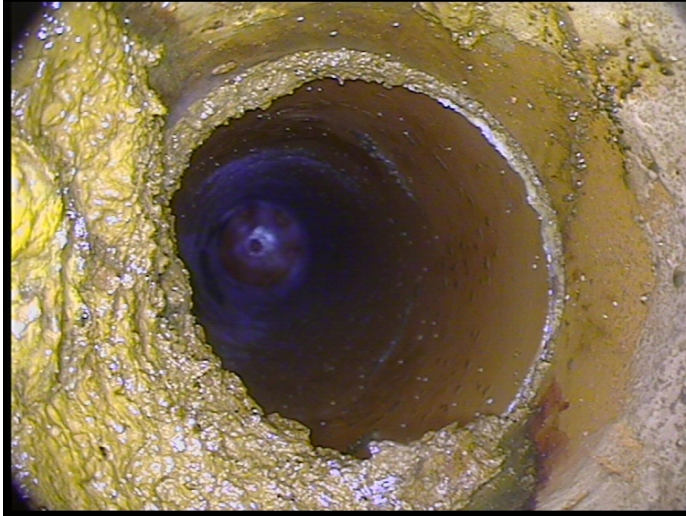
Code: **TF**
Description: **Tap Factory**

Distance (ft): **67.5**
Structural Grade: **0**
O&M Grade: **0**
Clock Start/From: **10**
Clock To:
1st Value: **4.000**
2nd Value:
Value Percent:
Continuous Index:
Within 8" of Joint: **NO**
Remarks:

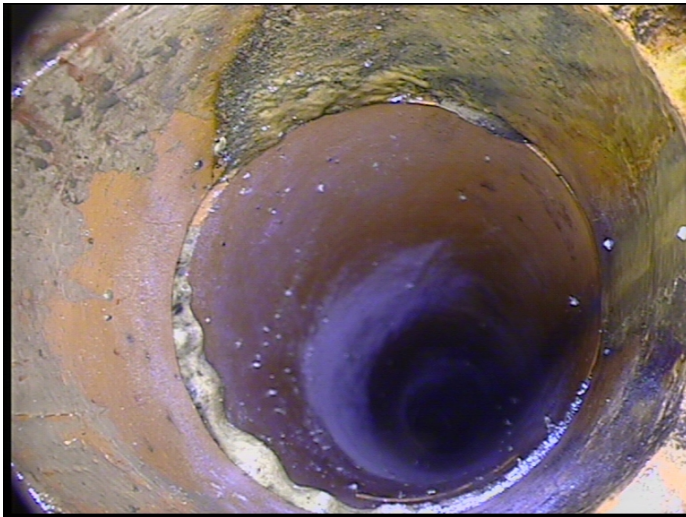
Code: **TF**
Description: **Tap Factory**

Distance (ft): **83.6**
Structural Grade: **0**
O&M Grade: **0**
Clock Start/From: **2**
Clock To:
1st Value: **4.000**
2nd Value:
Value Percent:
Continuous Index:
Within 8" of Joint: **NO**
Remarks:

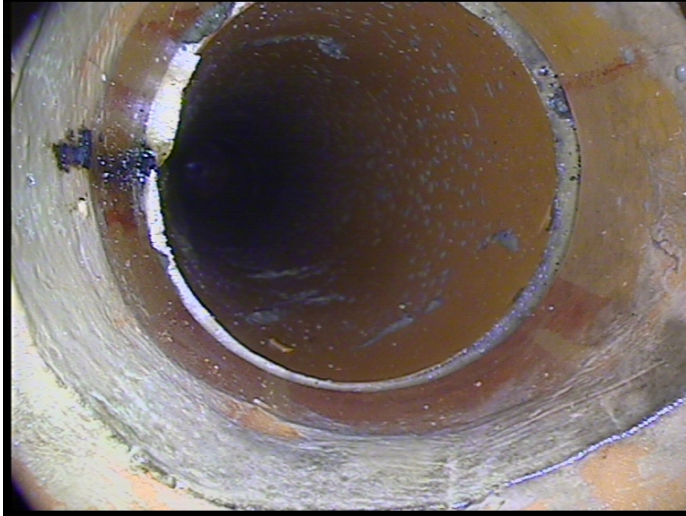
Code: **TF**
Description: **Tap Factory**

Distance (ft): **135.0**
Structural Grade: **0**
O&M Grade: **0**
Clock Start/From: **10**
Clock To:
1st Value: **4.000**
2nd Value:
Value Percent:
Continuous Index:
Within 8" of Joint: **NO**
Remarks:

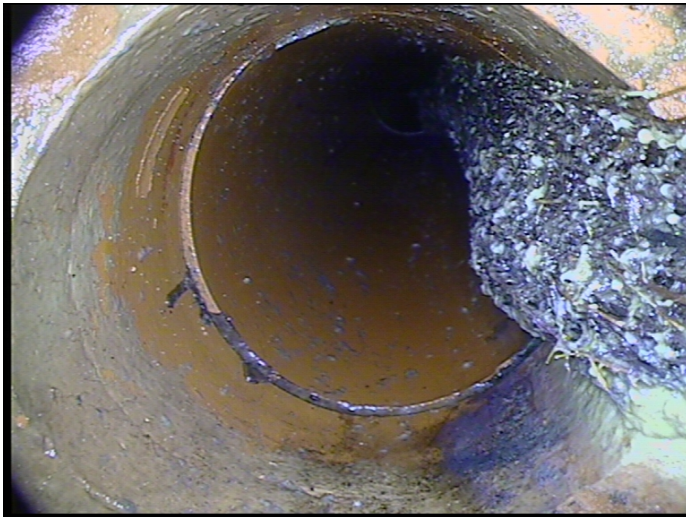
Code: **TFD**
Description: **Tap Factory Defective**

Distance (ft): **148.0**
Structural Grade: **0**
O&M Grade: **2**
Clock Start/From: **2**
Clock To:
1st Value: **4.000**
2nd Value:
Value Percent:
Continuous Index:
Within 8" of Joint: **NO**
Remarks: **roots**

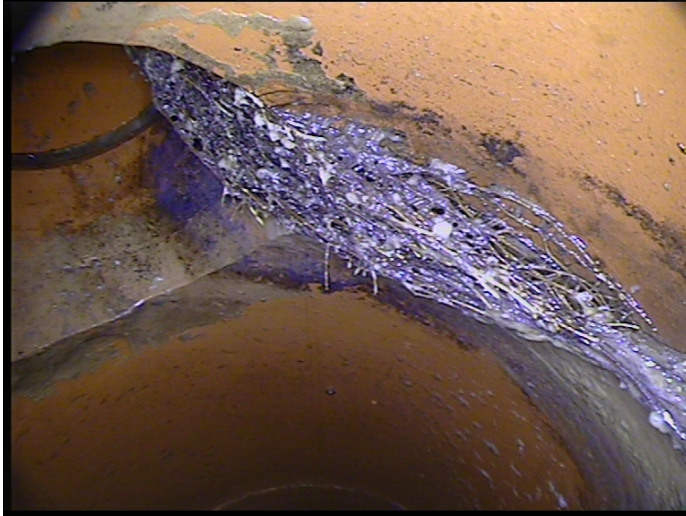
Code: **RFL**
Description: **Roots Fine Lateral**

Distance (ft): **148.0**
Structural Grade: **0**
O&M Grade: **1**
Clock Start/From: **2**
Clock To: **5**
1st Value:
2nd Value:
Value Percent:
Continuous Index:
Within 8" of Joint: **NO**
Remarks:

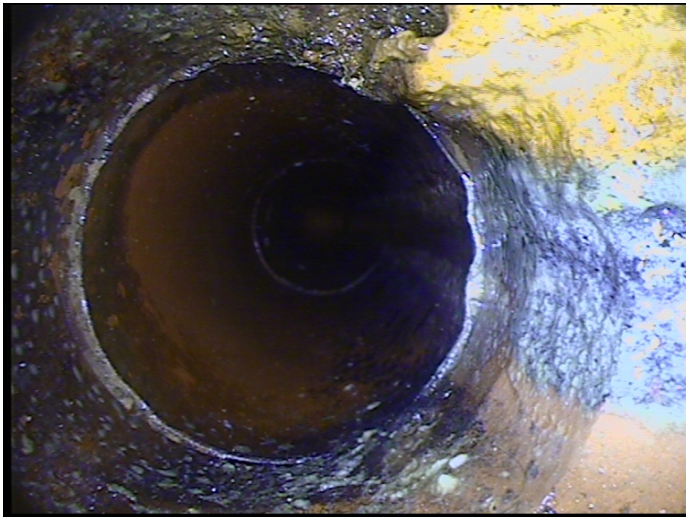
Code: **TFA**
Description: **Tap Factory Active**

Distance (ft): **186.3**
Structural Grade: **0**
O&M Grade: **0**
Clock Start/From: **2**
Clock To:
1st Value: **4.000**
2nd Value:
Value Percent:
Continuous Index:
Within 8" of Joint: **NO**
Remarks:

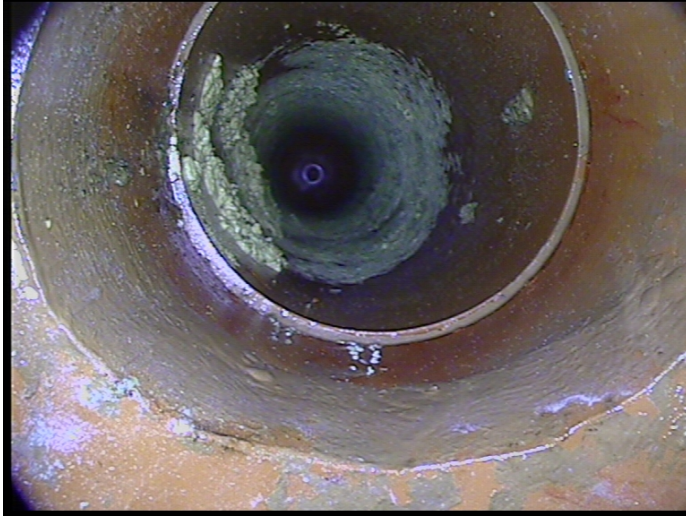
Code: **TF**
Description: **Tap Factory**

Distance (ft): **206.8**
Structural Grade: **0**
O&M Grade: **0**
Clock Start/From: **11**
Clock To:
1st Value: **4.000**
2nd Value:
Value Percent:
Continuous Index:
Within 8" of Joint: **NO**
Remarks:

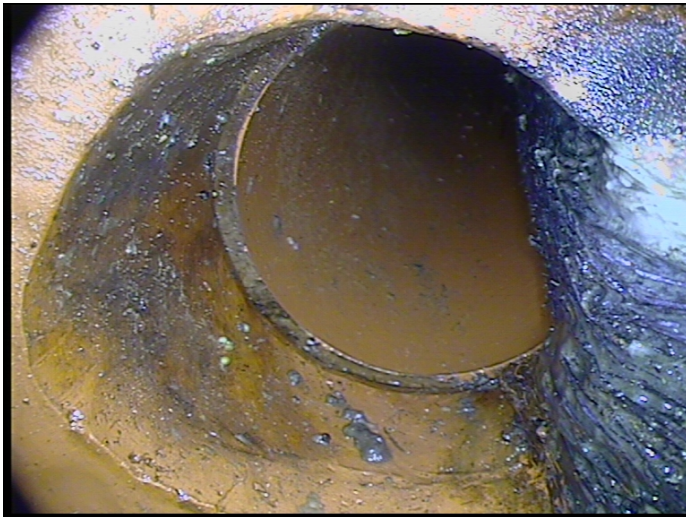
Code: **TFD**
Description: **Tap Factory Defective**

Distance (ft): **233.8**
Structural Grade: **0**
O&M Grade: **2**
Clock Start/From: **2**
Clock To:
1st Value: **4.000**
2nd Value:
Value Percent:
Continuous Index:
Within 8" of Joint: **NO**
Remarks: **roots**

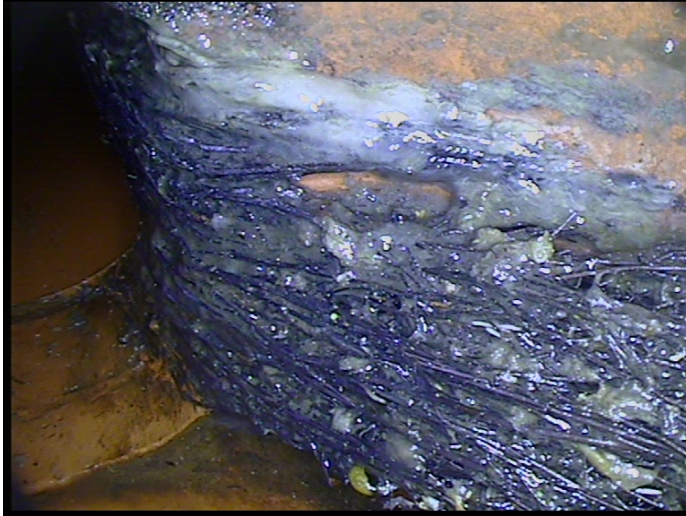
Code:	RFL
Description:	Roots Fine Lateral
Distance (ft):	233.8
Structural Grade:	0
O&M Grade:	1
Clock Start/From:	2
Clock To:	5
1st Value:	
2nd Value:	
Value Percent:	
Continuous Index:	
Within 8" of Joint:	NO
Remarks:

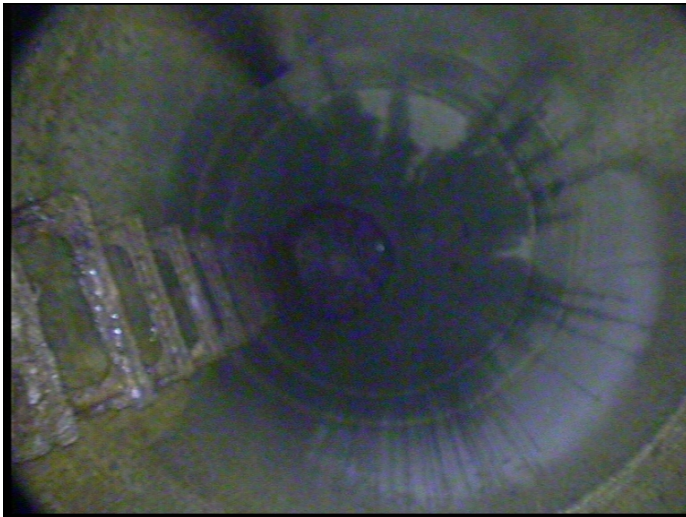
Code:	AMH
Description:	Manhole
Distance (ft):	246.6
Structural Grade:	0
O&M Grade:	0
Clock Start/From:	
Clock To:	
1st Value:	
2nd Value:	
Value Percent:	
Continuous Index:	
Within 8" of Joint:	NO
Remarks:	M-103-30
