Profile/Photo Observation Report

Date:	11/03/2021	Weather:		Coding:	PACP 7.0
Pipe Length (ft):	27.7	Owner:	City of Hobart	Pre Clean:	No Pre-Cleaning
P.O.#:	YES502259	Surveyor:	S. Bucklin	PSR:	
Customer:	City of Hobart	Clean Date:		Shape:	C

Street:	West Cleveland Avenue	Flow Control:	Not Controlled
City:	Hobart, IN	Year Renewed:	
Location:	Local rural streets with light traffic, t	Tape/Media #:	
Purpose:	Routine Assessment	Dia/Height:	15"
Use:	Sanitary Sewage Pipe	Material:	VCP
Drain Area:		Lining:	None
Category:	NA		
Comment:			
Location Details:		Direction of Survey:	Upstream
US MH:	UNK WABASH ST	DS MH:	M-404-002.1
		Total Length Surveyed (ft):	27.7

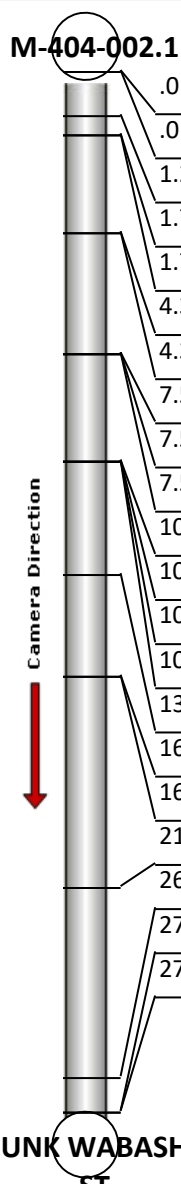
.0	AMH	Manhole	1	NA
	.0	MWL	Miscellaneous Water Level	41	NA
	1.2	DSF(S01)	Deposits Settled Fine	87	M 2
	1.7	DAE	Deposits Attached Encrustation	135	M 2
	1.7	IDJ	Infiltration Dripper Joint	146	M 3
	4.3	RFJ	Roots Fine Joint	216	M 1
	4.3	IRJ	Infiltration Runner Joint	229	M 4
	7.5	RFJ	Roots Fine Joint	305	M 1
	7.5	IRJ	Infiltration Runner Joint	320	M 4
	7.5	DAE	Deposits Attached Encrustation	336	M 2
	10.4	IRJ	Infiltration Runner Joint	432	M 4
	10.4	RFJ	Roots Fine Joint	475	M 1
	10.4	DAE	Deposits Attached Encrustation	490	M 2
	10.4	RFJ	Roots Fine Joint	515	M 1
	13.4	RFJ	Roots Fine Joint	584	M 1
	16.1	MMC	Miscellaneous Material Change	699	NA
	16.1	RFJ	Roots Fine Joint	729	M 1
	21.7	MGO	Miscellaneous General Observation	800	NA
	26.8	RBL	Roots Ball Lateral	868	M 4
	27.7	DSF(F01)	Deposits Settled Fine	979	M 2
	27.7	AMH	Manhole	1042	NA

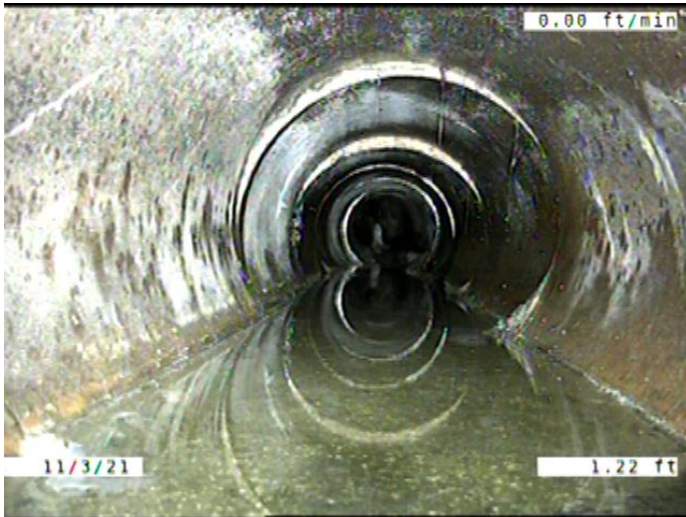
Code: **DSF**
 Description: **Deposits Settled Fine**

Distance (ft): **1.2**
 Structural Grade: **0**
 O&M Grade: **2**
 Clock Start/From: **5**
 Clock To: **7**
 1st Value:
 2nd Value:
 Value Percent: **5.000**
 Continuous Index: **S01**
 Within 8" of Joint: **YES**
 Remarks:

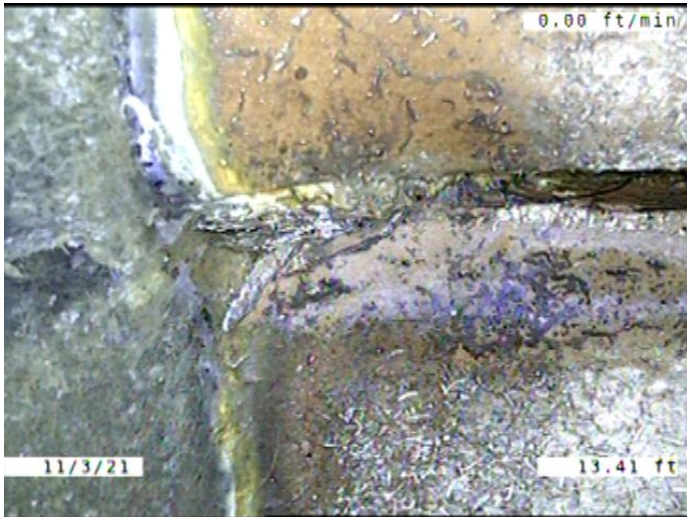
Code: **RFJ**
 Description: **Roots Fine Joint**

Distance (ft): **13.4**
 Structural Grade: **0**
 O&M Grade: **1**
 Clock Start/From: **8**
 Clock To: **4**
 1st Value:
 2nd Value:
 Value Percent:
 Continuous Index:
 Within 8" of Joint: **YES**
 Remarks:
