Profile/Photo Observation Report

Date:	04/19/2018	Weather:		Coding:	PACP 6.0
Pipe Length (ft):	279.0	Owner:	NA	Pre Clean:	Not Known
P.O.#:		Surveyor:	Justin Gonzales	PSR:	
Customer:		Clean Date:	01/01/1900	Shape:	C

Street:	Capitol	Flow Control:	Not Controlled
City:	Hobart, IN	Year Renewed:	
Location:	Light Highway	Tape/Media #:	
Purpose:	Maintenance Related	Dia/Height:	12"
Use:	Sanitary	Material:	PVC
Drain Area:	NA	Lining:	Cured in Place
Category:	NA		
Comment:	new segment-706-039 doesn't exist.		
Location Details:		Direction of Survey:	Upstream
US MH:	M-705-021	DS MH:	M-706-040
		Total Length Surveyed (ft):	280.9

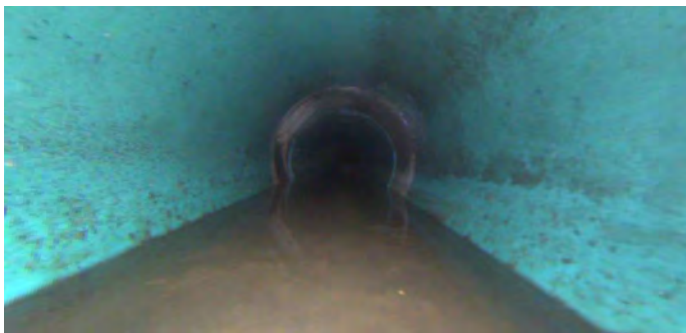
Code: **AMH**
Description: **Manhole**

Distance (ft): **.0**
Structural Grade: **0**
O&M Grade: **0**
Clock Start/From:
Clock To:
1st Value:
2nd Value:
Value Percent:
Continuous Index:
Within 8" of Joint: **NO**
Remarks: **M-706-040**

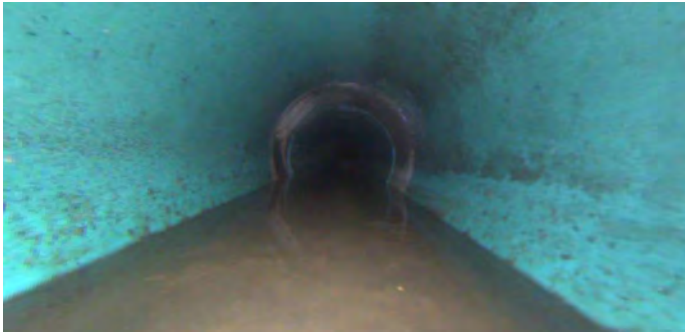
Code:	MWL
Description:	Water Level

Distance (ft):	.0
Structural Grade:	0
O&M Grade:	0
Clock Start/From:	
Clock To:	
1st Value:	
2nd Value:	
Value Percent:	10.000
Continuous Index:	
Within 8" of Joint:	NO
Remarks:

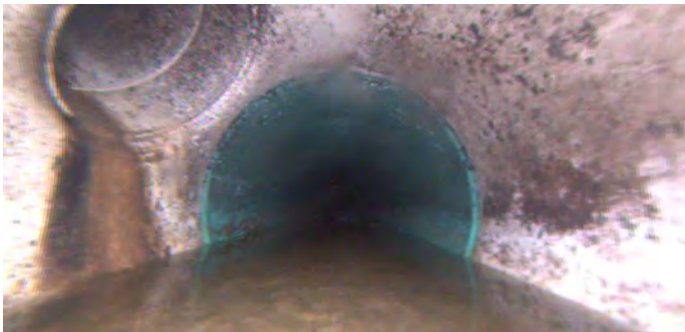
Code:	TF
Description:	Tap Factory

Distance (ft):	2.5
Structural Grade:	0
O&M Grade:	0
Clock Start/From:	10
Clock To:	
1st Value:	4.000
2nd Value:	
Value Percent:	
Continuous Index:	
Within 8" of Joint:	
Remarks:

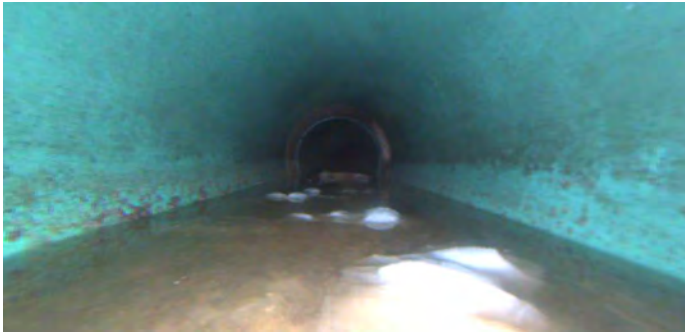
Code: **MGO**
Description: **General Observation**

Distance (ft): **6.6**
Structural Grade: **0**
O&M Grade: **0**
Clock Start/From:
Clock To:
1st Value:
2nd Value:
Value Percent:
Continuous Index:
Within 8" of Joint: **NO**
Remarks: **TOILET TISSUE**

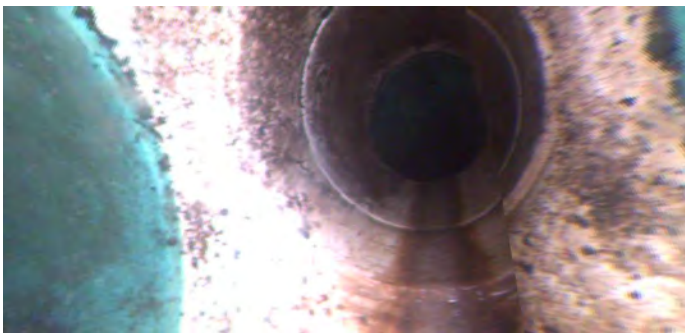
Code: **TF**
Description: **Tap Factory**

Distance (ft): **9.4**
Structural Grade: **0**
O&M Grade: **0**
Clock Start/From: **3**
Clock To:
1st Value: **4.000**
2nd Value:
Value Percent:
Continuous Index:
Within 8" of Joint:
Remarks:

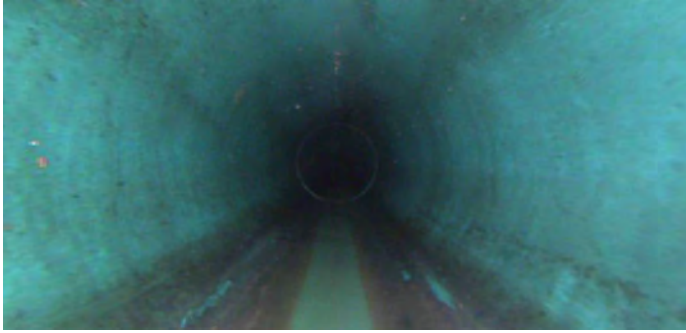
Code: **MWL**
Description: **Water Level**

Distance (ft): **20.0**
Structural Grade: **0**
O&M Grade: **0**
Clock Start/From:
Clock To:
1st Value:
2nd Value:
Value Percent: **5.000**
Continuous Index:
Within 8" of Joint: **NO**
Remarks:

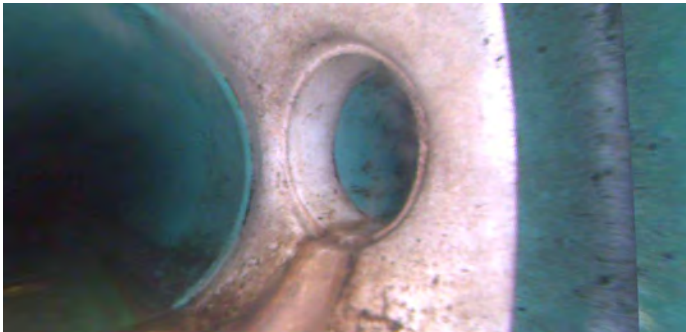
Code: **TF**
Description: **Tap Factory**

Distance (ft): **52.4**
Structural Grade: **0**
O&M Grade: **0**
Clock Start/From: **3**
Clock To:
1st Value: **4.000**
2nd Value:
Value Percent:
Continuous Index:
Within 8" of Joint:
Remarks:

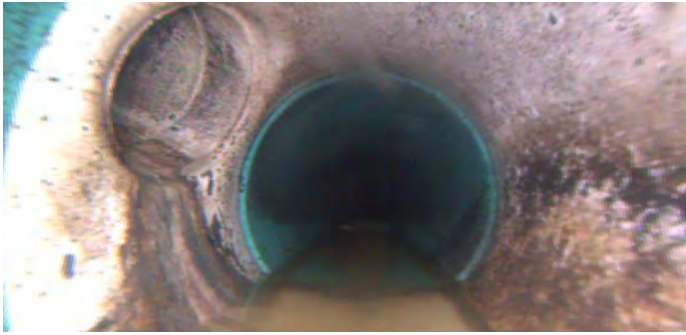
Code: **TF**
Description: **Tap Factory**

Distance (ft): **65.5**
Structural Grade: **0**
O&M Grade: **0**
Clock Start/From: **10**
Clock To:
1st Value: **4.000**
2nd Value:
Value Percent:
Continuous Index:
Within 8" of Joint:
Remarks:

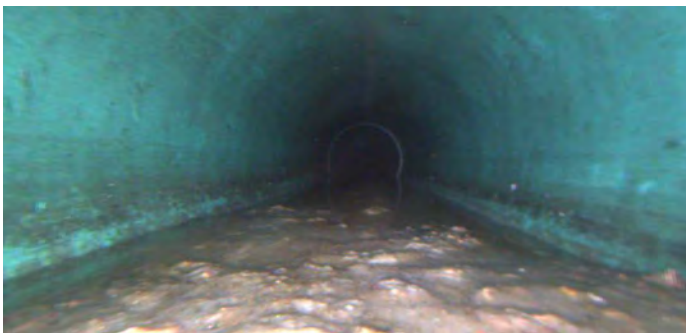
Code: **MGO**
Description: **General Observation**

Distance (ft): **98.5**
Structural Grade: **0**
O&M Grade: **0**
Clock Start/From:
Clock To:
1st Value:
2nd Value:
Value Percent:
Continuous Index:
Within 8" of Joint: **NO**
Remarks: **TOILET TISSUE**

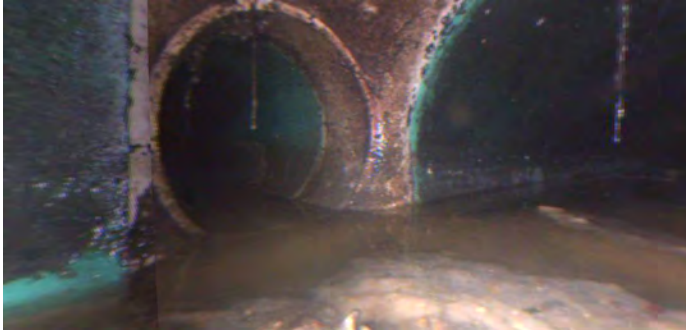
Code: **TF**
Description: **Tap Factory**

Distance (ft): **116.1**
Structural Grade: **0**
O&M Grade: **0**
Clock Start/From: **9**
Clock To:
1st Value: **4.000**
2nd Value:
Value Percent:
Continuous Index:
Within 8" of Joint:
Remarks:

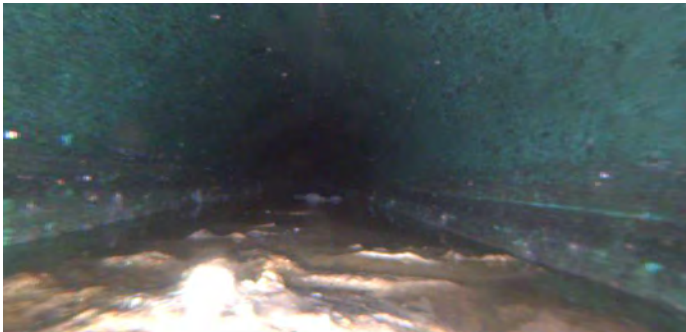
Code: **MGO**
Description: **General Observation**

Distance (ft): **121.8**
Structural Grade: **0**
O&M Grade: **0**
Clock Start/From:
Clock To:
1st Value:
2nd Value:
Value Percent:
Continuous Index:
Within 8" of Joint: **NO**
Remarks: **TOILET TISSUE**

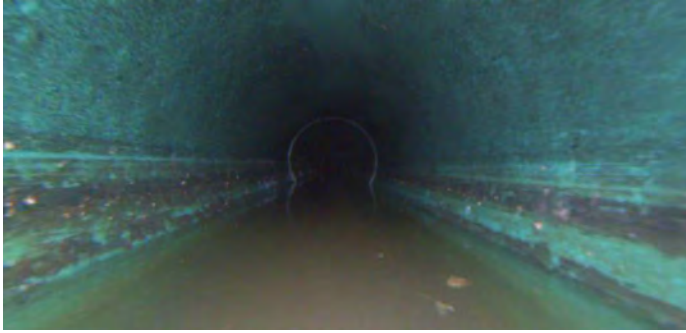
Code: **MWL**
Description: **Water Level**

Distance (ft): **127.3**
Structural Grade: **0**
O&M Grade: **0**
Clock Start/From:
Clock To:
1st Value:
2nd Value:
Value Percent: **30.000**
Continuous Index:
Within 8" of Joint: **NO**
Remarks:

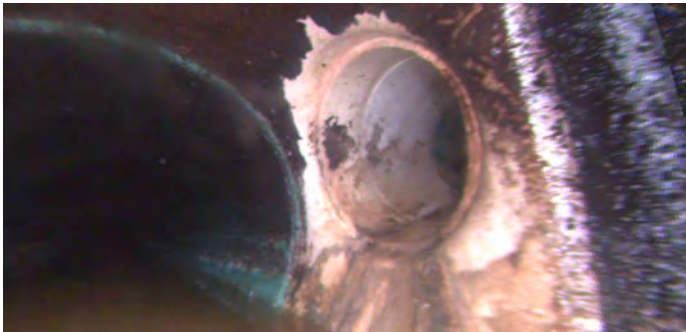
Code: **TF**
Description: **Tap Factory**

Distance (ft): **138.4**
Structural Grade: **0**
O&M Grade: **0**
Clock Start/From: **3**
Clock To:
1st Value: **4.000**
2nd Value:
Value Percent:
Continuous Index:
Within 8" of Joint:
Remarks:

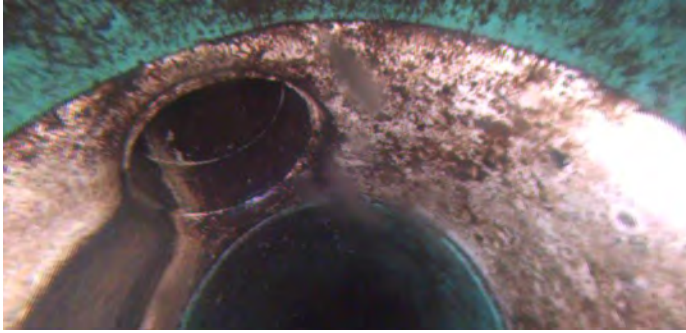
Code: **TF**
Description: **Tap Factory**

Distance (ft): **160.7**
Structural Grade: **0**
O&M Grade: **0**
Clock Start/From: **11**
Clock To:
1st Value: **4.000**
2nd Value:
Value Percent:
Continuous Index:
Within 8" of Joint:
Remarks:

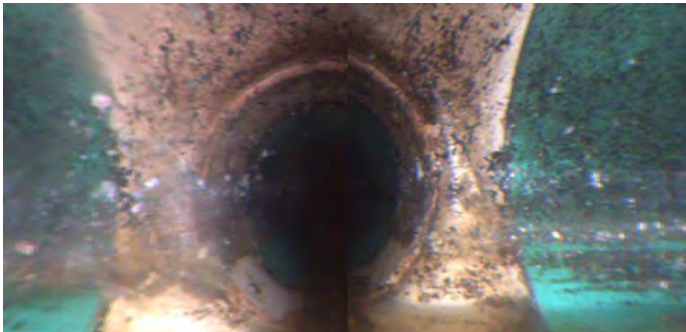
Code: **TF**
Description: **Tap Factory**

Distance (ft): **204.8**
Structural Grade: **0**
O&M Grade: **0**
Clock Start/From: **9**
Clock To:
1st Value: **4.000**
2nd Value:
Value Percent:
Continuous Index:
Within 8" of Joint:
Remarks:

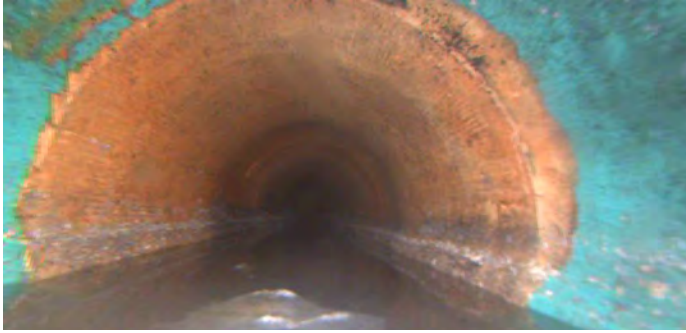
Code: **MLC**
Description: **Lining Change**

Distance (ft): **262.9**
Structural Grade: **0**
O&M Grade: **0**
Clock Start/From:
Clock To:
1st Value:
2nd Value:
Value Percent:
Continuous Index:
Within 8" of Joint: **NO**
Remarks: **cip**

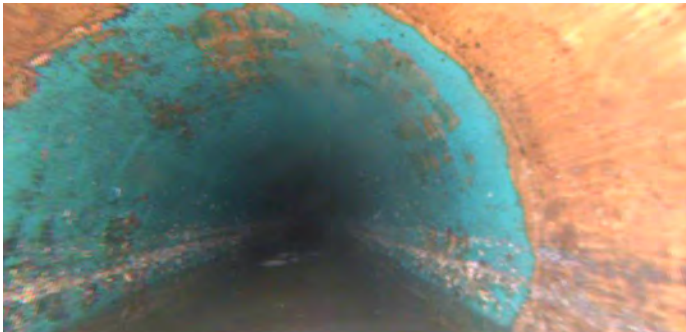
Code: **MLC**
Description: **Lining Change**

Distance (ft): **266.9**
Structural Grade: **0**
O&M Grade: **0**
Clock Start/From:
Clock To:
1st Value:
2nd Value:
Value Percent:
Continuous Index:
Within 8" of Joint: **NO**
Remarks: **end cip**

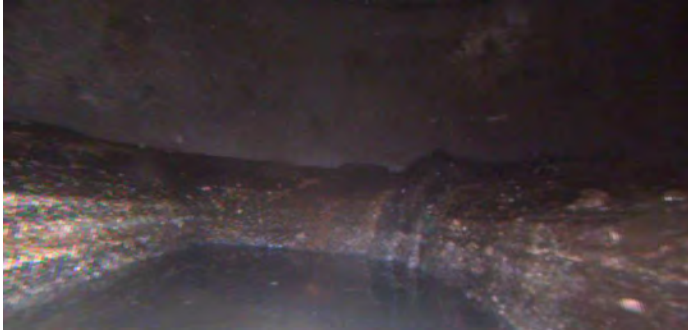
Code:	AMH
Description:	Manhole
Distance (ft):	280.9
Structural Grade:	0
O&M Grade:	0
Clock Start/From:	
Clock To:	
1st Value:	
2nd Value:	
Value Percent:	
Continuous Index:	
Within 8" of Joint:	NO
Remarks:	M-705-021
