Profile/Photo Observation Report

Date:	03/23/2018	Weather:		Coding:	PACP 6.0
Pipe Length (ft):	155.0	Owner:	NA	Pre Clean:	Not Known
P.O.#:		Surveyor:	Jen Costello	PSR:	P-103-033-LS005
Customer:		Clean Date:	01/01/1900	Shape:	C

Street:	ALLEY BETWEEN W 37TH AVE & W 3	Flow Control:	Not Controlled
City:	Hobart, IN	Year Renewed:	
Location:	Other	Tape/Media #:	
Purpose:	Not Known	Dia/Height:	12"
Use:	Sanitary	Material:	VCP
Drain Area:	NA	Lining:	
Category:	NA		
Comment:

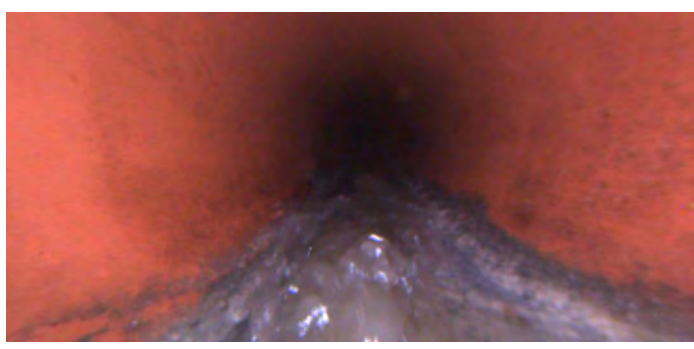
Code: **AMH**
Description: **Manhole**

Distance (ft): **.0**
Structural Grade: **0**
O&M Grade: **0**
Clock Start/From:
Clock To:
1st Value:
2nd Value:
Value Percent:
Continuous Index:
Within 8" of Joint: **NO**
Remarks: **M-103-033**

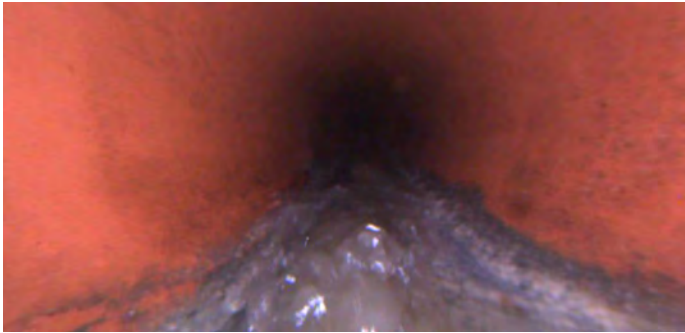
Code:	MWL
Description:	Water Level

Distance (ft):	.0
Structural Grade:	0
O&M Grade:	0
Clock Start/From:	
Clock To:	
1st Value:	
2nd Value:	
Value Percent:	20.000
Continuous Index:	
Within 8" of Joint:	NO
Remarks:

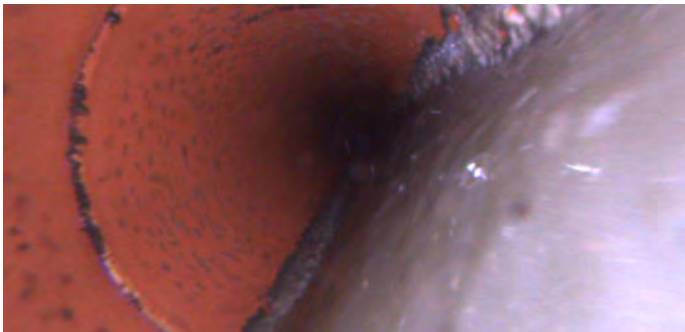
Code:	MSA
Description:	Abandoned Survey

Distance (ft):	15.0
Structural Grade:	0
O&M Grade:	0
Clock Start/From:	
Clock To:	
1st Value:	
2nd Value:	
Value Percent:	
Continuous Index:	
Within 8" of Joint:	NO
Remarks:	overturned
