Profile/Photo Observation Report

Street:	Off Colbourne Street	Flow Control:	Not Controlled
City:	Hobart, IN	Year Renewed:	
Location:	Alley	Tape/Media #:	DEP 68
Purpose:	Routine Assessment	Dia/Height:	12"
Use:	Sanitary	Material:	VCP
Drain Area:		Lining:	
Category:	NA		
Comment:	YES501824 Submittal 2		
Location Details:		Direction of Survey:	Downstream
US MH:	M-103-003	DS MH:	Lift Station LS-005
		Total Length Surveyed (ft):	146.3

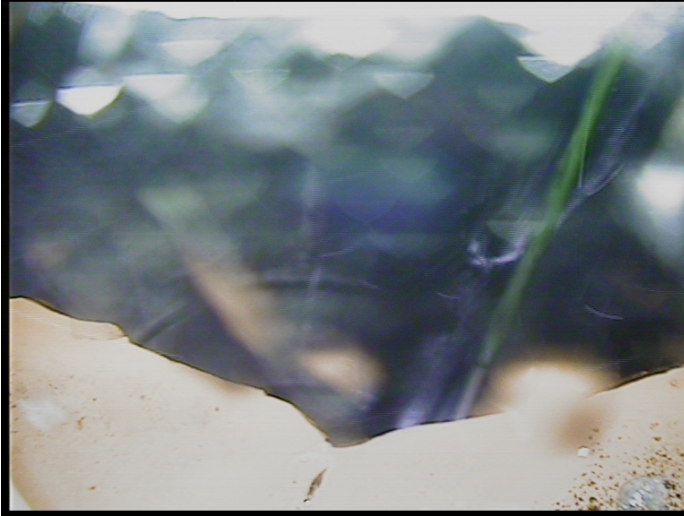
Code: **AMH**
Description: **Manhole**

Distance (ft): **.0**
Structural Grade: **0**
O&M Grade: **0**
Clock Start/From:
Clock To:
1st Value:
2nd Value:
Value Percent:
Continuous Index:
Within 8" of Joint: **NO**
Remarks: **M-103-003**

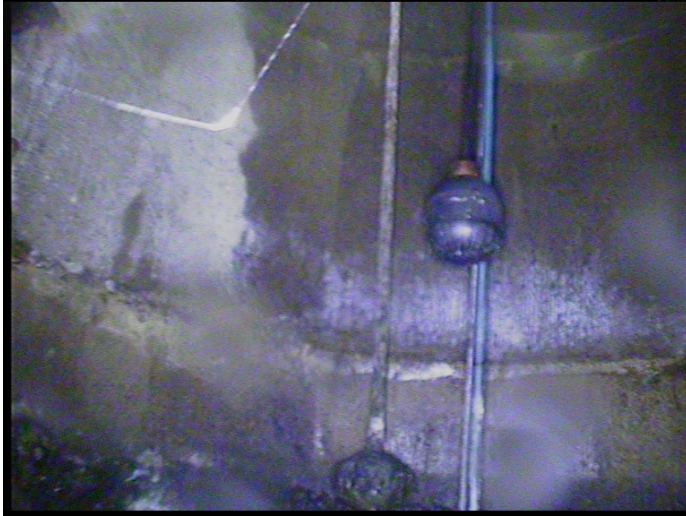
Code:	AWW
Description:	Wet Well
Distance (ft):	146.3
Structural Grade:	0
O&M Grade:	0
Clock Start/From:	
Clock To:	
1st Value:	
2nd Value:	
Value Percent:	
Continuous Index:	
Within 8" of Joint:	NO
Remarks:	Lift Station LS-005
