## Profile/Photo Observation Report

Street:	<b>Maple Street</b>	Flow Control:	
City:	<b>Hobart, IN</b>	Year Renewed:	
Location:	<b>Light Highway</b>	Tape/Media #:	<b>825</b>
Purpose:	<b>Routine Assessment</b>	Dia/Height:	<b>8"</b>
Use:	<b>Sanitary</b>	Material:	<b>PVC</b>
Drain Area:		Lining:	
Category:	<b>NA</b>		
Comment:

Location Details:		Direction of Survey:	<b>Upstream</b>
US MH:	<b>M-103-103</b>	DS MH:	<b>M-103-102</b>
		Total Length Surveyed (ft):	<b>131.8</b>

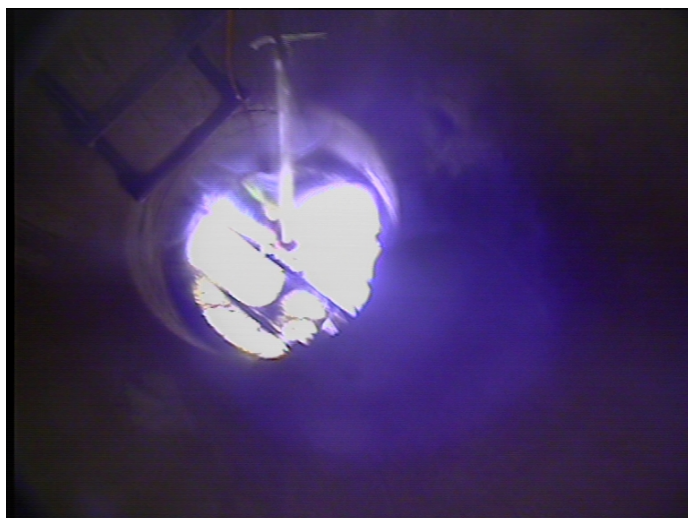
Code: **AMH**  
Description: **Manhole**

Distance (ft): **.0**  
Structural Grade: **0**  
O&M Grade: **0**  
Clock Start/From:  
Clock To:  
1st Value:  
2nd Value:  
Value Percent:  
Continuous Index:  
Within 8" of Joint: **NO**  
Remarks: **M-103-102**

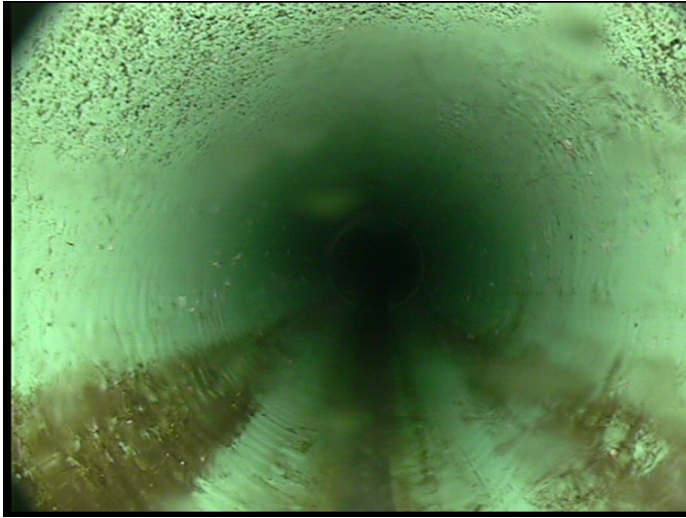
Code:	<b>MWL</b>
Description:	<b>Water Level</b>
Distance (ft):	<b>.0</b>
Structural Grade:	<b>0</b>
O&M Grade:	<b>0</b>
Clock Start/From:	
Clock To:	
1st Value:	
2nd Value:	
Value Percent:	<b>5.000</b>
Continuous Index:	
Within 8" of Joint:	<b>NO</b>
Remarks:

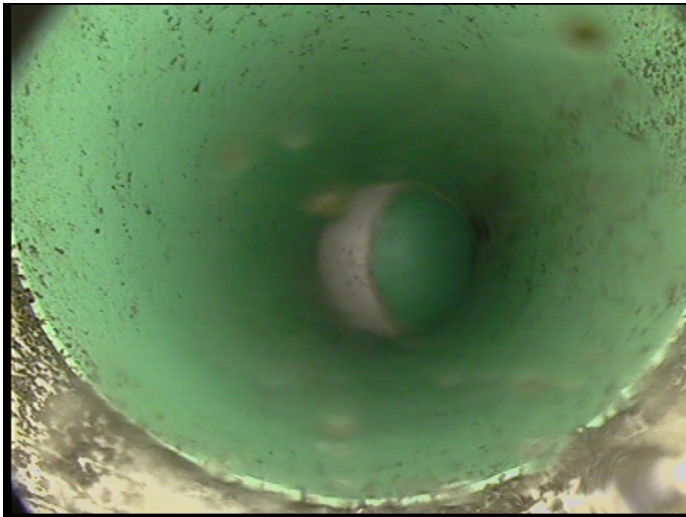
Code:	<b>TF</b>
Description:	<b>Tap Factory</b>
Distance (ft):	<b>25.8</b>
Structural Grade:	<b>0</b>
O&M Grade:	<b>0</b>
Clock Start/From:	<b>2</b>
Clock To:	
1st Value:	<b>4.000</b>
2nd Value:	
Value Percent:	
Continuous Index:	
Within 8" of Joint:	<b>NO</b>
Remarks:

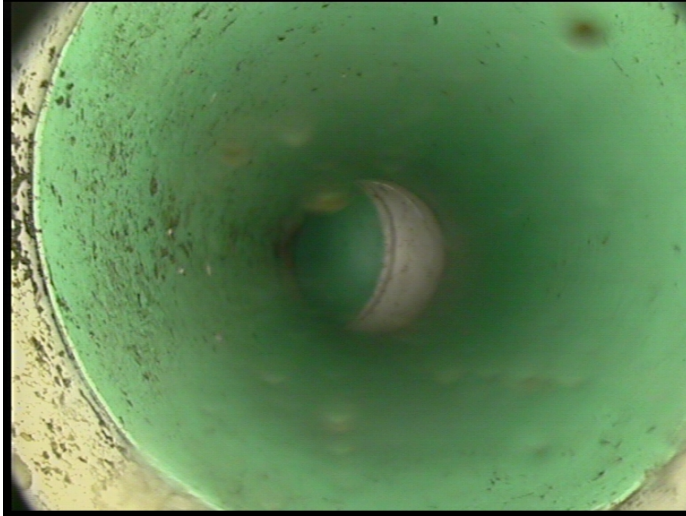
Code: **TF**  
Description: **Tap Factory**

Distance (ft): **43.8**  
Structural Grade: **0**  
O&M Grade: **0**  
Clock Start/From: **10**  
Clock To:  
1st Value: **4.000**  
2nd Value:  
Value Percent:  
Continuous Index:  
Within 8" of Joint: **NO**  
Remarks:

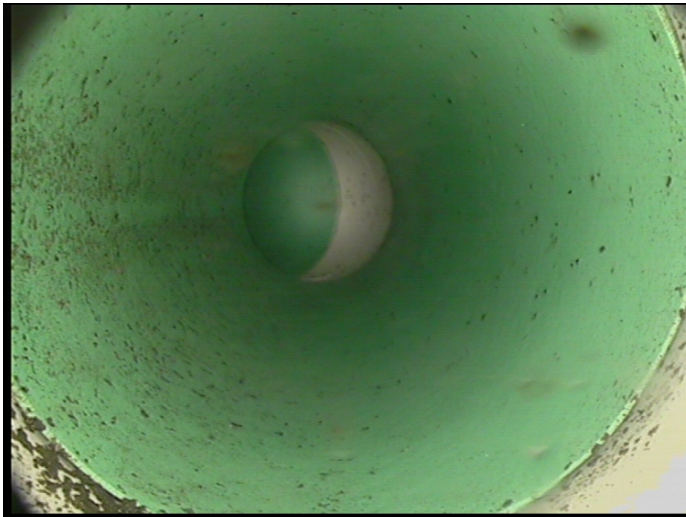
Code: **TF**  
Description: **Tap Factory**

Distance (ft): **101.1**  
Structural Grade: **0**  
O&M Grade: **0**  
Clock Start/From: **10**  
Clock To:  
1st Value: **4.000**  
2nd Value:  
Value Percent:  
Continuous Index:  
Within 8" of Joint: **NO**  
Remarks:

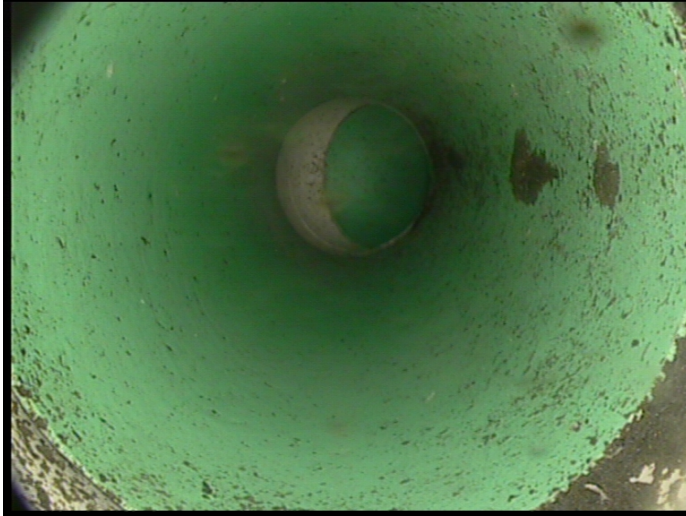
Code: **TF**  
Description: **Tap Factory**

Distance (ft): **114.1**  
Structural Grade: **0**  
O&M Grade: **0**  
Clock Start/From: **2**  
Clock To:  
1st Value: **4.000**  
2nd Value:  
Value Percent:  
Continuous Index:  
Within 8" of Joint: **NO**  
Remarks:

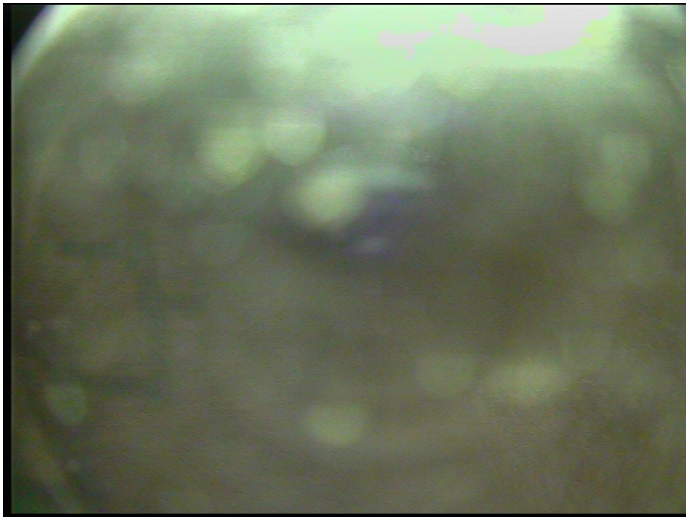
Code: **AMH**  
Description: **Manhole**

Distance (ft): **131.8**  
Structural Grade: **0**  
O&M Grade: **0**  
Clock Start/From:  
Clock To:  
1st Value:  
2nd Value:  
Value Percent:  
Continuous Index:  
Within 8" of Joint: **NO**  
Remarks: **M-103-103**
