## Profile/Photo Observation Report

Street:	<b>Maple Street</b>	Flow Control:	
City:	<b>Hobart, IN</b>	Year Renewed:	
Location:	<b>Light Highway</b>	Tape/Media #:	<b>823</b>
Purpose:	<b>Routine Assessment</b>	Dia/Height:	<b>8"</b>
Use:	<b>Sanitary</b>	Material:	<b>PVC</b>
Drain Area:		Lining:	
Category:	<b>NA</b>		
Comment:

Location Details:		Direction of Survey:	<b>Downstream</b>
US MH:	<b>M-103-105</b>	DS MH:	<b>M-103-103</b>
		Total Length Surveyed (ft):	<b>147.0</b>

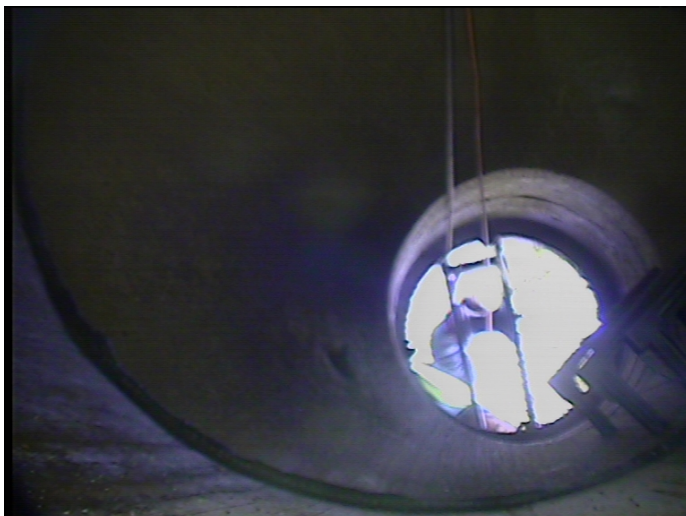
Code: **AMH**  
Description: **Manhole**

Distance (ft): **.0**  
Structural Grade: **0**  
O&M Grade: **0**  
Clock Start/From:  
Clock To:  
1st Value:  
2nd Value:  
Value Percent:  
Continuous Index:  
Within 8" of Joint: **NO**  
Remarks: **M-103-105**

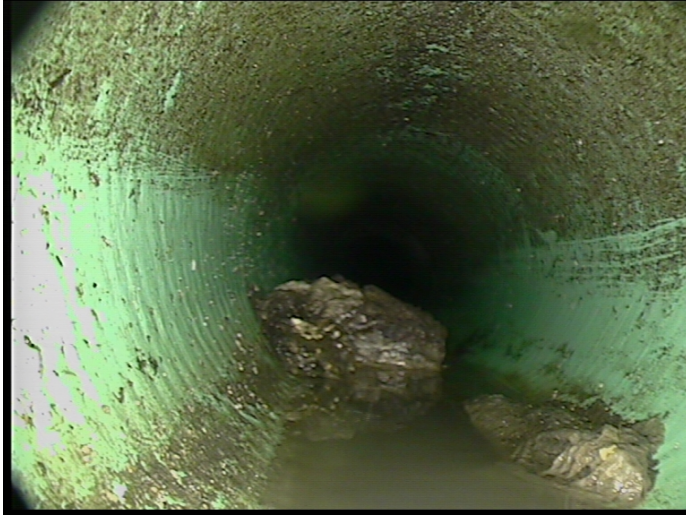
Code: **MWL**  
Description: **Water Level**

Distance (ft): **.0**  
Structural Grade: **0**  
O&M Grade: **0**  
Clock Start/From:  
Clock To:  
1st Value:  
2nd Value:  
Value Percent: **5.000**  
Continuous Index:  
Within 8" of Joint: **NO**  
Remarks:

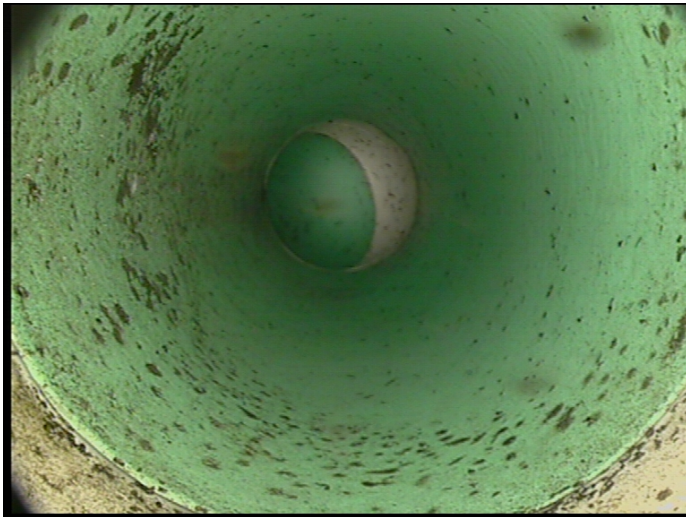
Code: **TF**  
Description: **Tap Factory**

Distance (ft): **25.5**  
Structural Grade: **0**  
O&M Grade: **0**  
Clock Start/From: **10**  
Clock To:  
1st Value: **4.000**  
2nd Value:  
Value Percent:  
Continuous Index:  
Within 8" of Joint: **NO**  
Remarks:

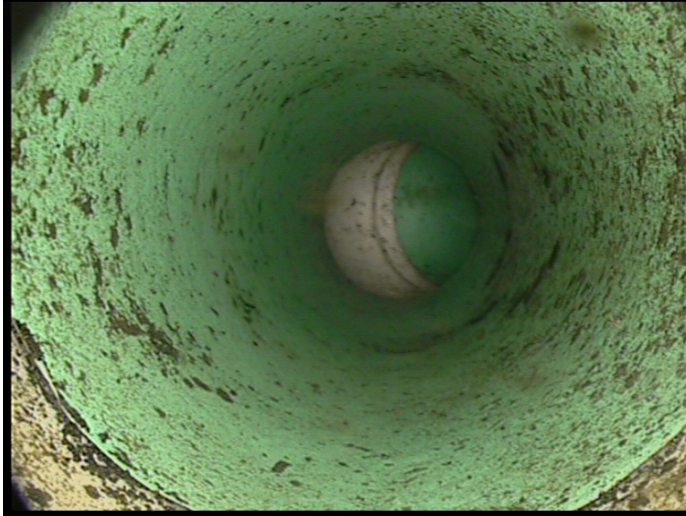
Code: **TF**  
Description: **Tap Factory**

Distance (ft): **76.6**  
Structural Grade: **0**  
O&M Grade: **0**  
Clock Start/From: **2**  
Clock To:  
1st Value: **4.000**  
2nd Value:  
Value Percent:  
Continuous Index:  
Within 8" of Joint: **NO**  
Remarks:

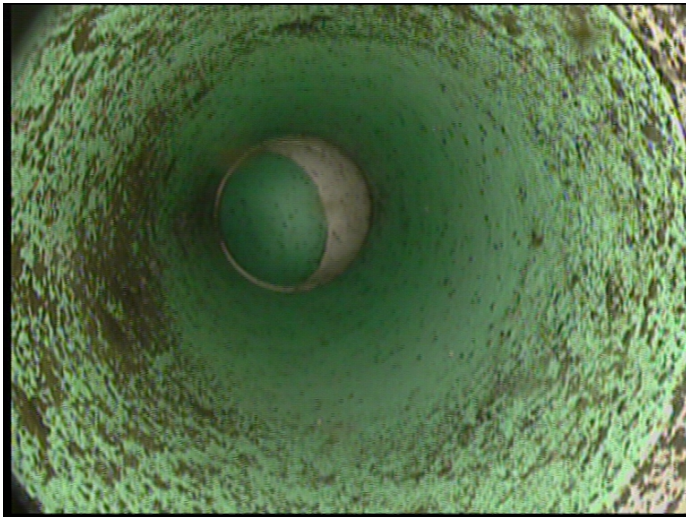
Code: **TF**  
Description: **Tap Factory**

Distance (ft): **94.7**  
Structural Grade: **0**  
O&M Grade: **0**  
Clock Start/From: **10**  
Clock To:  
1st Value: **4.000**  
2nd Value:  
Value Percent:  
Continuous Index:  
Within 8" of Joint: **NO**  
Remarks:

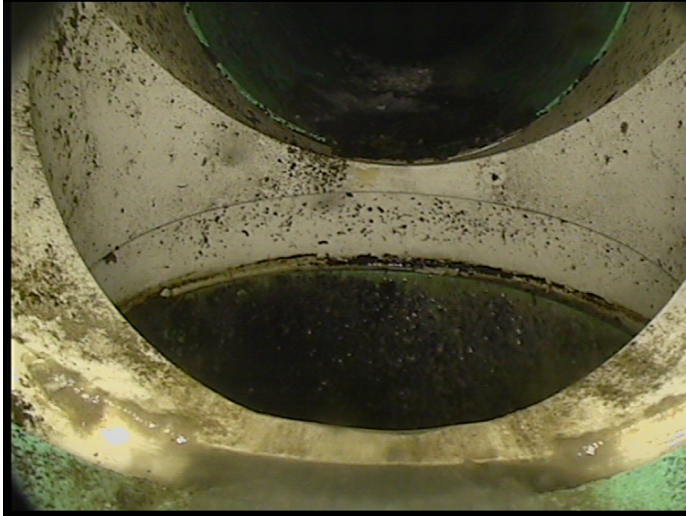
Code: **TFA**  
Description: **Tap Factory Active**

Distance (ft): **144.2**  
Structural Grade: **0**  
O&M Grade: **0**  
Clock Start/From: **6**  
Clock To:  
1st Value: **8.000**  
2nd Value:  
Value Percent:  
Continuous Index:  
Within 8" of Joint: **NO**  
Remarks: **Drop connection**

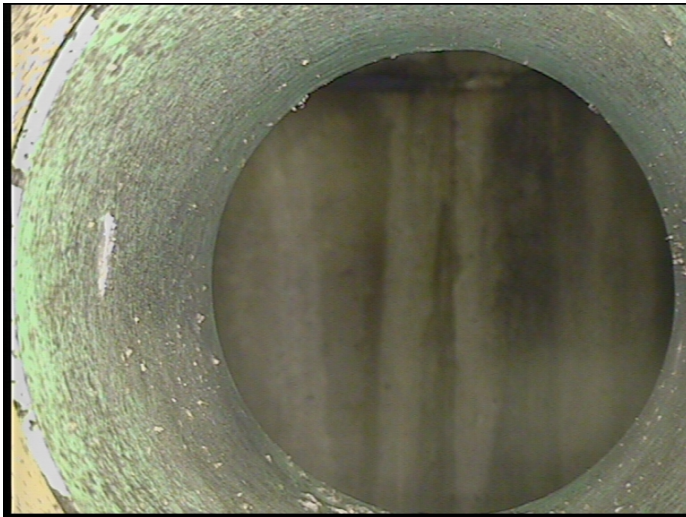
Code: **AMH**  
Description: **Manhole**

Distance (ft): **147.0**  
Structural Grade: **0**  
O&M Grade: **0**  
Clock Start/From:  
Clock To:  
1st Value:  
2nd Value:  
Value Percent:  
Continuous Index:  
Within 8" of Joint: **NO**  
Remarks: **M-103-103**
