Profile/Photo Observation Report

Street:	Alabama Street	Flow Control:	
City:	Hobart, IN	Year Renewed:	
Location:	Light Highway	Tape/Media #:	820
Purpose:	Routine Assessment	Dia/Height:	8"
Use:	Sanitary	Material:	PVC
Drain Area:		Lining:	
Category:	NA		
Comment:

Location Details:		Direction of Survey:	Downstream
US MH:	M-103-108	DS MH:	M-103-109
		Total Length Surveyed (ft):	298.3

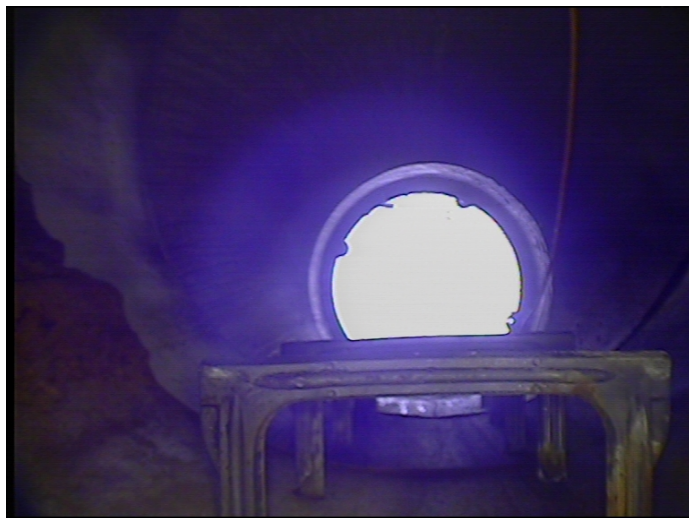
Code: **AMH**
 Description: **Manhole**

Distance (ft): **.0**
 Structural Grade: **0**
 O&M Grade: **0**
 Clock Start/From:
 Clock To:
 1st Value:
 2nd Value:
 Value Percent:
 Continuous Index:
 Within 8" of Joint: **NO**
 Remarks: **M-103-108**

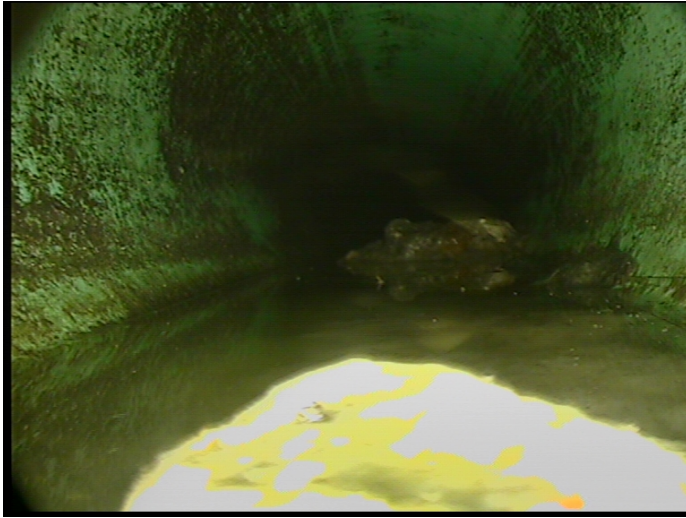
Code:	MWL
Description:	Water Level
Distance (ft):	.0
Structural Grade:	0
O&M Grade:	0
Clock Start/From:	
Clock To:	
1st Value:	
2nd Value:	
Value Percent:	5.000
Continuous Index:	
Within 8" of Joint:	NO
Remarks:

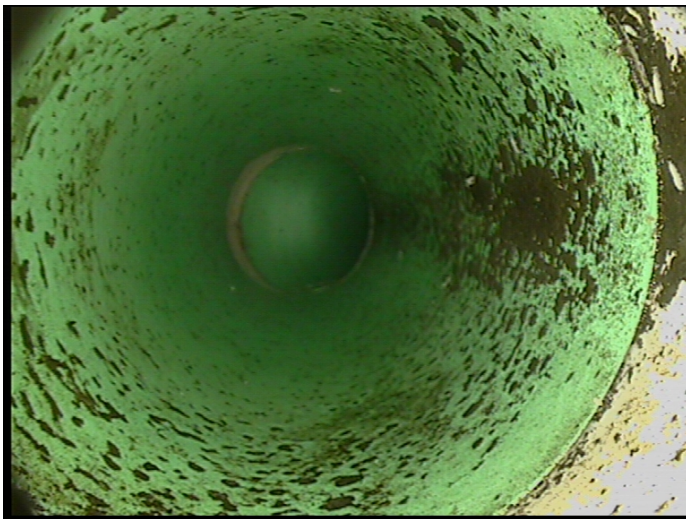
Code:	TF
Description:	Tap Factory
Distance (ft):	49.6
Structural Grade:	0
O&M Grade:	0
Clock Start/From:	2
Clock To:	
1st Value:	4.000
2nd Value:	
Value Percent:	
Continuous Index:	
Within 8" of Joint:	NO
Remarks:

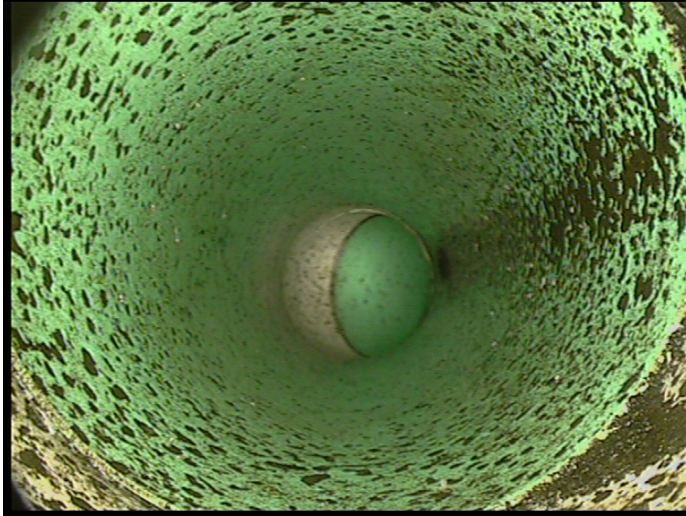
Code: **TF**
Description: **Tap Factory**

Distance (ft): **99.4**
Structural Grade: **0**
O&M Grade: **0**
Clock Start/From: **2**
Clock To:
1st Value: **4.000**
2nd Value:
Value Percent:
Continuous Index:
Within 8" of Joint: **NO**
Remarks:

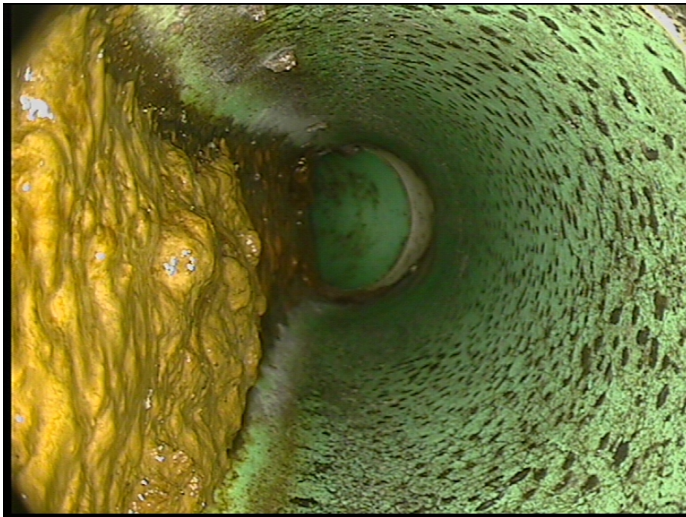
Code: **TF**
Description: **Tap Factory**

Distance (ft): **105.7**
Structural Grade: **0**
O&M Grade: **0**
Clock Start/From: **10**
Clock To:
1st Value: **4.000**
2nd Value:
Value Percent:
Continuous Index:
Within 8" of Joint: **NO**
Remarks:

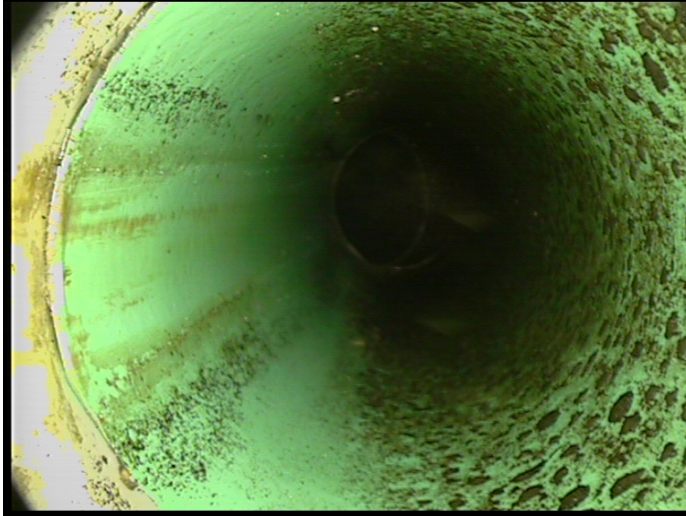
Code: **TF**
Description: **Tap Factory**

Distance (ft): **200.3**
Structural Grade: **0**
O&M Grade: **0**
Clock Start/From: **10**
Clock To:
1st Value: **4.000**
2nd Value:
Value Percent:
Continuous Index:
Within 8" of Joint: **NO**
Remarks:

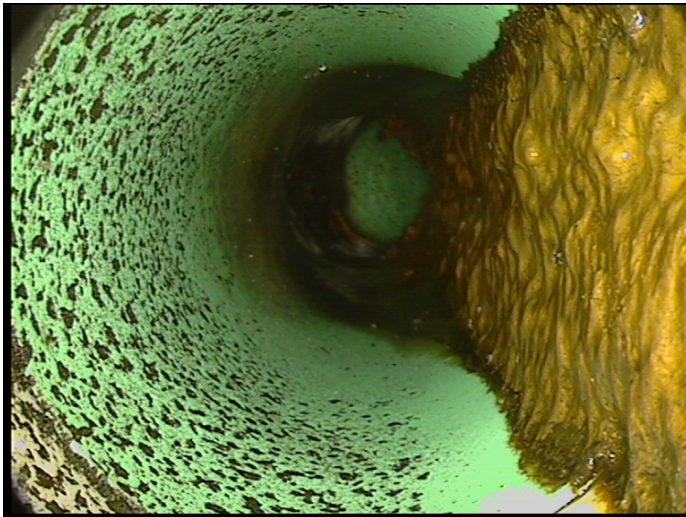
Code: **TF**
Description: **Tap Factory**

Distance (ft): **228.8**
Structural Grade: **0**
O&M Grade: **0**
Clock Start/From: **2**
Clock To:
1st Value: **4.000**
2nd Value:
Value Percent:
Continuous Index:
Within 8" of Joint: **NO**
Remarks:

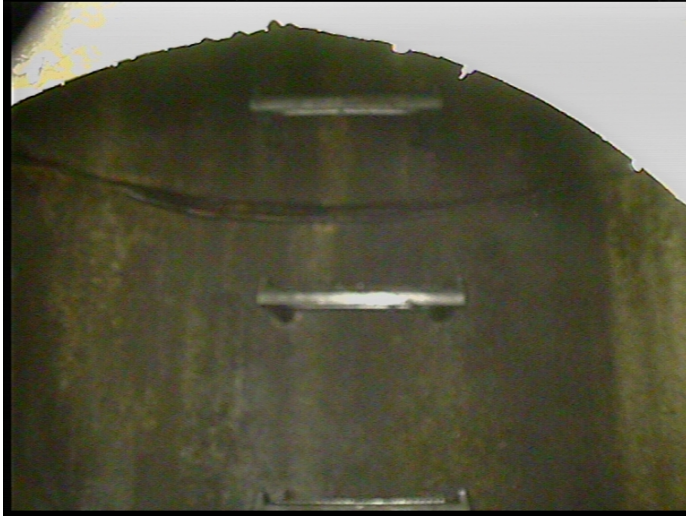
Code:	AMH
Description:	Manhole
Distance (ft):	298.3
Structural Grade:	0
O&M Grade:	0
Clock Start/From:	
Clock To:	
1st Value:	
2nd Value:	
Value Percent:	
Continuous Index:	
Within 8" of Joint:	NO
Remarks:	M-103-109
