## Profile/Photo Observation Report

Street:	<b>Alabama Street</b>	Flow Control:	
City:	<b>Hobart, IN</b>	Year Renewed:	
Location:	<b>Light Highway</b>	Tape/Media #:	<b>821</b>
Purpose:	<b>Routine Assessment</b>	Dia/Height:	<b>8"</b>
Use:	<b>Sanitary</b>	Material:	<b>PVC</b>
Drain Area:		Lining:	
Category:	<b>NA</b>		
Comment:

Location Details:		Direction of Survey:	<b>Upstream</b>
US MH:	<b>M-103-109</b>	DS MH:	<b>M-103-110</b>
		Total Length Surveyed (ft):	<b>303.6</b>

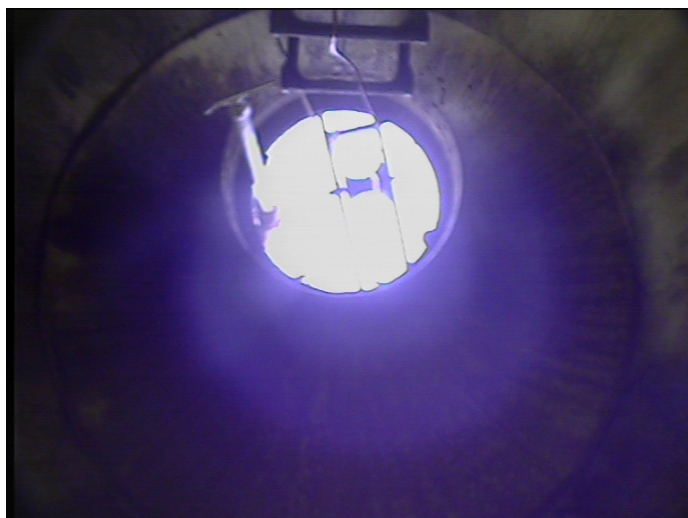
Code: **AMH**  
 Description: **Manhole**

Distance (ft): **.0**  
 Structural Grade: **0**  
 O&M Grade: **0**  
 Clock Start/From:  
 Clock To:  
 1st Value:  
 2nd Value:  
 Value Percent:  
 Continuous Index:  
 Within 8" of Joint: **NO**  
 Remarks: **M-103-110**

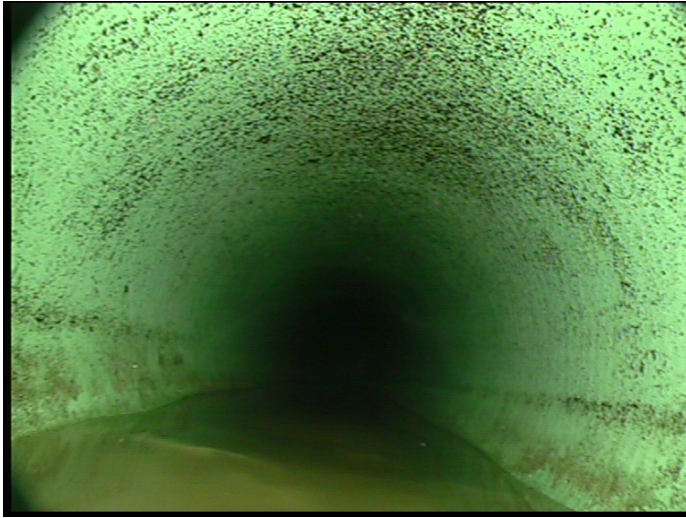
Code:	<b>MWL</b>
Description:	<b>Water Level</b>
Distance (ft):	<b>.0</b>
Structural Grade:	<b>0</b>
O&M Grade:	<b>0</b>
Clock Start/From:	
Clock To:	
1st Value:	
2nd Value:	
Value Percent:	<b>5.000</b>
Continuous Index:	
Within 8" of Joint:	<b>NO</b>
Remarks:

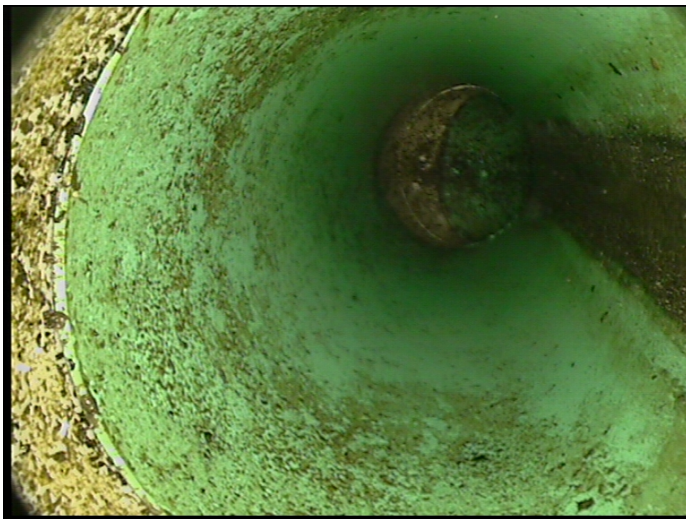
Code:	<b>TF</b>
Description:	<b>Tap Factory</b>
Distance (ft):	<b>13.5</b>
Structural Grade:	<b>0</b>
O&M Grade:	<b>0</b>
Clock Start/From:	<b>2</b>
Clock To:	
1st Value:	<b>4.000</b>
2nd Value:	
Value Percent:	
Continuous Index:	
Within 8" of Joint:	<b>NO</b>
Remarks:

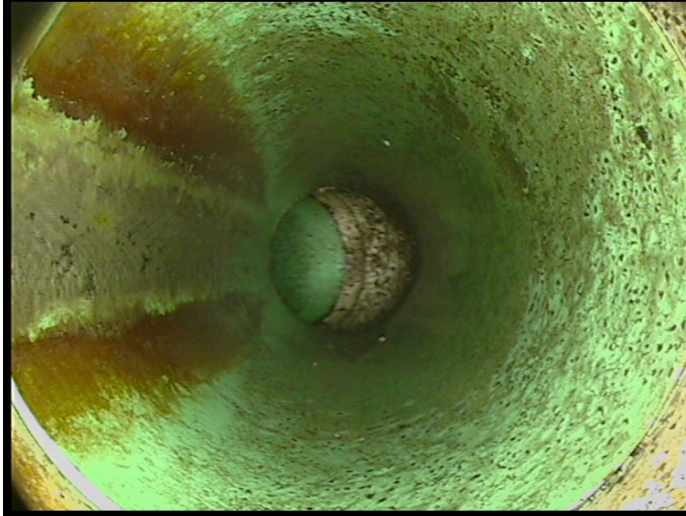
Code: **TF**  
Description: **Tap Factory**

Distance (ft): **38.6**  
Structural Grade: **0**  
O&M Grade: **0**  
Clock Start/From: **10**  
Clock To:  
1st Value: **4.000**  
2nd Value:  
Value Percent:  
Continuous Index:  
Within 8" of Joint: **NO**  
Remarks:

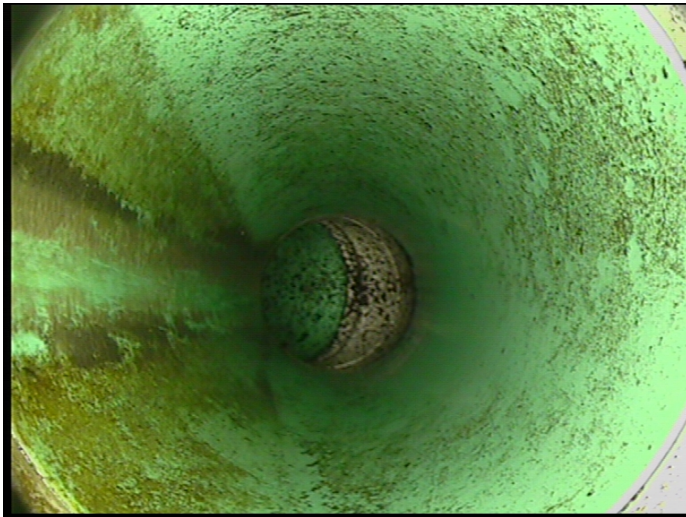
Code: **TF**  
Description: **Tap Factory**

Distance (ft): **83.1**  
Structural Grade: **0**  
O&M Grade: **0**  
Clock Start/From: **10**  
Clock To:  
1st Value: **4.000**  
2nd Value:  
Value Percent:  
Continuous Index:  
Within 8" of Joint: **NO**  
Remarks:

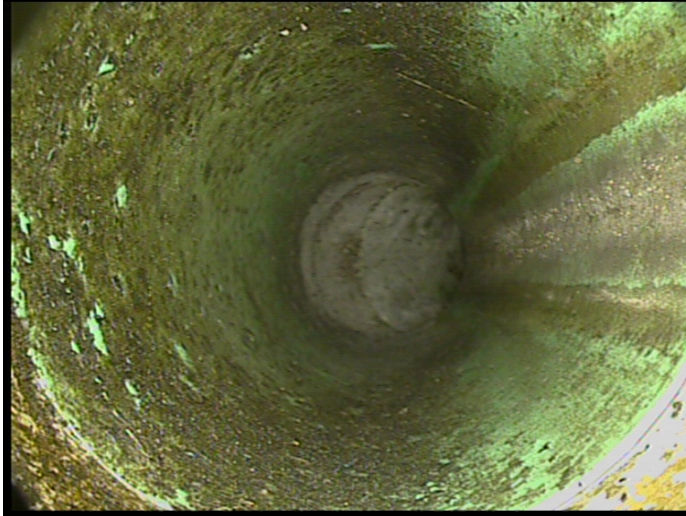
Code: **TF**  
Description: **Tap Factory**

Distance (ft): **95.6**  
Structural Grade: **0**  
O&M Grade: **0**  
Clock Start/From: **2**  
Clock To:  
1st Value: **4.000**  
2nd Value:  
Value Percent:  
Continuous Index:  
Within 8" of Joint: **NO**  
Remarks:

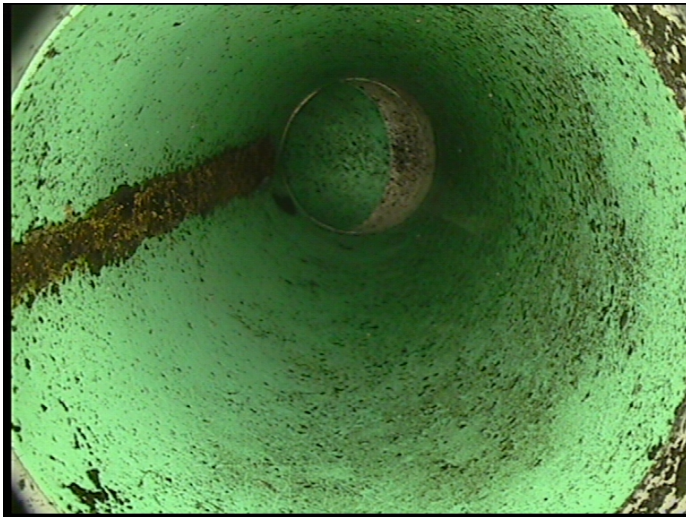
Code: **TF**  
Description: **Tap Factory**

Distance (ft): **149.3**  
Structural Grade: **0**  
O&M Grade: **0**  
Clock Start/From: **10**  
Clock To:  
1st Value: **4.000**  
2nd Value:  
Value Percent:  
Continuous Index:  
Within 8" of Joint: **NO**  
Remarks:

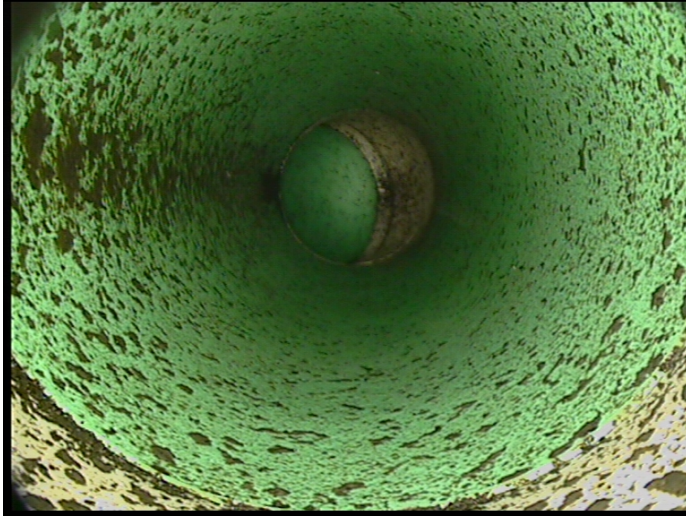
Code: **TF**  
Description: **Tap Factory**

Distance (ft): **200.0**  
Structural Grade: **0**  
O&M Grade: **0**  
Clock Start/From: **10**  
Clock To:  
1st Value: **4.000**  
2nd Value:  
Value Percent:  
Continuous Index:  
Within 8" of Joint: **NO**  
Remarks:

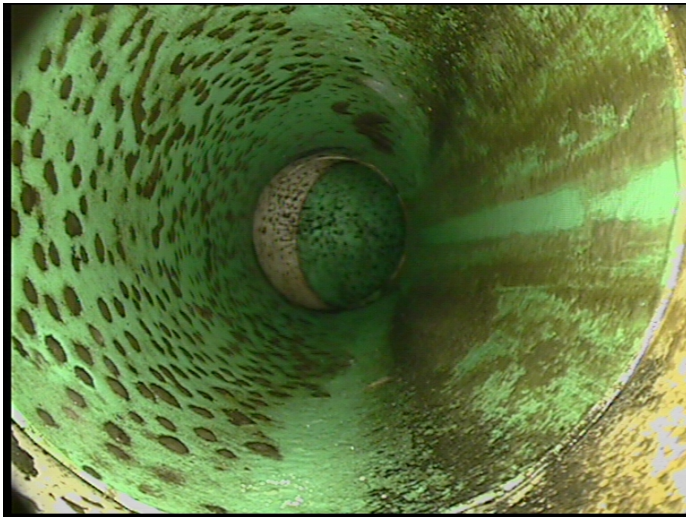
Code: **TF**  
Description: **Tap Factory**

Distance (ft): **252.4**  
Structural Grade: **0**  
O&M Grade: **0**  
Clock Start/From: **2**  
Clock To:  
1st Value: **4.000**  
2nd Value:  
Value Percent:  
Continuous Index:  
Within 8" of Joint: **NO**  
Remarks:

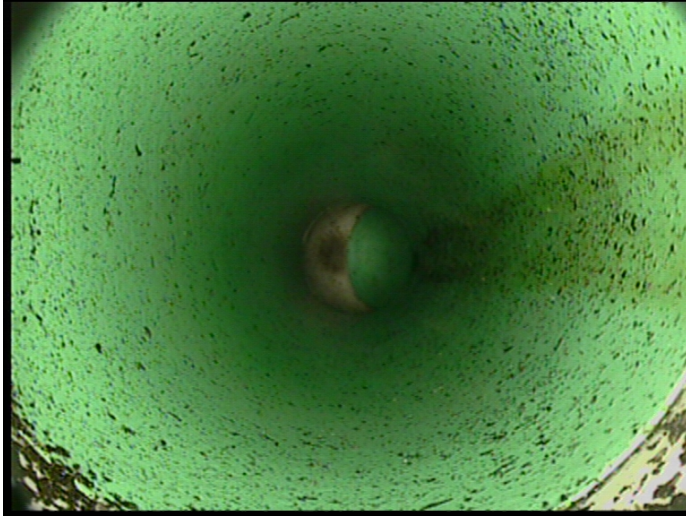
Code: **TF**  
Description: **Tap Factory**

Distance (ft): **282.9**  
Structural Grade: **0**  
O&M Grade: **0**  
Clock Start/From: **2**  
Clock To:  
1st Value: **4.000**  
2nd Value:  
Value Percent:  
Continuous Index:  
Within 8" of Joint: **NO**  
Remarks:

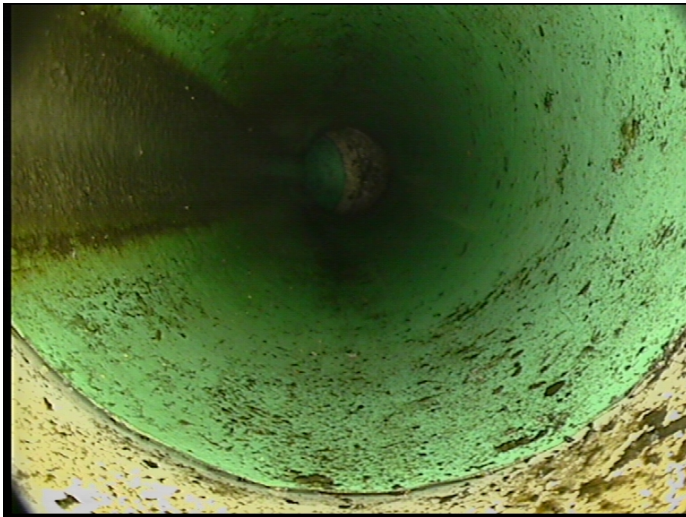
Code: **TF**  
Description: **Tap Factory**

Distance (ft): **301.1**  
Structural Grade: **0**  
O&M Grade: **0**  
Clock Start/From: **10**  
Clock To:  
1st Value: **4.000**  
2nd Value:  
Value Percent:  
Continuous Index:  
Within 8" of Joint: **NO**  
Remarks:

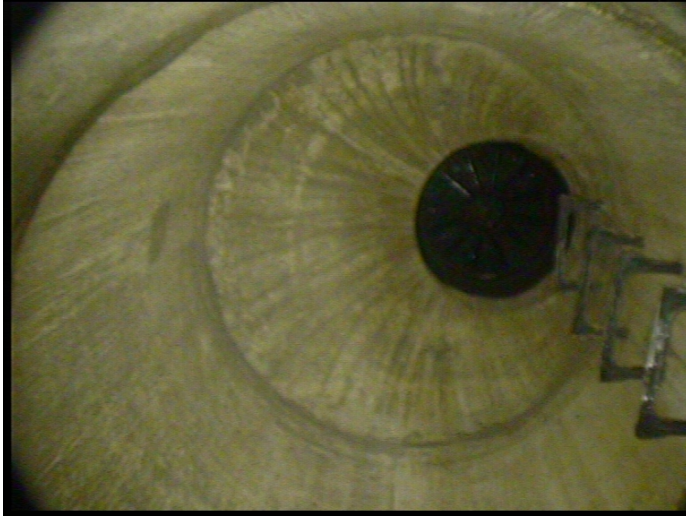
Code:	<b>AMH</b>
Description:	<b>Manhole</b>
Distance (ft):	<b>303.6</b>
Structural Grade:	<b>0</b>
O&M Grade:	<b>0</b>
Clock Start/From:	
Clock To:	
1st Value:	
2nd Value:	
Value Percent:	
Continuous Index:	
Within 8" of Joint:	<b>NO</b>
Remarks:	<b>M-103-109</b>
