Profile/Photo Observation Report

Street:	MAPLE ST	Flow Control:	Not Controlled
City:	Hobart, IN	Year Renewed:	
Location:	Other	Tape/Media #:	
Purpose:	Not Known	Dia/Height:	8"
Use:	Sanitary	Material:	PVC
Drain Area:	NA	Lining:	
Category:	NA		
Comment:

Location Details:		Direction of Survey:	Upstream
US MH:	M-103-115	DS MH:	M-103-105
		Total Length Surveyed (ft):	324.8

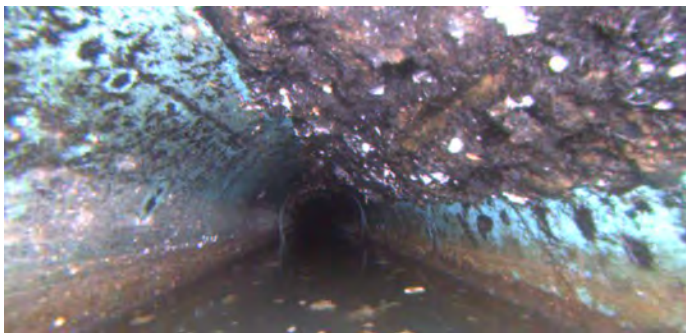
Code: **DAGS**
Description: **Deposits Attached Grease**

Distance (ft): **.0**
Structural Grade: **0**
O&M Grade: **2**
Clock Start/From: **8**
Clock To: **4**
1st Value:
2nd Value:
Value Percent: **10.000**
Continuous Index: **S01**
Within 8" of Joint: **NO**
Remarks:

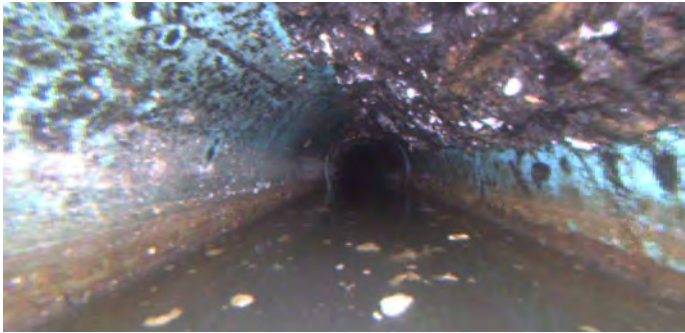
Code:	AMH
Description:	Manhole

Distance (ft):	.0
Structural Grade:	0
O&M Grade:	0
Clock Start/From:	
Clock To:	
1st Value:	
2nd Value:	
Value Percent:	
Continuous Index:	
Within 8" of Joint:	NO
Remarks:	M-103-105

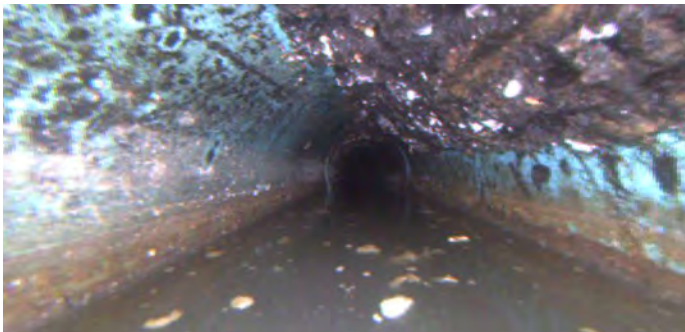
Code:	MWL
Description:	Water Level

Distance (ft):	.0
Structural Grade:	0
O&M Grade:	0
Clock Start/From:	
Clock To:	
1st Value:	
2nd Value:	
Value Percent:	5.000
Continuous Index:	
Within 8" of Joint:	NO
Remarks:

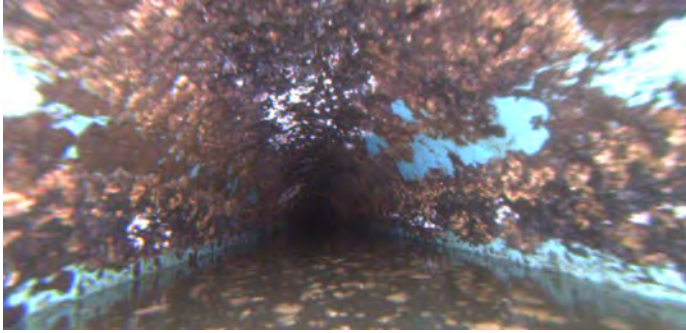
Code: **MWL**
Description: **Water Level**

Distance (ft): **65.8**
Structural Grade: **0**
O&M Grade: **0**
Clock Start/From:
Clock To:
1st Value:
2nd Value:
Value Percent: **40.000**
Continuous Index:
Within 8" of Joint: **NO**
Remarks:

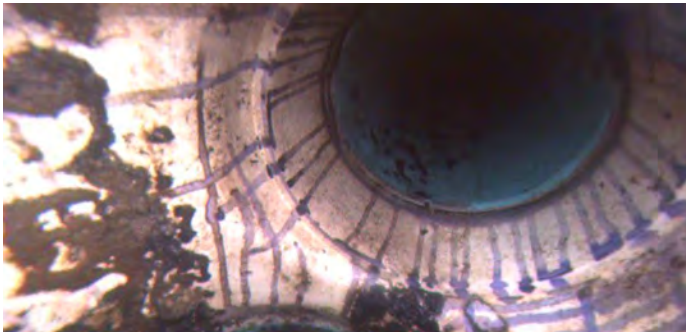
Code: **TF**
Description: **Tap Factory**

Distance (ft): **83.1**
Structural Grade: **0**
O&M Grade: **0**
Clock Start/From: **1**
Clock To:
1st Value: **4.000**
2nd Value:
Value Percent:
Continuous Index:
Within 8" of Joint:
Remarks:

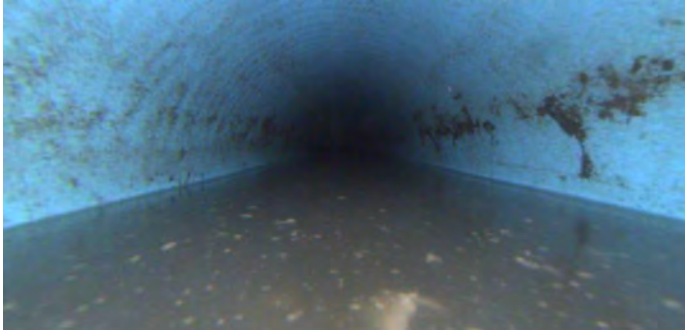
Code: **DAGS**
Description: **Deposits Attached Grease**

Distance (ft): **125.9**
Structural Grade: **0**
O&M Grade: **2**
Clock Start/From: **8**
Clock To: **4**
1st Value:
2nd Value:
Value Percent: **10.000**
Continuous Index: **F01**
Within 8" of Joint: **NO**
Remarks:

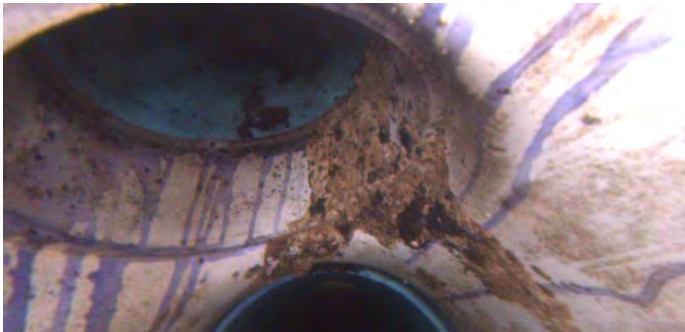
Code: **TF**
Description: **Tap Factory**

Distance (ft): **133.8**
Structural Grade: **0**
O&M Grade: **0**
Clock Start/From: **12**
Clock To:
1st Value: **4.000**
2nd Value:
Value Percent:
Continuous Index:
Within 8" of Joint:
Remarks:

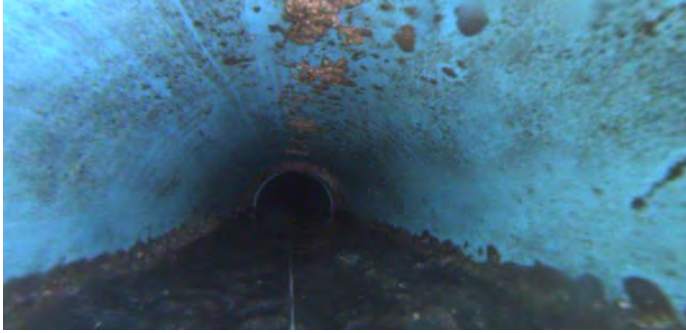
Code: **MGO**
Description: **General Observation**

Distance (ft): **136.3**
Structural Grade: **0**
O&M Grade: **0**
Clock Start/From:
Clock To:
1st Value:
2nd Value:
Value Percent:
Continuous Index:
Within 8" of Joint: **NO**
Remarks: **rear camera**

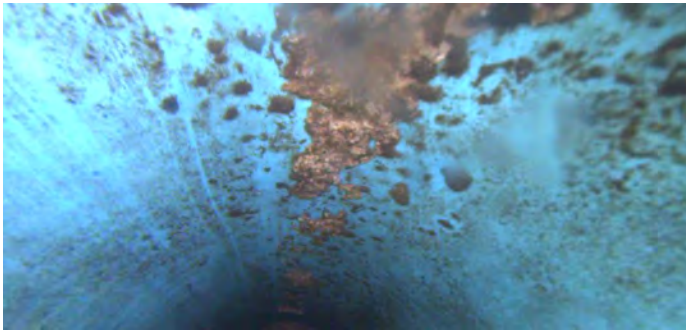
Code: **DAGS**
Description: **Deposits Attached Grease**

Distance (ft): **136.3**
Structural Grade: **0**
O&M Grade: **2**
Clock Start/From: **12**
Clock To:
1st Value:
2nd Value:
Value Percent: **5.000**
Continuous Index: **S02**
Within 8" of Joint: **NO**
Remarks:

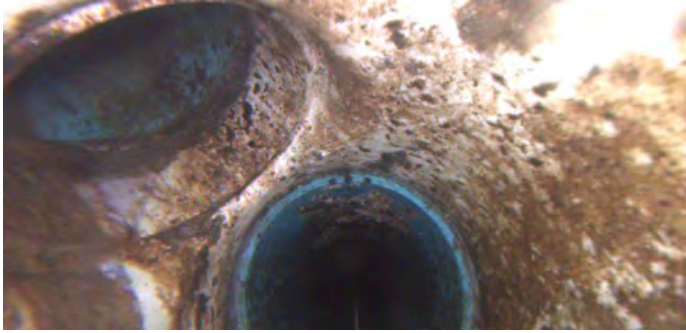
Code: **TF**
Description: **Tap Factory**

Distance (ft): **145.4**
Structural Grade: **0**
O&M Grade: **0**
Clock Start/From: **2**
Clock To:
1st Value: **4.000**
2nd Value:
Value Percent:
Continuous Index:
Within 8" of Joint:
Remarks:

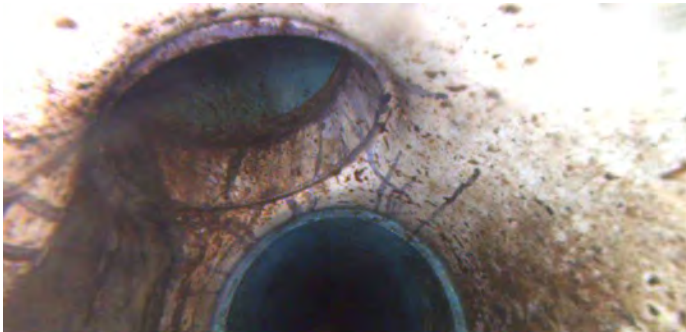
Code: **TF**
Description: **Tap Factory**

Distance (ft): **185.3**
Structural Grade: **0**
O&M Grade: **0**
Clock Start/From: **1**
Clock To:
1st Value: **4.000**
2nd Value:
Value Percent:
Continuous Index:
Within 8" of Joint:
Remarks:

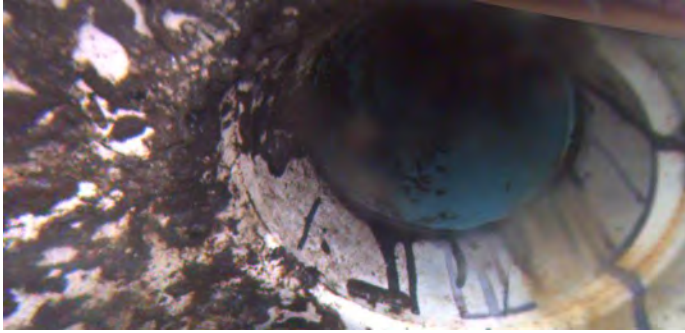
Code: **TF**
Description: **Tap Factory**

Distance (ft): **191.9**
Structural Grade: **0**
O&M Grade: **0**
Clock Start/From: **11**
Clock To:
1st Value: **4.000**
2nd Value:
Value Percent:
Continuous Index:
Within 8" of Joint:
Remarks:

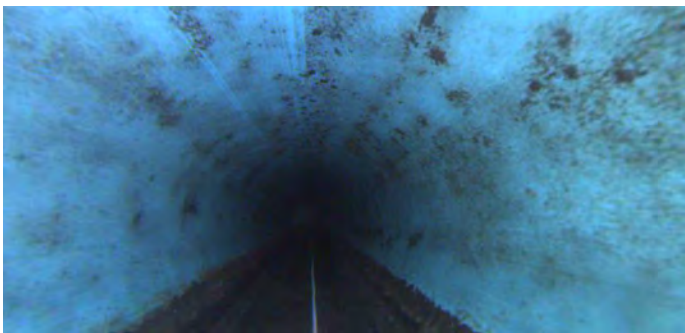
Code: **DAGS**
Description: **Deposits Attached Grease**

Distance (ft): **204.2**
Structural Grade: **0**
O&M Grade: **2**
Clock Start/From: **12**
Clock To:
1st Value:
2nd Value:
Value Percent: **5.000**
Continuous Index: **F02**
Within 8" of Joint: **NO**
Remarks:

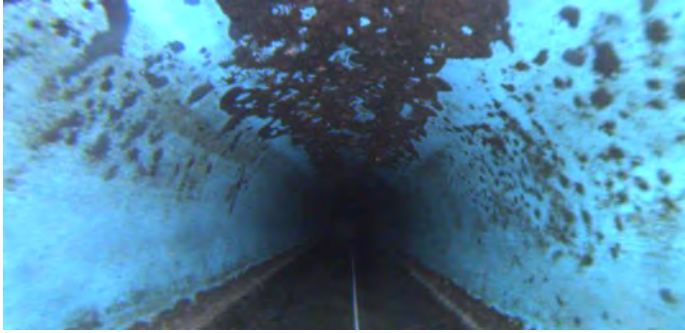
Code: **DAGS**
Description: **Deposits Attached Grease**

Distance (ft): **213.4**
Structural Grade: **0**
O&M Grade: **2**
Clock Start/From: **12**
Clock To:
1st Value:
2nd Value:
Value Percent: **5.000**
Continuous Index: **S03**
Within 8" of Joint: **NO**
Remarks:

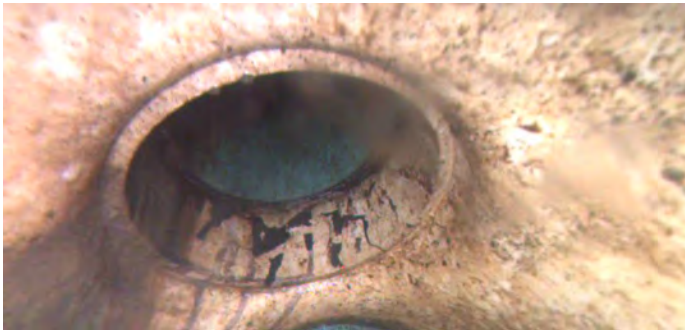
Code: **TF**
Description: **Tap Factory**

Distance (ft): **220.7**
Structural Grade: **0**
O&M Grade: **0**
Clock Start/From: **12**
Clock To:
1st Value: **4.000**
2nd Value:
Value Percent:
Continuous Index:
Within 8" of Joint:
Remarks:

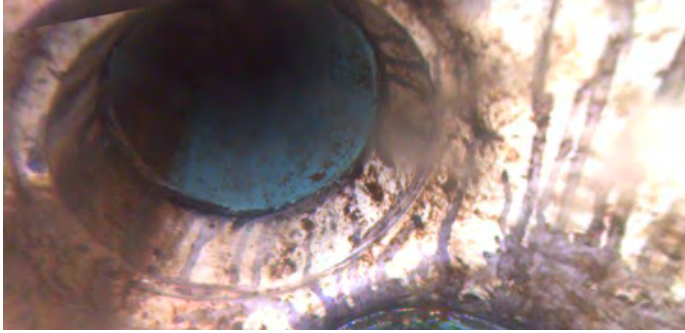
Code: **TF**
Description: **Tap Factory**

Distance (ft): **256.0**
Structural Grade: **0**
O&M Grade: **0**
Clock Start/From: **1**
Clock To:
1st Value: **4.000**
2nd Value:
Value Percent:
Continuous Index:
Within 8" of Joint:
Remarks:

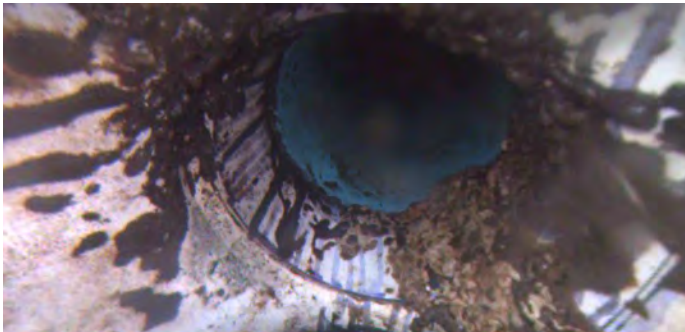
Code: **TF**
Description: **Tap Factory**

Distance (ft): **261.7**
Structural Grade: **0**
O&M Grade: **0**
Clock Start/From: **12**
Clock To:
1st Value: **4.000**
2nd Value:
Value Percent:
Continuous Index:
Within 8" of Joint:
Remarks:

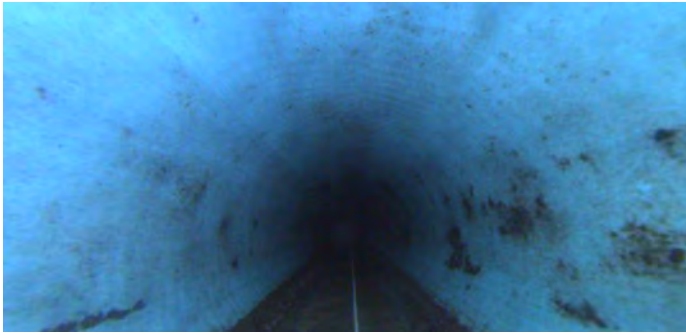
Code: **DAGS**
Description: **Deposits Attached Grease**

Distance (ft): **276.3**
Structural Grade: **0**
O&M Grade: **2**
Clock Start/From: **12**
Clock To:
1st Value:
2nd Value:
Value Percent: **5.000**
Continuous Index: **F03**
Within 8" of Joint: **NO**
Remarks:

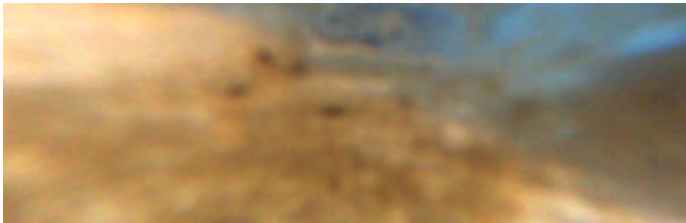
Code: **AMH**
Description: **Manhole**

Distance (ft): **324.8**
Structural Grade: **0**
O&M Grade: **0**
Clock Start/From:
Clock To:
1st Value:
2nd Value:
Value Percent:
Continuous Index:
Within 8" of Joint: **NO**
Remarks: **M-103-115**
