Profile/Photo Observation Report

Date:	03/22/2018	Weather:		Coding:	PACP 6.0
Pipe Length (ft):	306.1	Owner:	NA	Pre Clean:	Not Known
P.O.#:		Surveyor:	Selasie Honu	PSR:	P-103-115-105
Customer:		Clean Date:	01/01/1900	Shape:	C

Street:	E 38th Ave	Flow Control:	Not Controlled
City:	Hobart, IN	Year Renewed:	
Location:	Other	Tape/Media #:	
Purpose:	Not Known	Dia/Height:	8"
Use:	Sanitary	Material:	PVC
Drain Area:	NA	Lining:	
Category:	NA		
Comment:

Location Details:		Direction of Survey:	Upstream
US MH:	M-103-115	DS MH:	M-103-105
		Total Length Surveyed (ft):	324.8

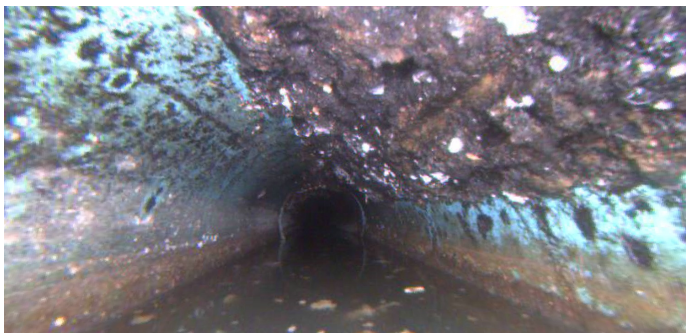
Code: **DAGS**
Description: **Deposits Attached Grease**

Distance (ft): **.0**
Structural Grade: **0**
O&M Grade: **2**
Clock Start/From: **8**
Clock To: **4**
1st Value:
2nd Value:
Value Percent: **10.000**
Continuous Index: **S01**
Within 8" of Joint: **NO**
Remarks:

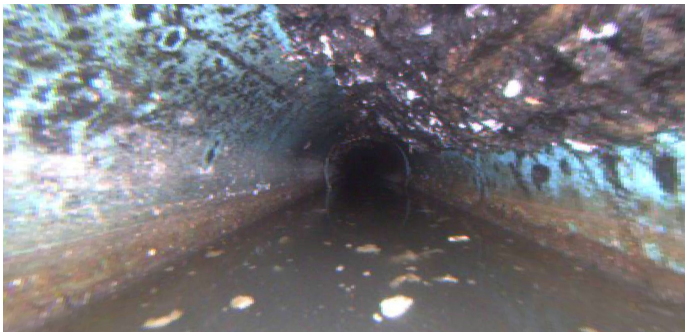
Code:	MWL
Description:	Water Level

Distance (ft):	.0
Structural Grade:	0
O&M Grade:	0
Clock Start/From:	
Clock To:	
1st Value:	
2nd Value:	
Value Percent:	5.000
Continuous Index:	
Within 8" of Joint:	NO
Remarks:

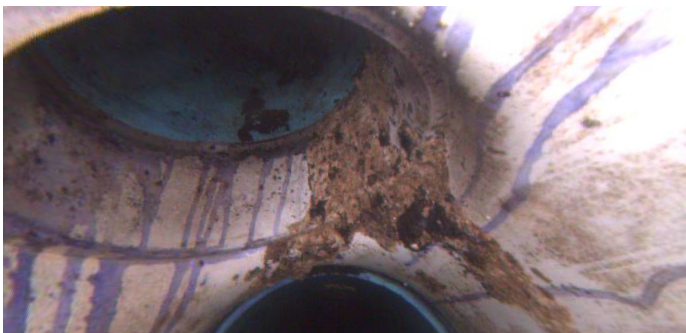
Code: **TF**
Description: **Tap Factory**

Distance (ft): **133.8**
Structural Grade: **0**
O&M Grade: **0**
Clock Start/From: **12**
Clock To:
1st Value: **4.000**
2nd Value:
Value Percent:
Continuous Index:
Within 8" of Joint:
Remarks:

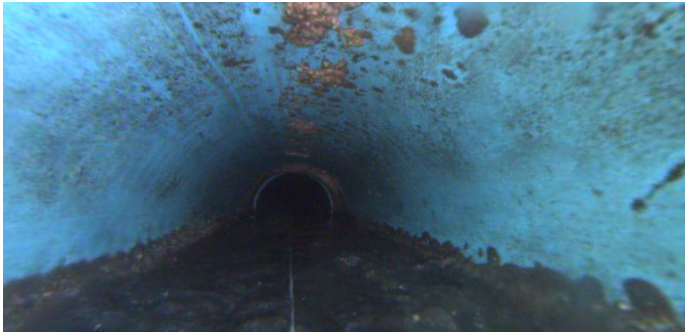
Code: **MGO**
Description: **General Observation**

Distance (ft): **136.3**
Structural Grade: **0**
O&M Grade: **0**
Clock Start/From:
Clock To:
1st Value:
2nd Value:
Value Percent:
Continuous Index:
Within 8" of Joint: **NO**
Remarks: **rear camera**

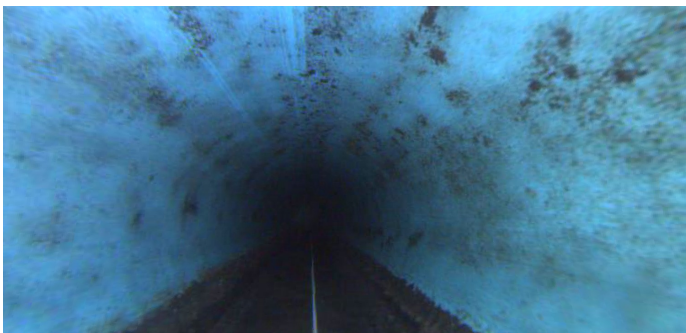
Code: **DAGS**
Description: **Deposits Attached Grease**

Distance (ft): **204.2**
Structural Grade: **0**
O&M Grade: **2**
Clock Start/From: **12**
Clock To:
1st Value:
2nd Value:
Value Percent: **5.000**
Continuous Index: **F02**
Within 8" of Joint: **NO**
Remarks:

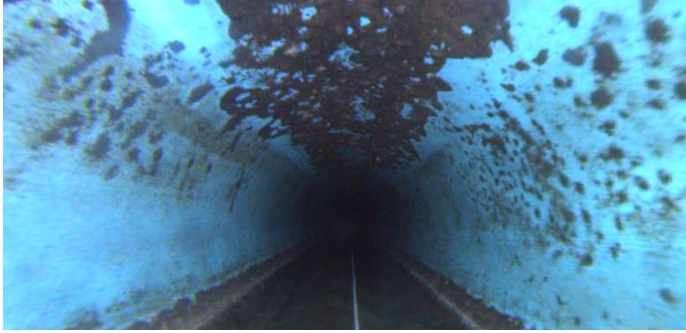
Code: **DAGS**
Description: **Deposits Attached Grease**

Distance (ft): **213.4**
Structural Grade: **0**
O&M Grade: **2**
Clock Start/From: **12**
Clock To:
1st Value:
2nd Value:
Value Percent: **5.000**
Continuous Index: **S03**
Within 8" of Joint: **NO**
Remarks:

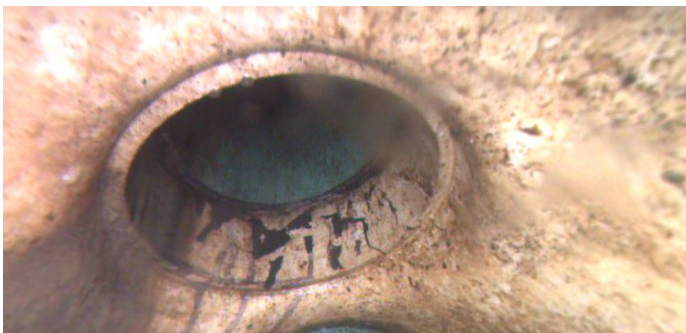
Code: **TF**
Description: **Tap Factory**

Distance (ft): **220.7**
Structural Grade: **0**
O&M Grade: **0**
Clock Start/From: **12**
Clock To:
1st Value: **4.000**
2nd Value:
Value Percent:
Continuous Index:
Within 8" of Joint:
Remarks:

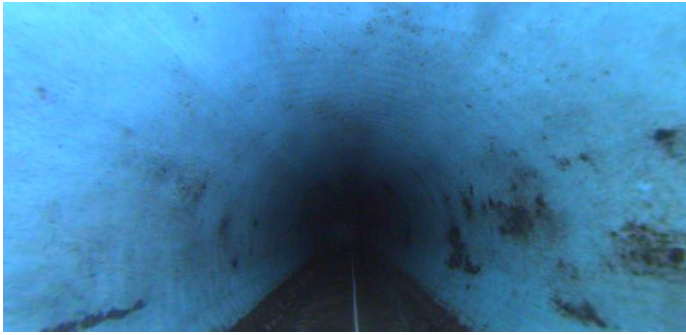
Code: **DAGS**
Description: **Deposits Attached Grease**

Distance (ft): **276.3**
Structural Grade: **0**
O&M Grade: **2**
Clock Start/From: **12**
Clock To:
1st Value:
2nd Value:
Value Percent: **5.000**
Continuous Index: **F03**
Within 8" of Joint: **NO**
Remarks:
