Profile/Photo Observation Report

Date:	03/22/2018	Weather:		Coding:	PACP 6.0
Pipe Length (ft):	365.2	Owner:	NA	Pre Clean:	Not Known
P.O.#:		Surveyor:	Selasie Honu	PSR:	P-103-116-115
Customer:		Clean Date:	01/01/1900	Shape:	C

Street:	MAPLE ST	Flow Control:	Not Controlled
City:	Hobart, IN	Year Renewed:	
Location:	Other	Tape/Media #:	
Purpose:	Not Known	Dia/Height:	8"
Use:	Sanitary	Material:	PVC
Drain Area:	NA	Lining:	
Category:	NA		
Comment:

Location Details:		Direction of Survey:	Downstream
US MH:	M-103-116	DS MH:	M-103-115
		Total Length Surveyed (ft):	319.7

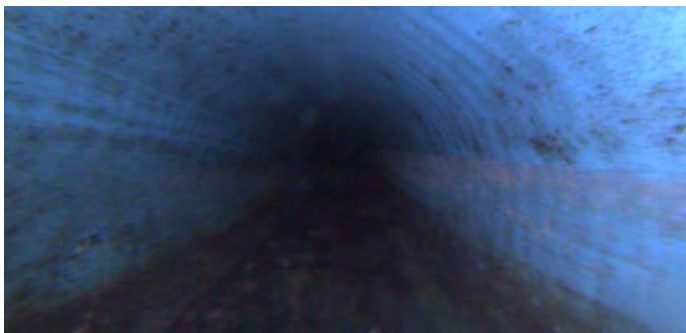
Code: **AMH**
Description: **Manhole**

Distance (ft): **.0**
Structural Grade: **0**
O&M Grade: **0**
Clock Start/From:
Clock To:
1st Value:
2nd Value:
Value Percent:
Continuous Index:
Within 8" of Joint: **NO**
Remarks: **M-103-116**

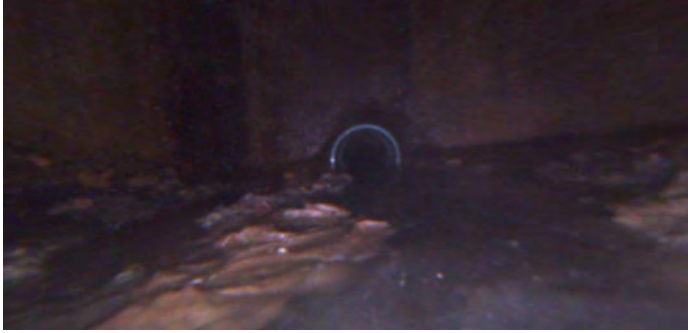
Code:	AMH
Description:	Manhole
Distance (ft):	319.7
Structural Grade:	0
O&M Grade:	0
Clock Start/From:	
Clock To:	
1st Value:	
2nd Value:	
Value Percent:	
Continuous Index:	
Within 8" of Joint:	NO
Remarks:	M-103-115
