Profile/Photo Observation Report

Street:	E 38th Ave	Flow Control:	Not Controlled
City:	Hobart, IN	Year Renewed:	
Location:	Other	Tape/Media #:	
Purpose:	Not Known	Dia/Height:	8"
Use:	Sanitary	Material:	PVC
Drain Area:	NA	Lining:	
Category:	NA		
Comment:

Location Details:		Direction of Survey:	Downstream
US MH:	M-103-116	DS MH:	M-103-115
		Total Length Surveyed (ft):	319.7

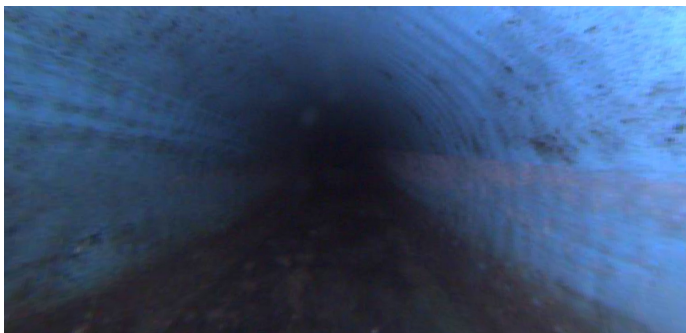
Code: **AMH**
Description: **Manhole**

Distance (ft): **.0**
Structural Grade: **0**
O&M Grade: **0**
Clock Start/From:
Clock To:
1st Value:
2nd Value:
Value Percent:
Continuous Index:
Within 8" of Joint: **NO**
Remarks: **M-103-116**

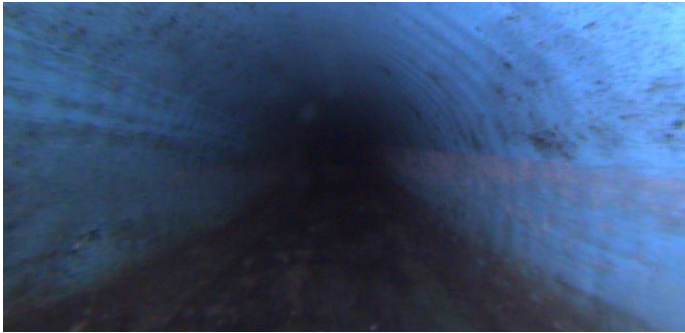
Code:	MWL
Description:	Water Level

Distance (ft):	.0
Structural Grade:	0
O&M Grade:	0
Clock Start/From:	
Clock To:	
1st Value:	
2nd Value:	
Value Percent:	5.000
Continuous Index:	
Within 8" of Joint:	NO
Remarks:

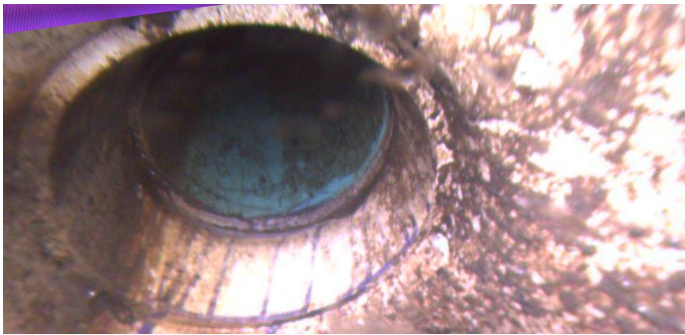
Code:	TF
Description:	Tap Factory

Distance (ft):	138.6
Structural Grade:	0
O&M Grade:	0
Clock Start/From:	12
Clock To:	
1st Value:	4.000
2nd Value:	
Value Percent:	
Continuous Index:	
Within 8" of Joint:	
Remarks:

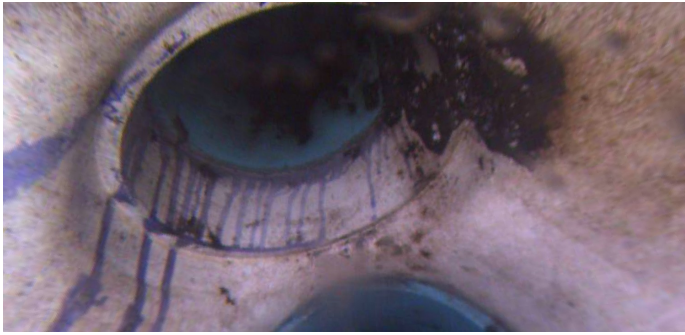
Code: **TF**
Description: **Tap Factory**

Distance (ft): **217.4**
Structural Grade: **0**
O&M Grade: **0**
Clock Start/From: **11**
Clock To:
1st Value: **4.000**
2nd Value:
Value Percent:
Continuous Index:
Within 8" of Joint:
Remarks:

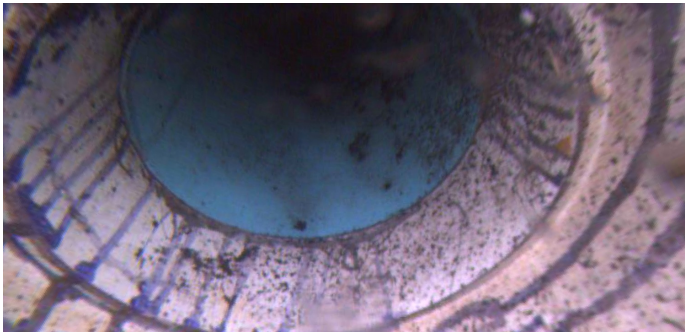
Code: **TF**
Description: **Tap Factory**

Distance (ft): **267.2**
Structural Grade: **0**
O&M Grade: **0**
Clock Start/From: **12**
Clock To:
1st Value: **4.000**
2nd Value:
Value Percent:
Continuous Index:
Within 8" of Joint:
Remarks:

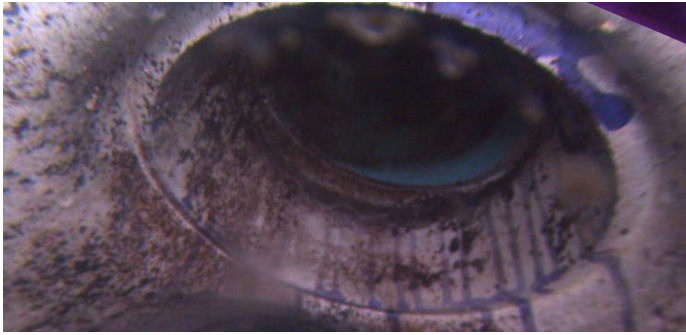
Code: **TF**
Description: **Tap Factory**

Distance (ft): **277.8**
Structural Grade: **0**
O&M Grade: **0**
Clock Start/From: **1**
Clock To:
1st Value: **4.000**
2nd Value:
Value Percent:
Continuous Index:
Within 8" of Joint:
Remarks:

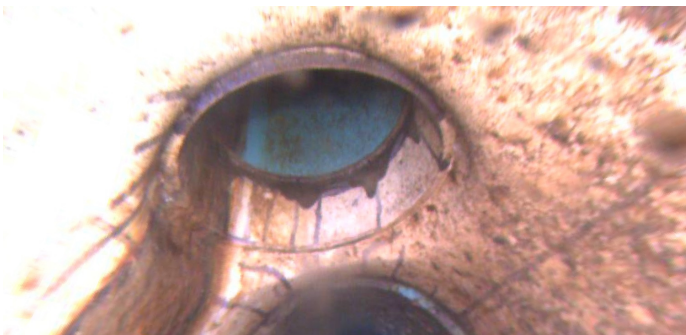
Code: **TF**
Description: **Tap Factory**

Distance (ft): **294.7**
Structural Grade: **0**
O&M Grade: **0**
Clock Start/From: **12**
Clock To:
1st Value: **4.000**
2nd Value:
Value Percent:
Continuous Index:
Within 8" of Joint:
Remarks:

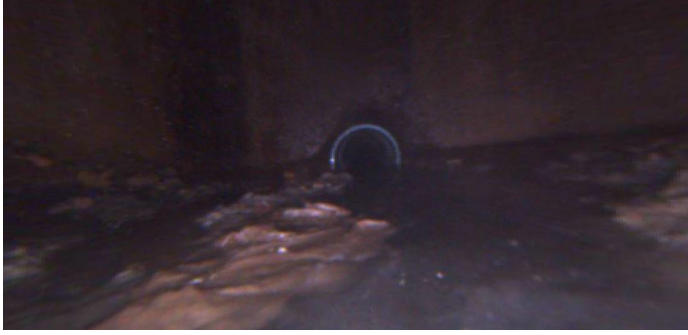
Code:	AMH
Description:	Manhole
Distance (ft):	319.7
Structural Grade:	0
O&M Grade:	0
Clock Start/From:	
Clock To:	
1st Value:	
2nd Value:	
Value Percent:	
Continuous Index:	
Within 8" of Joint:	NO
Remarks:	M-103-115
