Profile/Photo Observation Report

Street:	Maple Street	Flow Control:	
City:	Hobart, IN	Year Renewed:	
Location:	Light Highway	Tape/Media #:	801
Purpose:	Routine Assessment	Dia/Height:	8"
Use:	Sanitary	Material:	PVC
Drain Area:		Lining:	
Category:	NA		
Comment:

Location Details:		Direction of Survey:	Downstream
US MH:	M-103-116	DS MH:	M-103-117
		Total Length Surveyed (ft):	193.1

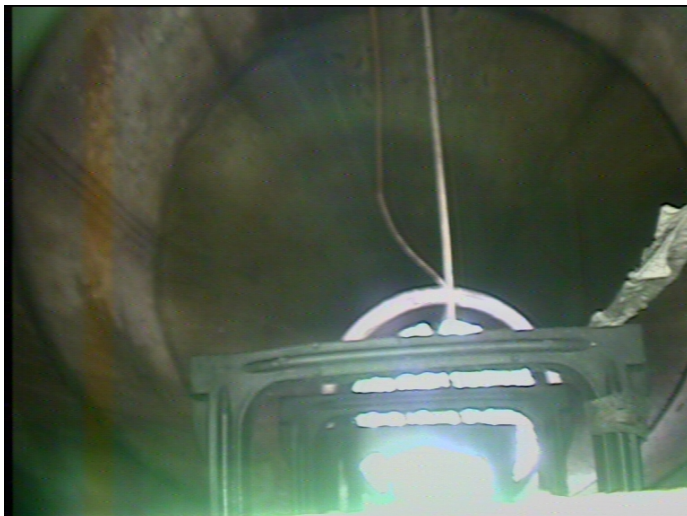
Code: **AMH**
 Description: **Manhole**

Distance (ft): **.0**
 Structural Grade: **0**
 O&M Grade: **0**
 Clock Start/From:
 Clock To:
 1st Value:
 2nd Value:
 Value Percent:
 Continuous Index:
 Within 8" of Joint: **NO**
 Remarks: **M-103-116**

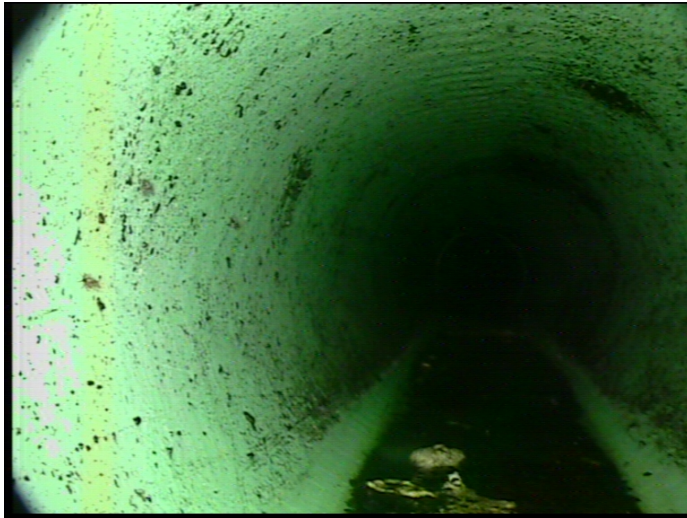
Code:	MWL
Description:	Water Level
Distance (ft):	.0
Structural Grade:	0
O&M Grade:	0
Clock Start/From:	
Clock To:	
1st Value:	
2nd Value:	
Value Percent:	5.000
Continuous Index:	
Within 8" of Joint:	NO
Remarks:

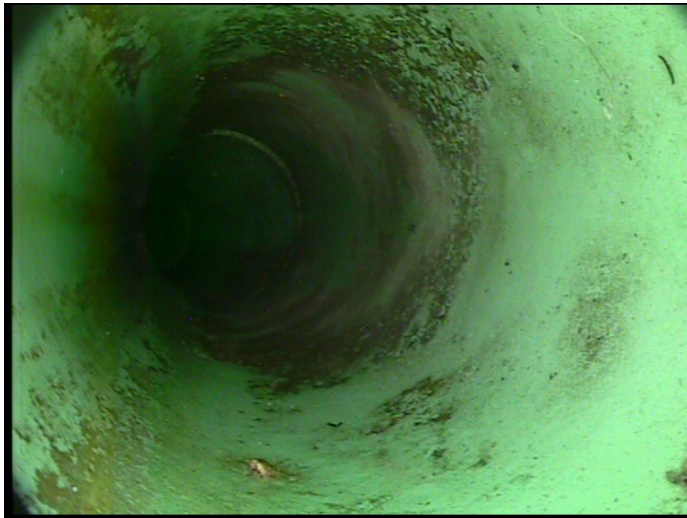
Code:	TF
Description:	Tap Factory
Distance (ft):	7.2
Structural Grade:	0
O&M Grade:	0
Clock Start/From:	10
Clock To:	
1st Value:	4.000
2nd Value:	
Value Percent:	
Continuous Index:	
Within 8" of Joint:	NO
Remarks:

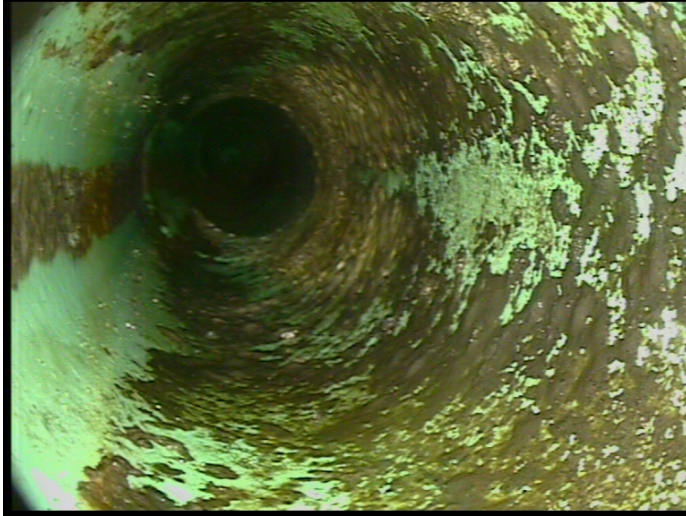
Code:	TF
Description:	Tap Factory
Distance (ft):	61.1
Structural Grade:	0
O&M Grade:	0
Clock Start/From:	9
Clock To:	
1st Value:	4.000
2nd Value:	
Value Percent:	
Continuous Index:	
Within 8" of Joint:	NO
Remarks:

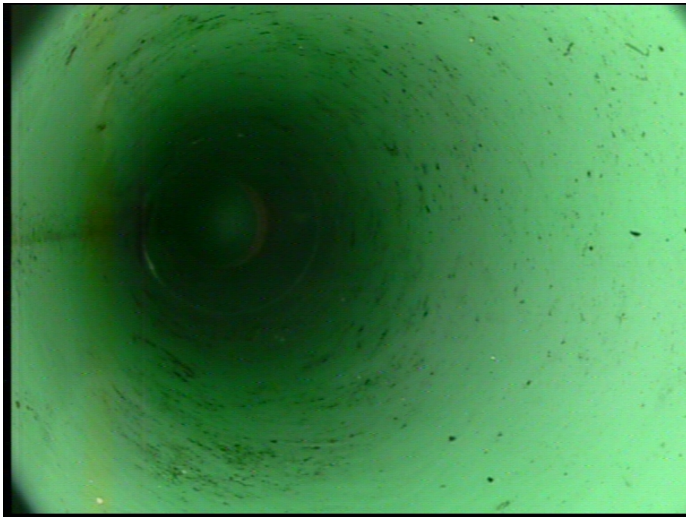
Code:	TF
Description:	Tap Factory
Distance (ft):	109.9
Structural Grade:	0
O&M Grade:	0
Clock Start/From:	9
Clock To:	
1st Value:	4.000
2nd Value:	
Value Percent:	
Continuous Index:	
Within 8" of Joint:	NO
Remarks:

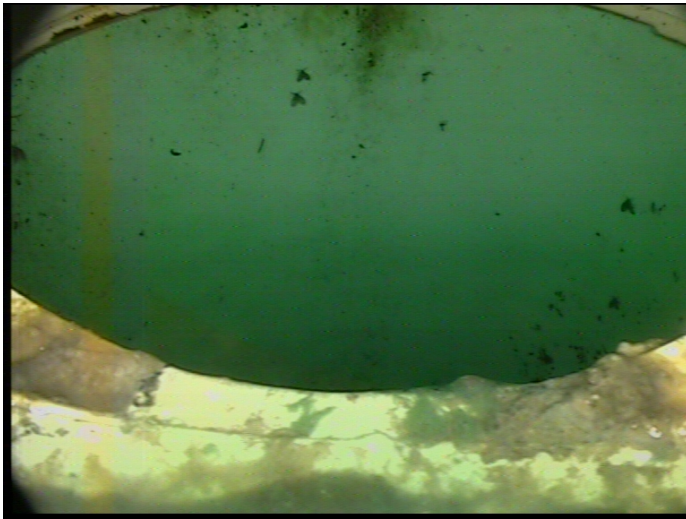
Code: **TFA**
Description: **Tap Factory Active**

Distance (ft): **193.1**
Structural Grade: **0**
O&M Grade: **0**
Clock Start/From: **6**
Clock To:
1st Value: **8.000**
2nd Value:
Value Percent:
Continuous Index:
Within 8" of Joint: **NO**
Remarks: **Drop connection**

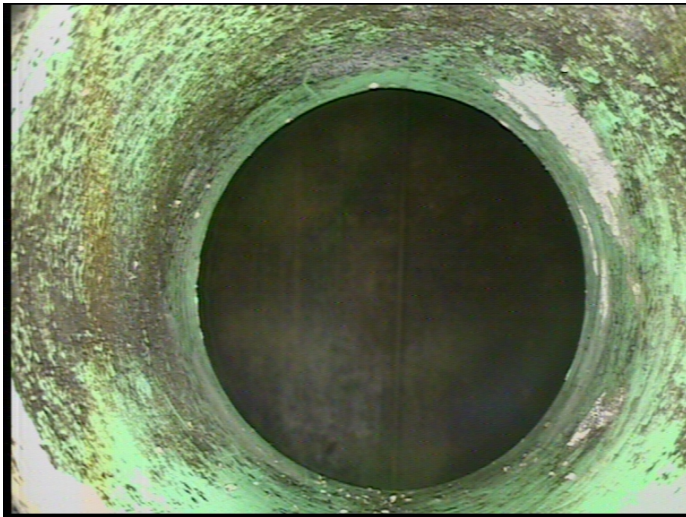
Code: **AMH**
Description: **Manhole**

Distance (ft): **193.1**
Structural Grade: **0**
O&M Grade: **0**
Clock Start/From:
Clock To:
1st Value:
2nd Value:
Value Percent:
Continuous Index:
Within 8" of Joint: **NO**
Remarks: **M-103-117**
