Profile/Photo Observation Report

Street:	E 38th Ave	Flow Control:	Not Controlled
City:	Hobart, IN	Year Renewed:	
Location:	Other	Tape/Media #:	
Purpose:	Not Known	Dia/Height:	8"
Use:	Sanitary	Material:	PVC
Drain Area:	NA	Lining:	
Category:	NA		
Comment:

Location Details:		Direction of Survey:	Upstream
US MH:	M-103-116	DS MH:	M-103-118
		Total Length Surveyed (ft):	285.3

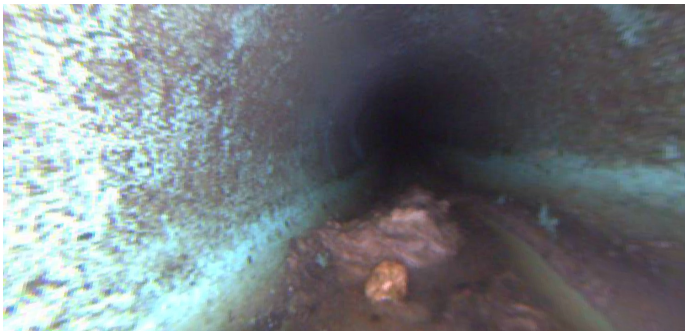
Code: **AMH**
Description: **Manhole**

Distance (ft): **.0**
Structural Grade: **0**
O&M Grade: **0**
Clock Start/From:
Clock To:
1st Value:
2nd Value:
Value Percent:
Continuous Index:
Within 8" of Joint: **NO**
Remarks: **M-103-118**

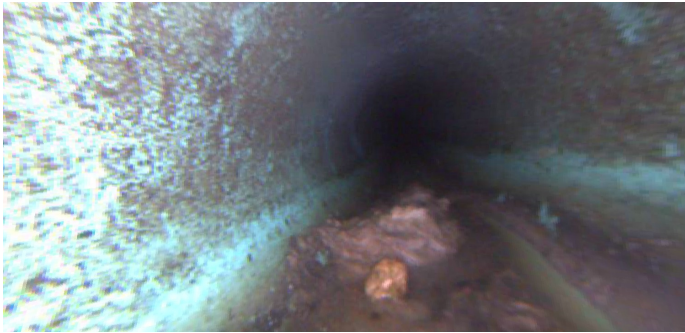
Code:	MWL
Description:	Water Level

Distance (ft):	.0
Structural Grade:	0
O&M Grade:	0
Clock Start/From:	
Clock To:	
1st Value:	
2nd Value:	
Value Percent:	5.000
Continuous Index:	
Within 8" of Joint:	NO
Remarks:

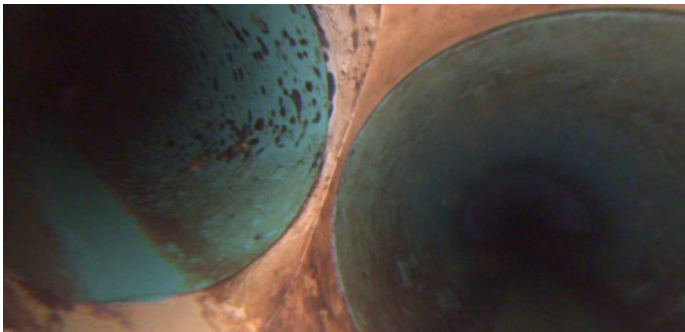
Code:	TF
Description:	Tap Factory

Distance (ft):	58.6
Structural Grade:	0
O&M Grade:	0
Clock Start/From:	9
Clock To:	
1st Value:	4.000
2nd Value:	
Value Percent:	
Continuous Index:	
Within 8" of Joint:	
Remarks:

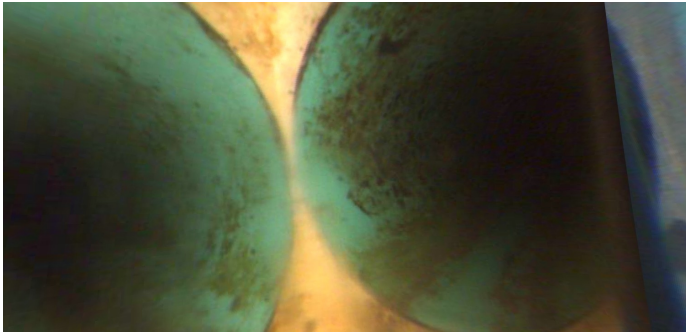
Code: **TF**
Description: **Tap Factory**

Distance (ft): **134.3**
Structural Grade: **0**
O&M Grade: **0**
Clock Start/From: **9**
Clock To:
1st Value: **4.000**
2nd Value:
Value Percent:
Continuous Index:
Within 8" of Joint:
Remarks:

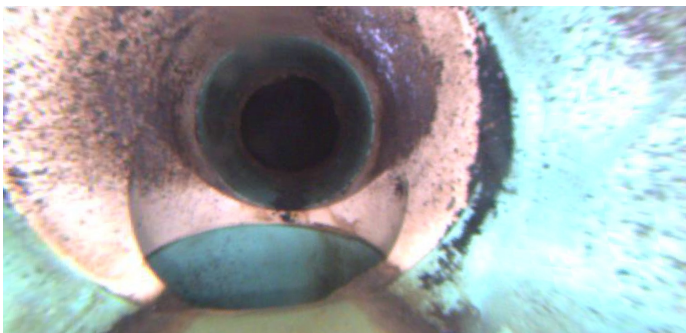
Code: **TF**
Description: **Tap Factory**

Distance (ft): **275.8**
Structural Grade: **0**
O&M Grade: **0**
Clock Start/From: **6**
Clock To:
1st Value: **6.000**
2nd Value:
Value Percent:
Continuous Index:
Within 8" of Joint:
Remarks: **drop connection**

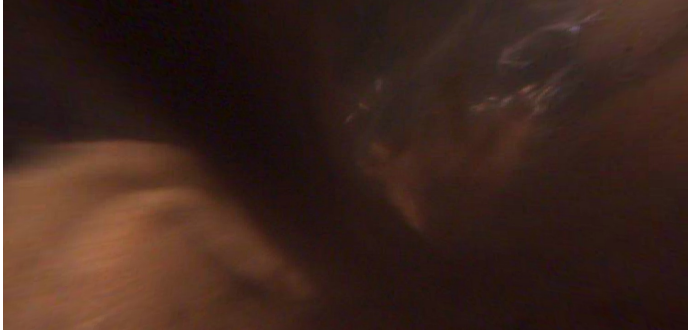
Code:	AMH
Description:	Manhole
Distance (ft):	285.3
Structural Grade:	0
O&M Grade:	0
Clock Start/From:	
Clock To:	
1st Value:	
2nd Value:	
Value Percent:	
Continuous Index:	
Within 8" of Joint:	NO
Remarks:	M-103-116
