## Profile/Photo Observation Report

Street:	<b>MISSOURI ST</b>	Flow Control:	<b>Not Controlled</b>
City:	<b>Hobart, IN</b>	Year Renewed:	
Location:	<b>Other</b>	Tape/Media #:	
Purpose:	<b>Not Known</b>	Dia/Height:	<b>8"</b>
Use:	<b>Sanitary</b>	Material:	<b>PVC</b>
Drain Area:	<b>NA</b>	Lining:	
Category:	<b>NA</b>		
Comment:

Location Details:		Direction of Survey:	<b>Upstream</b>
US MH:	<b>M-103-119</b>	DS MH:	<b>M-103-120</b>
		Total Length Surveyed (ft):	<b>180.7</b>

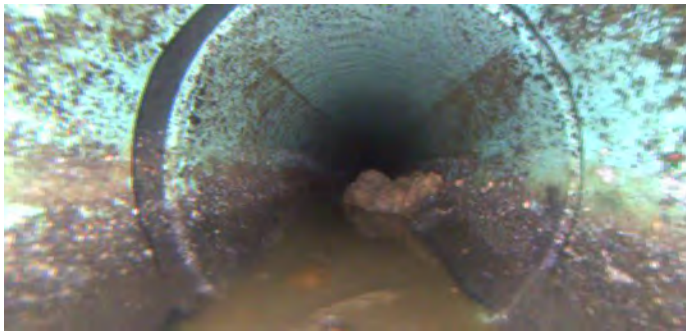
Code: **AMH**  
Description: **Manhole**

Distance (ft): **.0**  
Structural Grade: **0**  
O&M Grade: **0**  
Clock Start/From:  
Clock To:  
1st Value:  
2nd Value:  
Value Percent:  
Continuous Index:  
Within 8" of Joint: **NO**  
Remarks: **M-103-120**

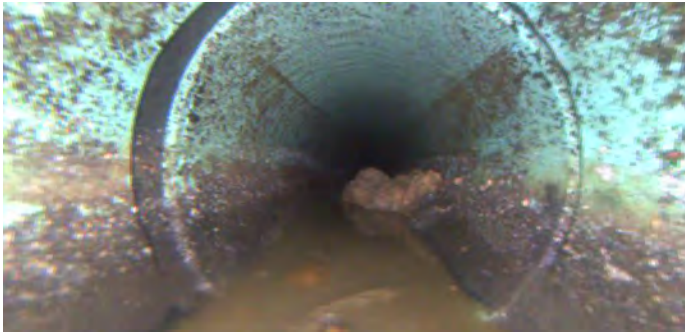
Code:	<b>MWL</b>
Description:	<b>Water Level</b>

Distance (ft):	<b>.0</b>
Structural Grade:	<b>0</b>
O&M Grade:	<b>0</b>
Clock Start/From:	
Clock To:	
1st Value:	
2nd Value:	
Value Percent:	<b>5.000</b>
Continuous Index:	
Within 8" of Joint:	<b>NO</b>
Remarks:

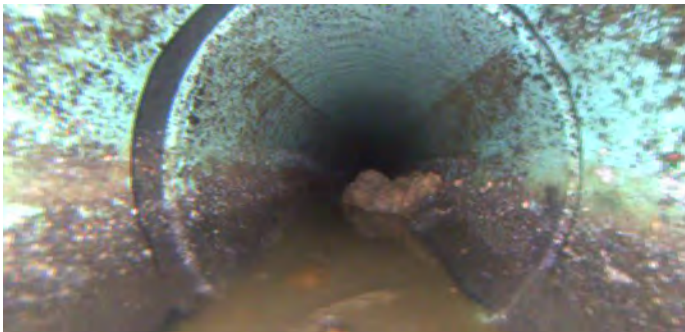
Code:	<b>DAZ</b>
Description:	<b>Deposits Attached Other</b>

Distance (ft):	<b>.0</b>
Structural Grade:	<b>0</b>
O&M Grade:	<b>2</b>
Clock Start/From:	<b>7</b>
Clock To:	<b>5</b>
1st Value:	
2nd Value:	
Value Percent:	<b>5.000</b>
Continuous Index:	<b>S01</b>
Within 8" of Joint:	<b>YES</b>
Remarks:	<b>WANDER</b>

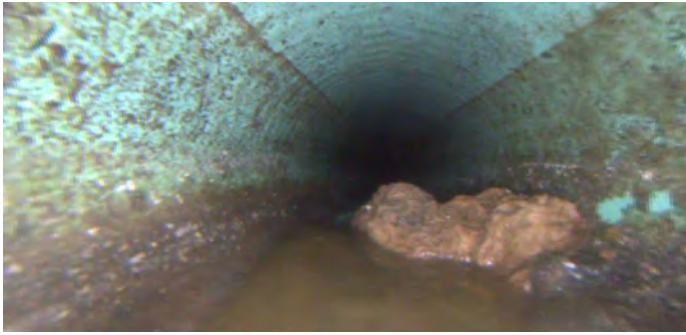
Code: **DSC**  
Description: **Deposits Settled Compacted**

Distance (ft): **1.6**  
Structural Grade: **0**  
O&M Grade: **2**  
Clock Start/From: **5**  
Clock To: **6**  
1st Value:  
2nd Value:  
Value Percent: **5.000**  
Continuous Index:  
Within 8" of Joint: **NO**  
Remarks:

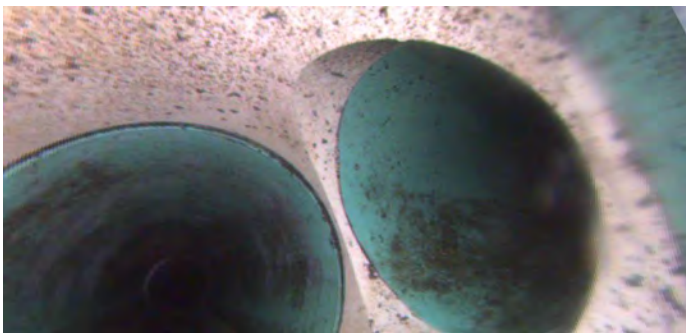
Code: **TF**  
Description: **Tap Factory**

Distance (ft): **9.0**  
Structural Grade: **0**  
O&M Grade: **0**  
Clock Start/From: **2**  
Clock To:  
1st Value: **4.000**  
2nd Value:  
Value Percent:  
Continuous Index:  
Within 8" of Joint:  
Remarks:

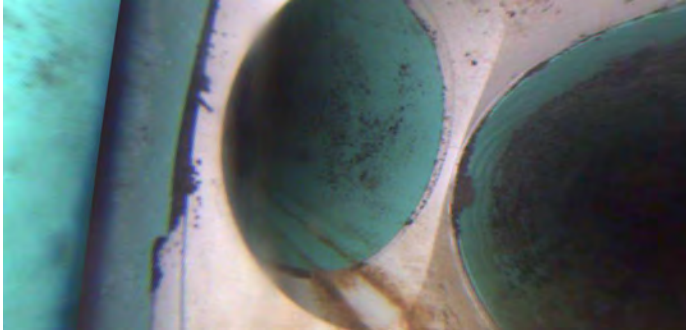
Code: **TF**  
Description: **Tap Factory**

Distance (ft): **12.7**  
Structural Grade: **0**  
O&M Grade: **0**  
Clock Start/From: **10**  
Clock To:  
1st Value: **4.000**  
2nd Value:  
Value Percent:  
Continuous Index:  
Within 8" of Joint:  
Remarks:

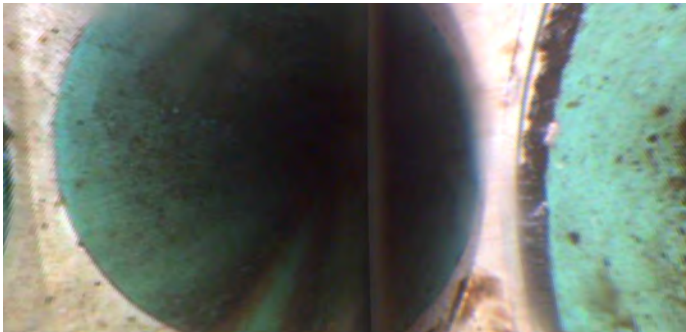
Code: **TF**  
Description: **Tap Factory**

Distance (ft): **31.9**  
Structural Grade: **0**  
O&M Grade: **0**  
Clock Start/From: **10**  
Clock To:  
1st Value: **4.000**  
2nd Value:  
Value Percent:  
Continuous Index:  
Within 8" of Joint:  
Remarks:

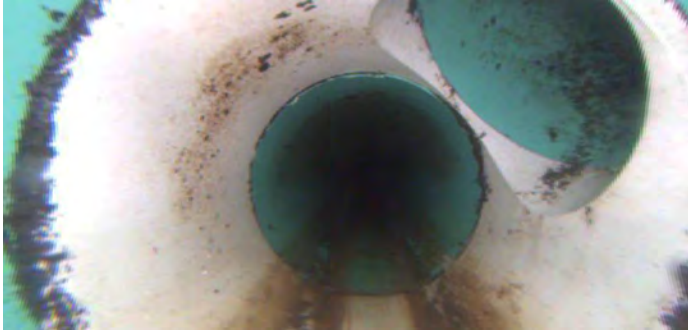
Code: **TF**  
Description: **Tap Factory**

Distance (ft): **112.6**  
Structural Grade: **0**  
O&M Grade: **0**  
Clock Start/From: **2**  
Clock To:  
1st Value: **4.000**  
2nd Value:  
Value Percent:  
Continuous Index:  
Within 8" of Joint:  
Remarks:

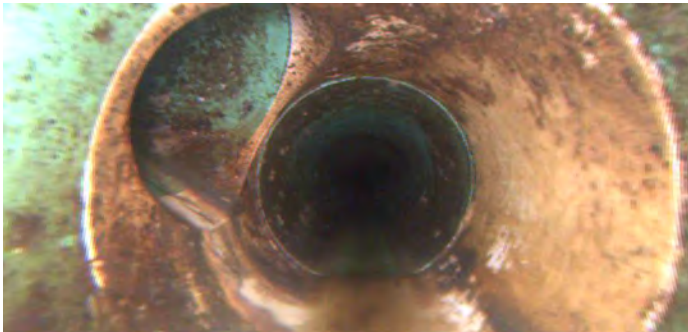
Code: **TF**  
Description: **Tap Factory**

Distance (ft): **137.5**  
Structural Grade: **0**  
O&M Grade: **0**  
Clock Start/From: **10**  
Clock To:  
1st Value: **4.000**  
2nd Value:  
Value Percent:  
Continuous Index:  
Within 8" of Joint:  
Remarks:

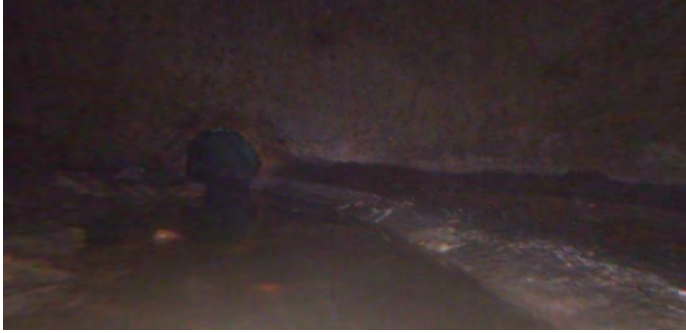
Code: **AMH**  
Description: **Manhole**

Distance (ft): **180.7**  
Structural Grade: **0**  
O&M Grade: **0**  
Clock Start/From:  
Clock To:  
1st Value:  
2nd Value:  
Value Percent:  
Continuous Index:  
Within 8" of Joint: **NO**  
Remarks: **M-103-119**

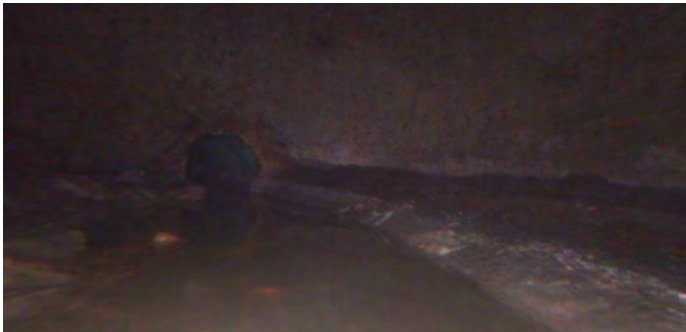
Code: **DAZ**  
Description: **Deposits Attached Other**

Distance (ft): **180.7**  
Structural Grade: **0**  
O&M Grade: **2**  
Clock Start/From: **7**  
Clock To: **5**  
1st Value:  
2nd Value:  
Value Percent: **5.000**  
Continuous Index: **F01**  
Within 8" of Joint: **YES**  
Remarks: **WANDER**
