## Profile/Photo Observation Report

Street:	<b>W 38TH AVE</b>	Flow Control:	<b>Not Controlled</b>
City:	<b>Hobart, IN</b>	Year Renewed:	
Location:	<b>Other</b>	Tape/Media #:	
Purpose:	<b>Not Known</b>	Dia/Height:	<b>8"</b>
Use:	<b>Sanitary</b>	Material:	<b>PVC</b>
Drain Area:	<b>NA</b>	Lining:	
Category:	<b>NA</b>		
Comment:

Location Details:		Direction of Survey:	<b>Downstream</b>
US MH:	<b>M-103-122</b>	DS MH:	<b>M-103-123</b>
		Total Length Surveyed (ft):	<b>63.4</b>

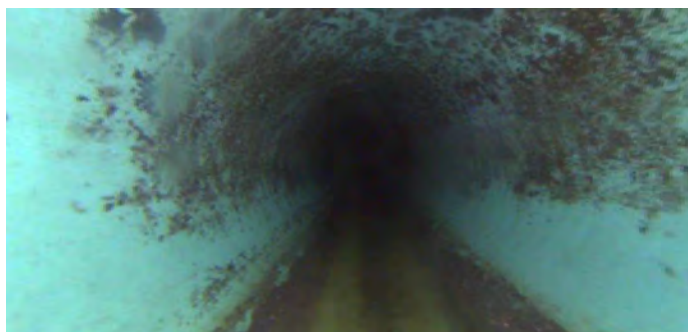
Code: **AMH**  
Description: **Manhole**

Distance (ft): **.0**  
Structural Grade: **0**  
O&M Grade: **0**  
Clock Start/From:  
Clock To:  
1st Value:  
2nd Value:  
Value Percent:  
Continuous Index:  
Within 8" of Joint: **NO**  
Remarks: **M-103-123**

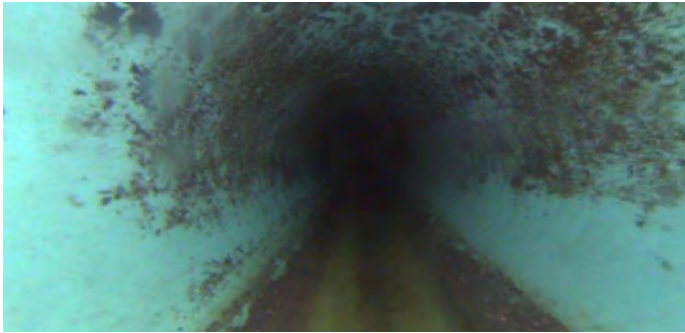
Code:	<b>MWL</b>
Description:	<b>Water Level</b>

Distance (ft):	<b>.0</b>
Structural Grade:	<b>0</b>
O&M Grade:	<b>0</b>
Clock Start/From:	
Clock To:	
1st Value:	
2nd Value:	
Value Percent:	<b>5.000</b>
Continuous Index:	
Within 8" of Joint:	<b>NO</b>
Remarks:

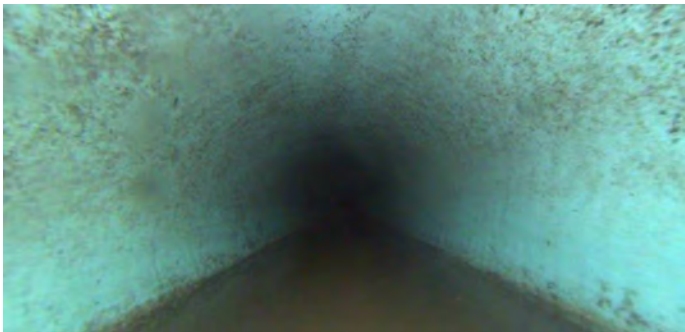
Code:	<b>MWL</b>
Description:	<b>Water Level</b>

Distance (ft):	<b>39.8</b>
Structural Grade:	<b>0</b>
O&M Grade:	<b>0</b>
Clock Start/From:	
Clock To:	
1st Value:	
2nd Value:	
Value Percent:	<b>20.000</b>
Continuous Index:	
Within 8" of Joint:	<b>NO</b>
Remarks:

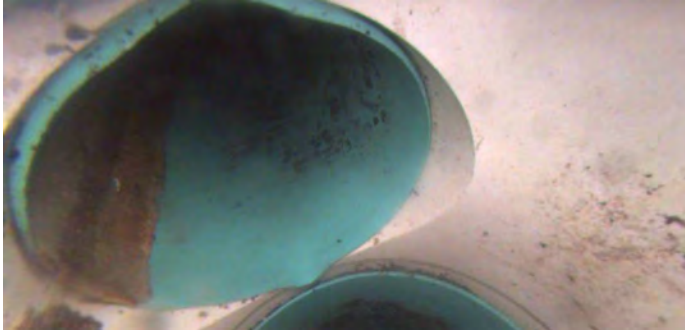
Code: **TF**  
Description: **Tap Factory**

Distance (ft): **59.6**  
Structural Grade: **0**  
O&M Grade: **0**  
Clock Start/From: **11**  
Clock To:  
1st Value: **4.000**  
2nd Value:  
Value Percent:  
Continuous Index:  
Within 8" of Joint:  
Remarks:

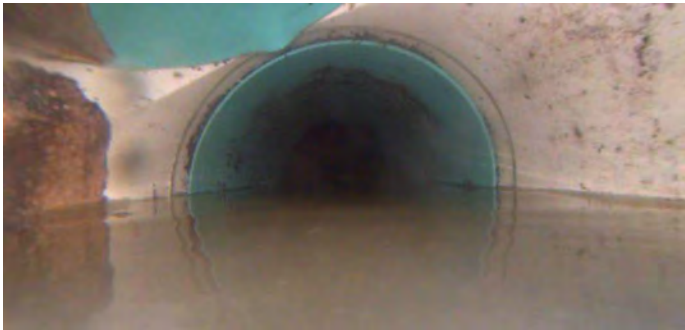
Code: **MWL**  
Description: **Water Level**

Distance (ft): **59.6**  
Structural Grade: **0**  
O&M Grade: **0**  
Clock Start/From:  
Clock To:  
1st Value:  
2nd Value:  
Value Percent: **40.000**  
Continuous Index:  
Within 8" of Joint: **NO**  
Remarks:

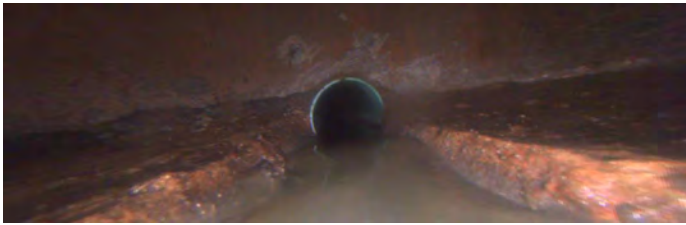
Code: **AMH**  
Description: **Manhole**

Distance (ft): **63.4**  
Structural Grade: **0**  
O&M Grade: **0**  
Clock Start/From:  
Clock To:  
1st Value:  
2nd Value:  
Value Percent:  
Continuous Index:  
Within 8" of Joint: **NO**  
Remarks: **M-103-123**
